# **WALGREENS 44-60 N STONE AVE.**

## **HISTORIC PRESERVATION FEASIBILITY STUDY**

**FINAL DRAFT REPORT, MAY - 2004**

# **BUILDING FEATURE ANALYSIS**

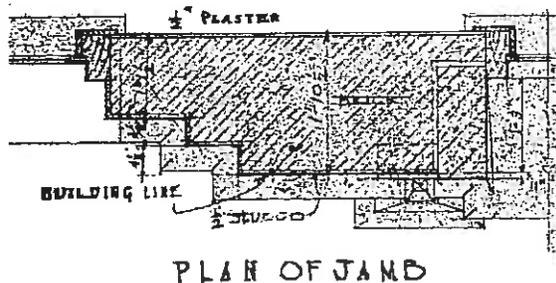
"Masonry jamb @ Pennington entry, 1929"

The historic brick masonry walls appear to be largely intact in their original form, although buried below the 1956 remodel work. The 1956 Terry Atkinson remodel drawings show the extent of existing masonry to remain, and this has been confirmed to the extent possible through selective demolition and investigation. In general terms the ceramic veneer was installed on framing and set clear of the masonry walls

below the belt-course preserving most of the detail work and much of the original heavy stucco finish in these areas. Above the belt-course much of the old brick, though still in place, was in-filled and/ or overlaid with new brick to form a flat surface to receive the new thin-set ceramic veneer. Masonry piers at the storefront along Stone and at the corner tower were removed and replaced with steel columns in 1956; this is documented but is also plainly visible.

Remove non-historic (1956) ceramic veneer panels, associated steel framing, and aluminum sun shade louvers. Carefully remove veneer that is thin-set to historic masonry. Carefully remove in-fill and overlay masonry added in 1956 without damage to the underlying historic brick. Replace missing storefront piers and missing detail where needed with new matching brick. Evaluate the entire façade and repair any structural deficiencies as needed. Evaluate the entire façade and patch/ repair stucco as needed, re-stucco above belt course, and consider re-stucco or skim coat of entire building with finish to match existing historic texture.

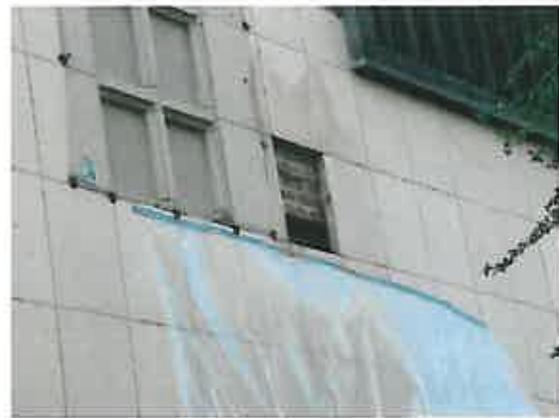
"Existing brick at Pennington entry uncovered during selective demolition"

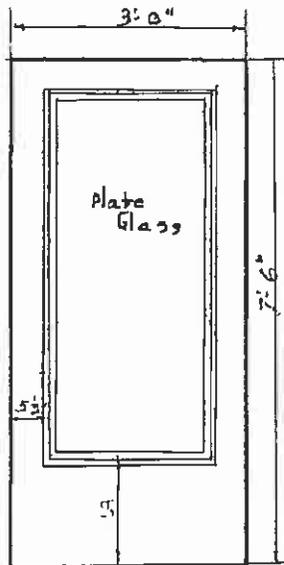
"Typical storefront door typ, 1929"

All, or nearly all, historic exterior doors and storefronts were removed or replaced during the renovation of 1956 and are missing. The original 1929 Roy Place construction

Verify original wood species and custom fabricate doors, frames, door transoms, and storefront sections per original details using a custom door shop.

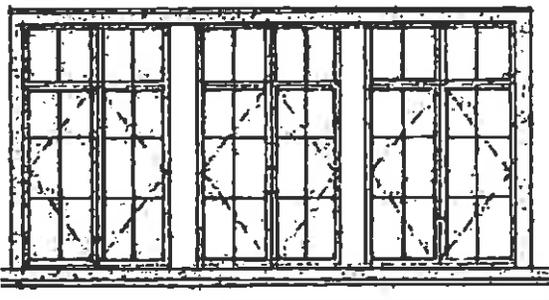
"Steel sash in redwood frames, 1929"

Most of the original exterior windows and frames were removed in 1956. Fortunately, though, the original steel sash remains in place on the east elevation along the alley;

Steel sash is still manufactured in sections very similar or identical to the existing historic windows by A&S Windows (Series 200 Commercial Windows for Historic Landmarks) and possibly others. Remove existing 1956 windows, prep openings, and install new rough sawn redwood mullions, commercial steel sash, clear 1/8" glass, putty glazing, and hardwood interior sills and trim to match original details. Service and preserve remaining historic sash.

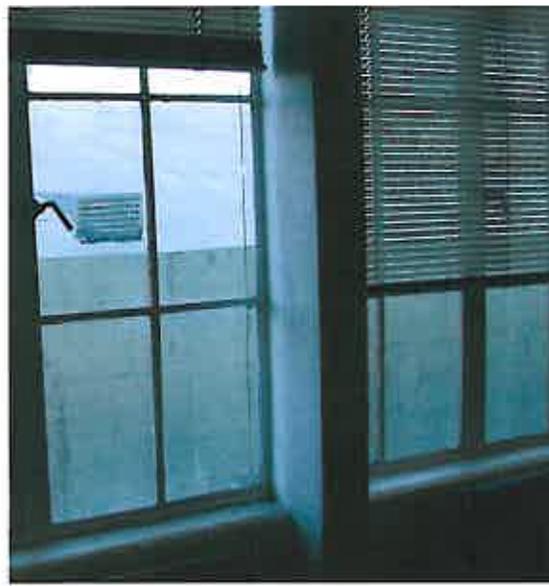
presumably these were left because they are not visible or accessible to the public. These provide excellent physical evidence of the type of steel windows used. The 1929 Roy Place drawings provide excellent documentary evidence of the configurations of the sash along the street frontages, and this is confirmed by the 1930s era photographs. The Place drawings have 1½" scale details of storefront transom windows and ¾" scale details of other windows. Wood species of interior trim is not noted.

"Existing historic steel sash, 2004"

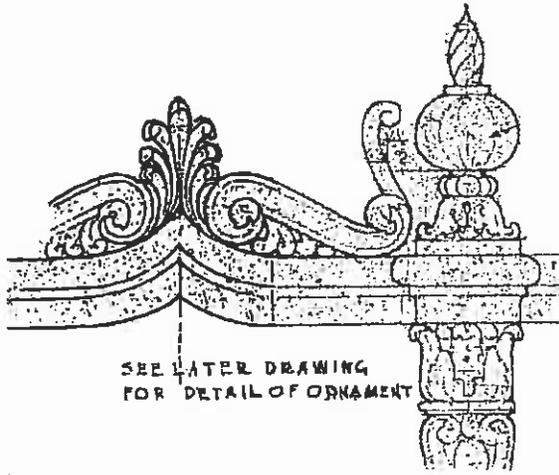
"Cast stone detail, 1929"

The bottom molding of the belt-course was discovered intact in several areas during selective demolition. Unfortunately it seems that most or all other cast stone was removed in 1956 and is lost. The original Roy Place drawings have 3/4" elevation and section details of all areas. The 1930s era photographs show the stone in relatively good detail and confirm that it was in fact built per the original drawings.

Use the remaining historic material as a sample and standard of quality to reconstruct and install new cast stone ornamentation to match the original. Cast stone is still produced today in much the same way it was in 1929. The Cast Stone Institute ([www.caststone.org](http://www.caststone.org)) lists over forty producer members, mostly in Texas and the southeastern states. The ideal panel size is approximately 2 feet by 5 feet. The original drawings show a jointing pattern considerably tighter than this but note that some joints were false.

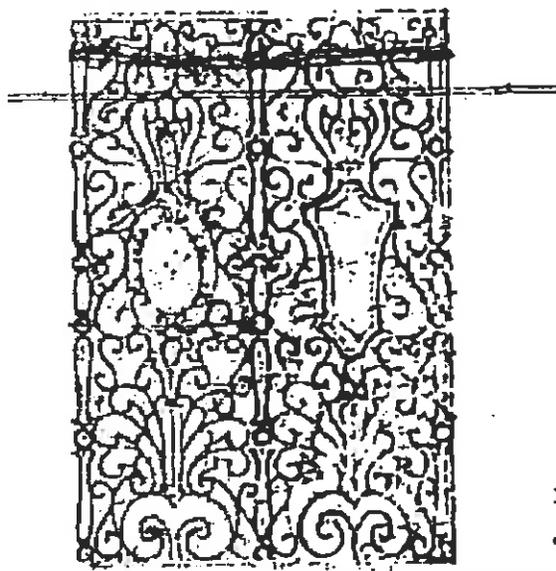
*"Wrought iron detail @ Walgreens building, 1929"*

All decorative wrought iron grilles were removed from the first floor transoms as part of the 1956 remodel and are lost. The 1929 drawings include ¾" scale elevations of the grille work. The historic photographs clearly show that some screens or grilles were installed but the design of the grilles can not be conclusively confirmed because of lighting and distance. In this case the drawings are the best documentary evidence available.

Reconstruct and install grilles based on the historic drawings. To limit conjecture other works by the same architect could be studied for additional clues. Place used this same material on two other notable projects (the Pima County Court House and the Veterans Administration Hospital) done in the same style (Spanish Colonial Revival) and in the same year (1929) as the Walgreens Building. It is likely that all three were on the boards in his office at the same time.

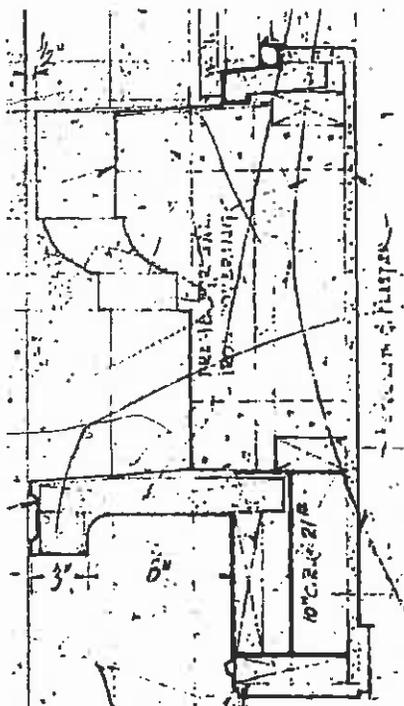
"Transom bar detail, 1929"

The galvanized iron transom bars were removed as part of the 1956 remodel and are lost. However there is ample documentary and physical evidence to support their reconstruction; the 1929 drawings provide 1½" scale details of the transom bars, the historic photographs depict them in some detail, and the plaster outline remains where they were removed. There is one notable discrepancy in the way the transom bars were built from how they were detailed. The original drawings show the transom bars continuous on both the Pennington and the Stone Ave sides, but in actuality the Pennington side transom bar was installed between (and broken by) the storefront piers. This is the single biggest variation noted between Place's drawings and the original built form.

Reconstruct the "crimped" galvanized iron transom bars and wood framing in accordance with their original details. However, place the transom bars based on their original plaster profile which remains on the building and which confirms the placement seen in the historic photographs.

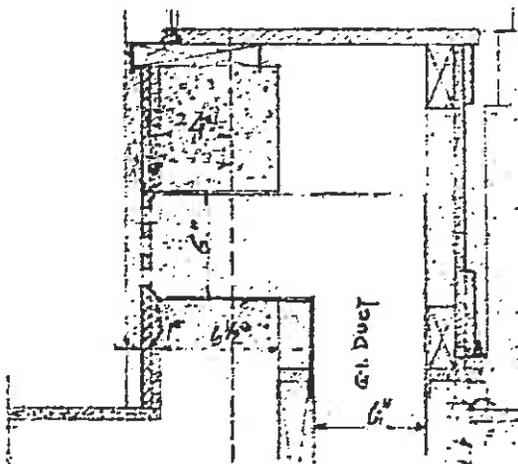
"Detail of ceramic tile base, 1929"

Pieces of this historic tile work remain, in relatively good condition, in two storefront bays behind the retrofit ceramic veneer installed in 1956. No other evidence of the original tile was seen.

Santa Teresa Tile, who helped with historic research of these tiles, has provided samples of newly made tile from a tile shop in Berkeley California that closely resemble the originals. Color, glaze, and finish are almost indistinguishable from the historic and these replacement tiles can be made in custom sizes matching the original 3"x3" field tiles and 6"x6" ventilators.

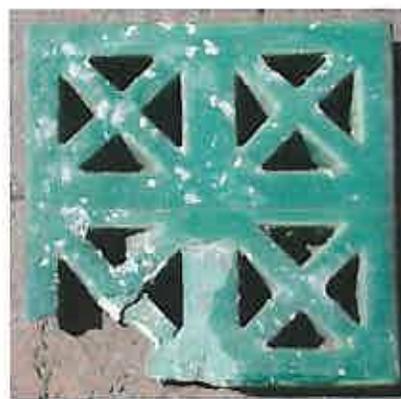
"Existing historic vent tile, 2004"

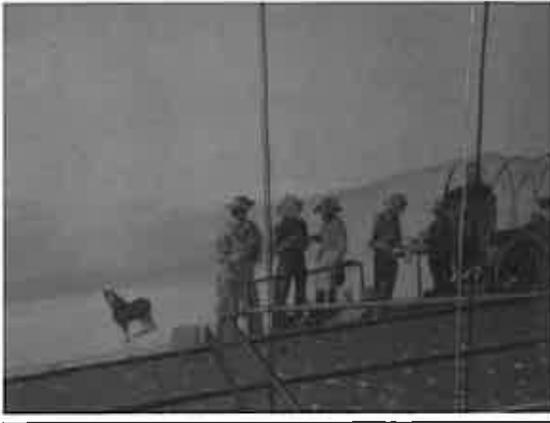
*"Mural at interior wall, Pre-1957"*

It appears as if much of the original interior plaster finish and wood detailing of the high volume first floor retail space remain intact. An acoustic tile ceiling and grid was installed during the rehab of 1956 and the upper reaches of the space were forgotten. This "ceiling" space is cluttered with retrofit air conditioning and ventilation

ducts, plumbing and fire sprinkler lines, and electrical conduit but otherwise has a high degree of integrity.

Depending on the end user, the County should consider removing grid ceiling and repairing and/ or renovating existing historic interior detailing and spaces. Lighting as well as routing for air conditioning ducts, plumbing, and fire sprinkler lines will need to be addressed.
