NOTICE OF VIOLATION # PC 0912-067

Complaint Investigation Report

Tracking ID: PC0912-067

Source: ASARCO, LLC - Mission Complex

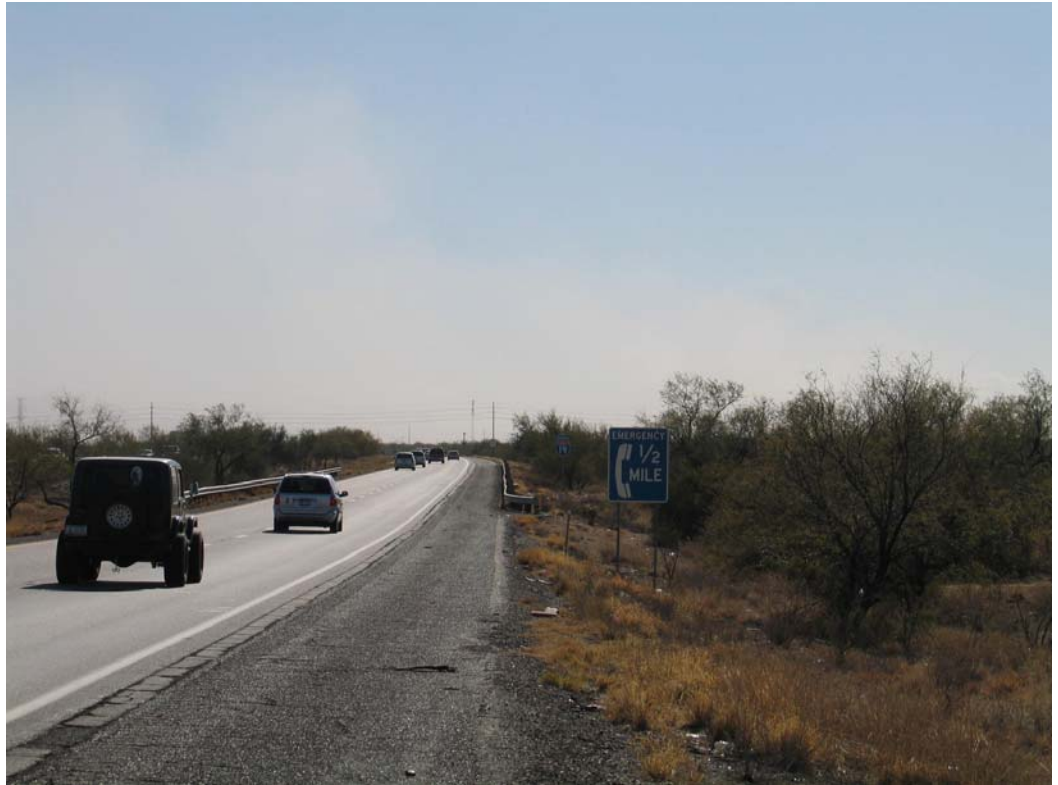
View of the light colored visible particulate emissions generating from tailings dam #8 on ASARCO, LLC – Mission Complex property observed crossing I-19 as the inspectors drove southward on I-19 toward Sahuarita Road at 1:00 pm.

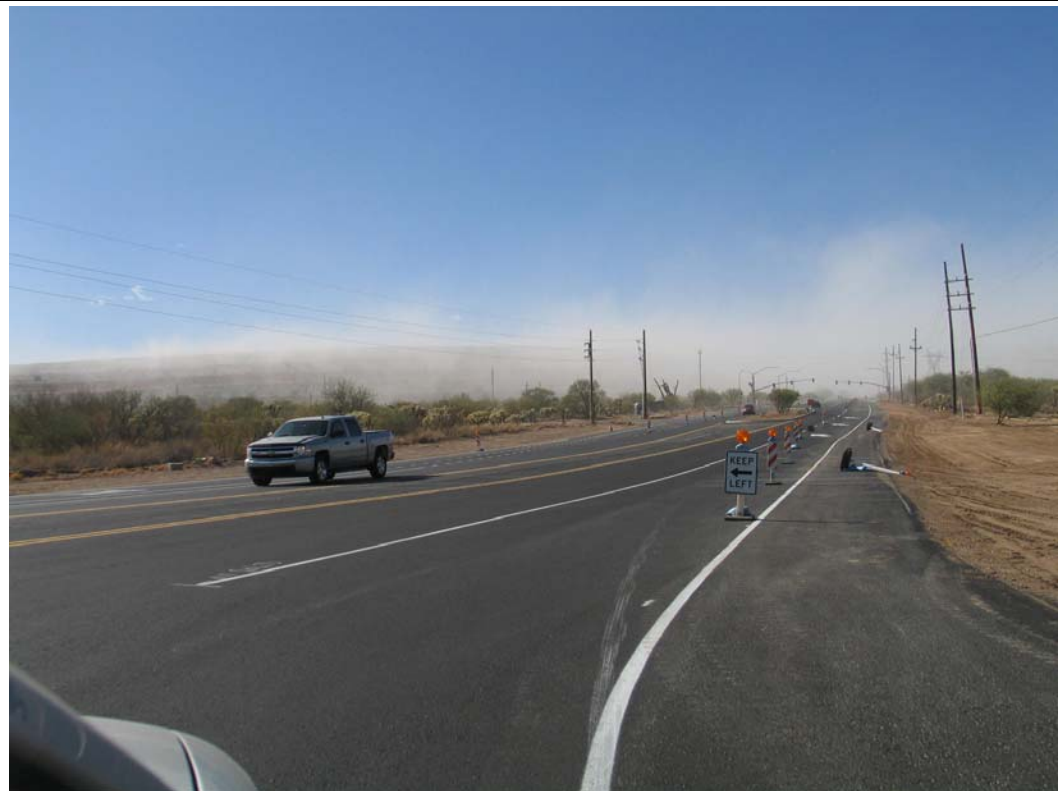
Photo No. 2

View of the light colored visible particulate emissions generating from tailings dam #8 at 1:05 pm as viewed from the side of Sahuarita Road west of I-19. The visible emissions can be observed blowing across Helmet Peak Road and obscuring visibility.

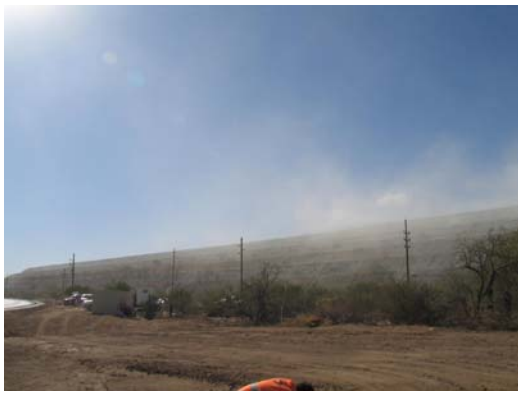
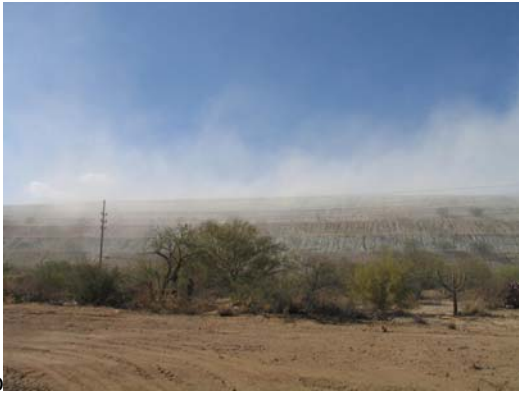
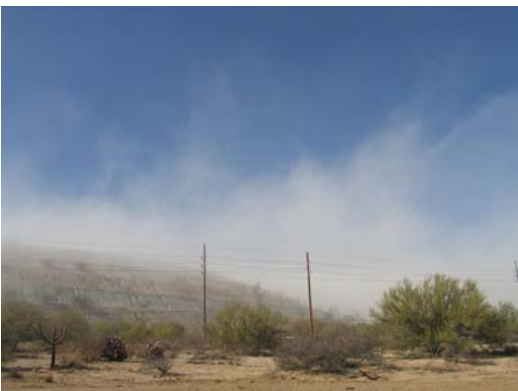
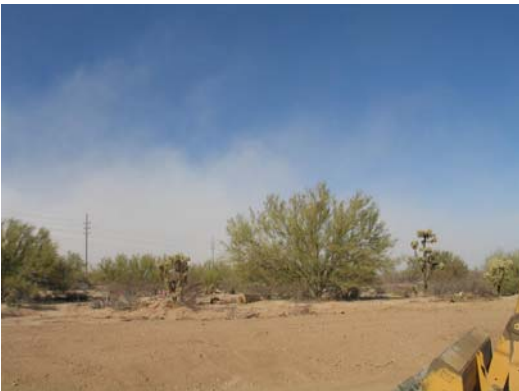
<p>Photo No. 3 a,b,c,d</p>

<p>Photo Description:</p> <p>View of visible particulate emissions generating from tailings dam #8 blowing northeast as viewed from La Canada Drive at 1:10 pm.</p>	<p>a</p>

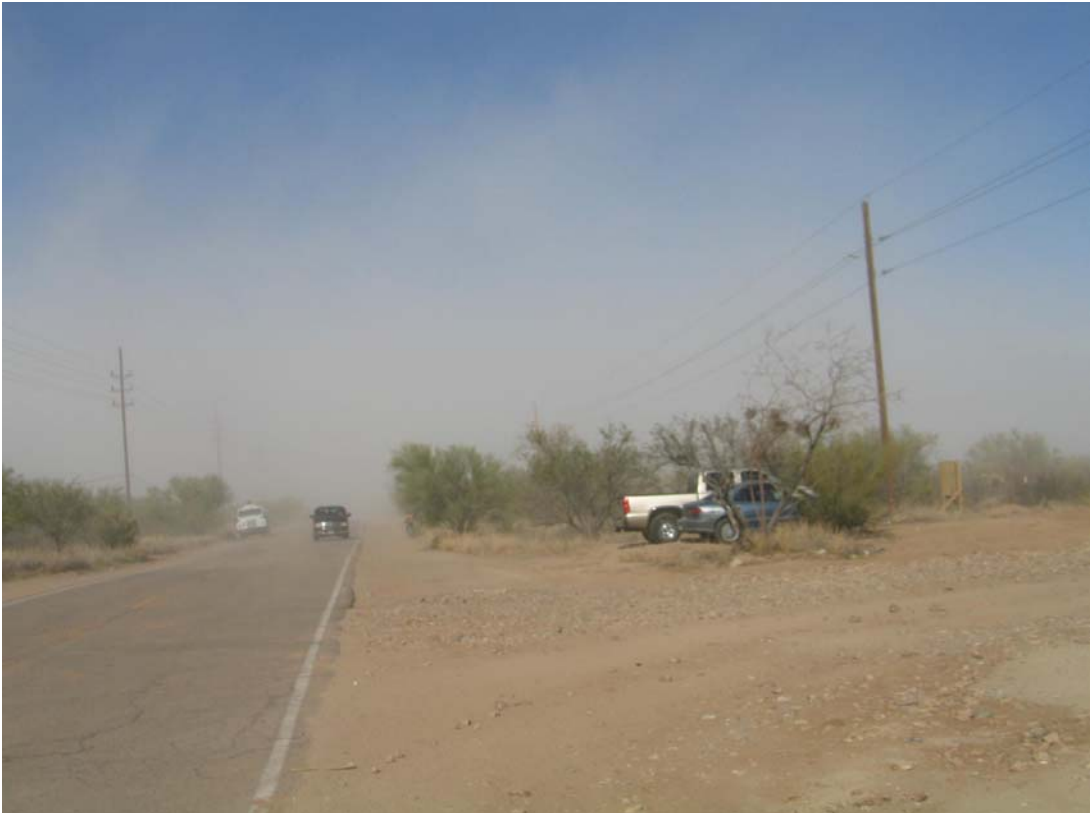
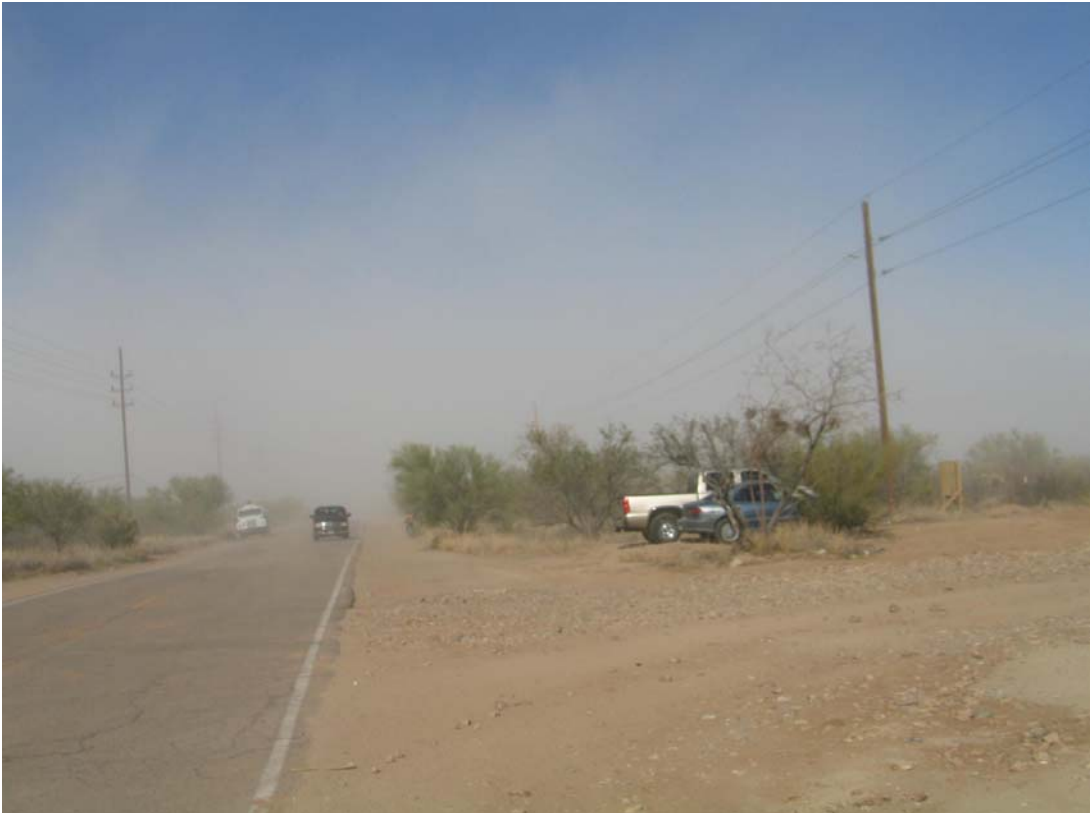
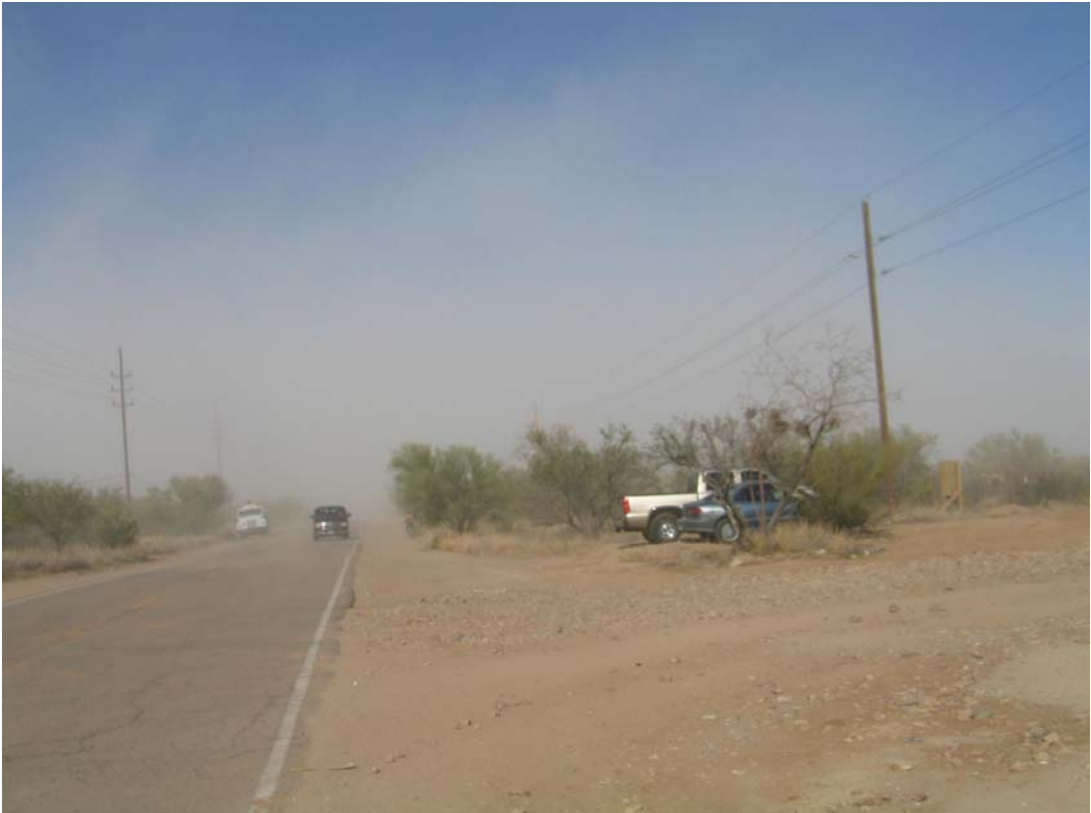
<p>Photo No. 4</p>

<p>Photo Description:</p> <p>View visible particulate emissions plume generating from tailings dam #8 crossing the east property line at La Canada Drive. The inspector took a VE between 1:15 pm and 1:22 pm using the telephone pole along La Canada Drive as a background and a guide to the east property line of ASARCO, LLC – Mission Complex.</p>

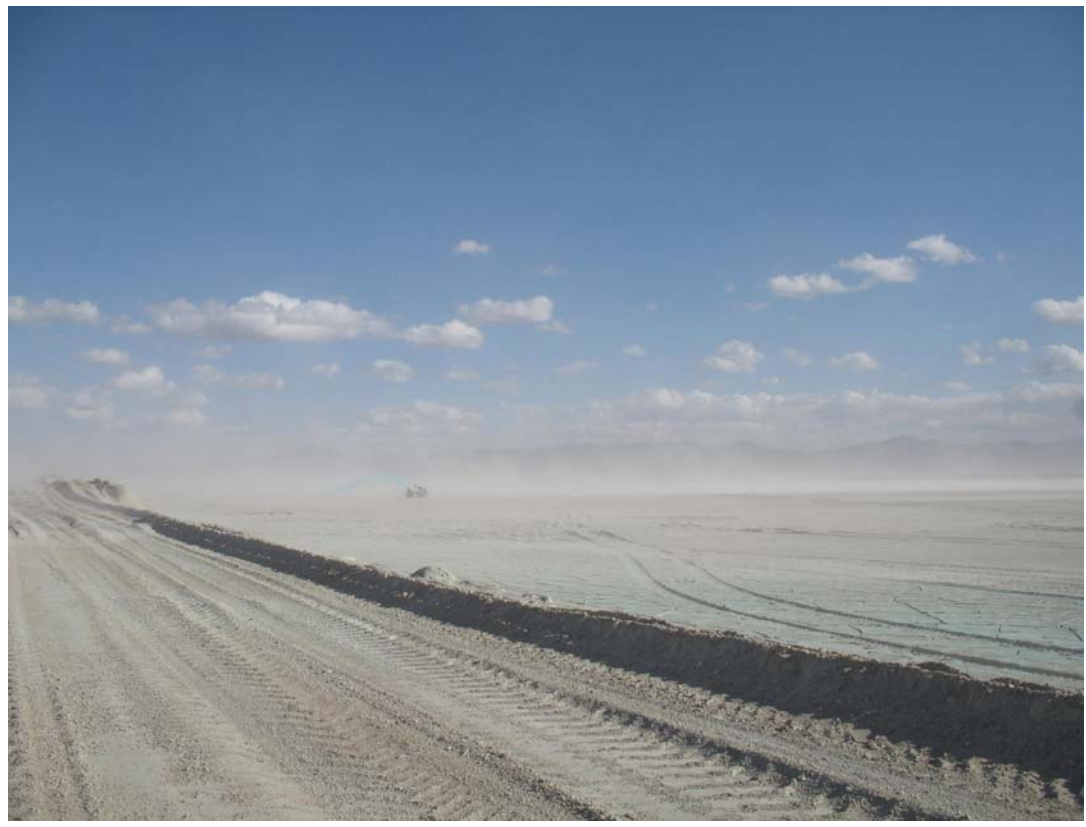
Photo No. 10

The inspector walked to the southeast quadrant of the tailings dam surface and observed that trucks were applying water and polymer to the area on the southeast side of the tailings dam surface. The inspector also observed that only a relatively small portion of upper berm construction was required to complete the berm building.

Date: 11/22/2009	
Photo Description: View of a truck applying water and polymer on south east quadrant of the tailings dam surface.

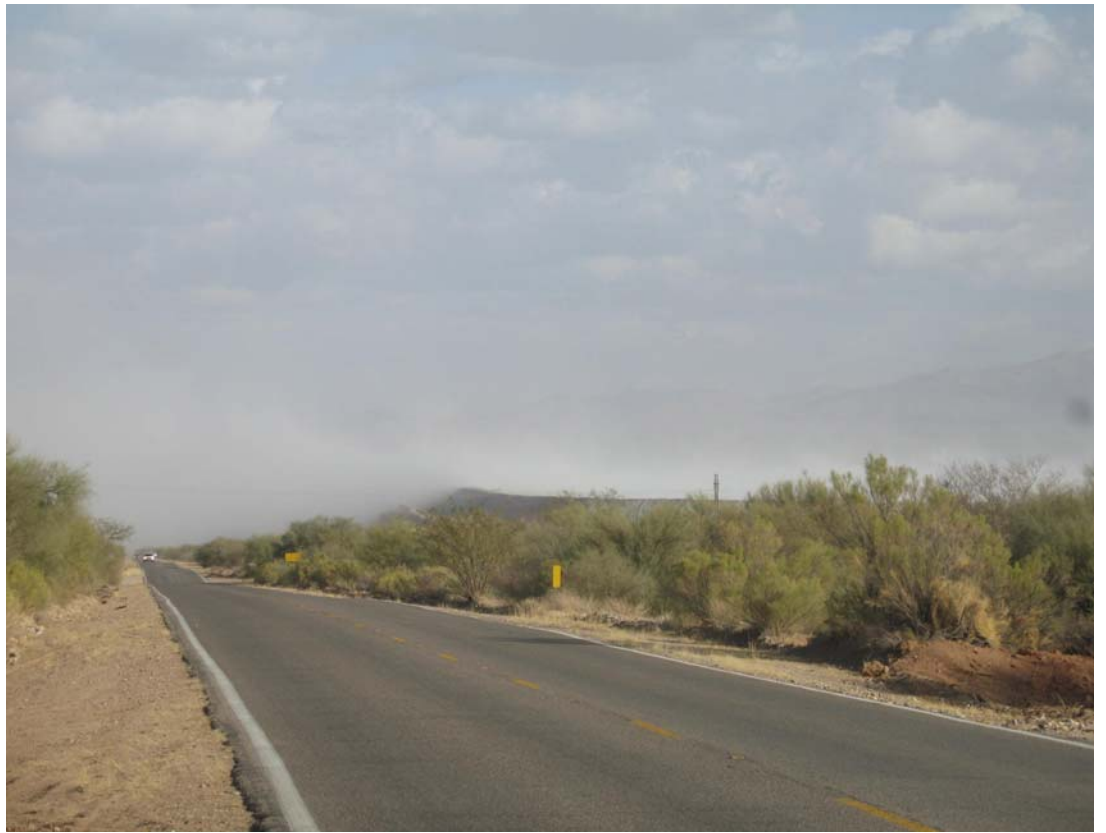
View of the particulate emission plume and generating from tailings dam #8 blowing across Helmet Peak Road as the inspector views looking east at 3:21 pm.
