# Santa Cruz River at Canoa Ranch Photo Monitoring

Field Work Dates  
June 20-21, 2006

Pima County  
Natural Resources,  
Parks and Recreation

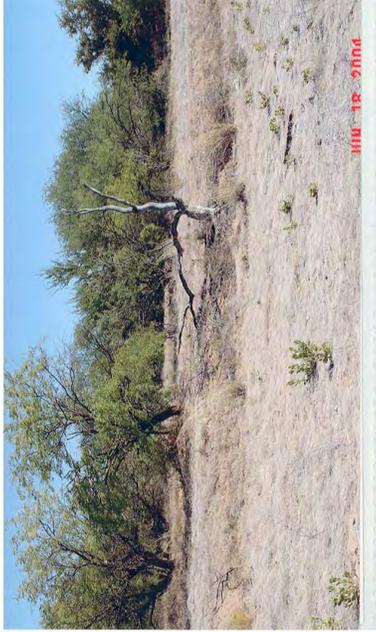
**Photo Point No. 1 South**  
\*\*\*  
The bunch grasses are taller. There are fewer tumbleweeds. Mesquite on far left appears less vigorous.

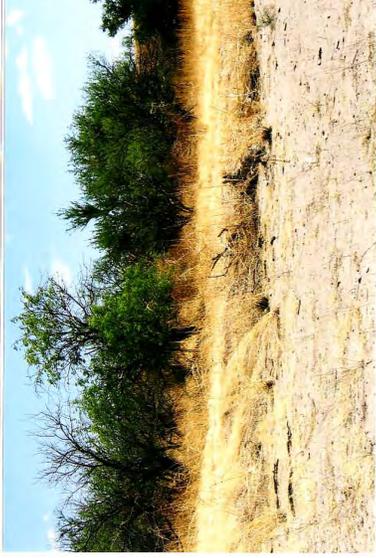
**Photo Point No. 1 South**  
The dead tree has fallen over. Evidence of overbank flooding. Trees show signs of stress likely due to extended drought conditions.

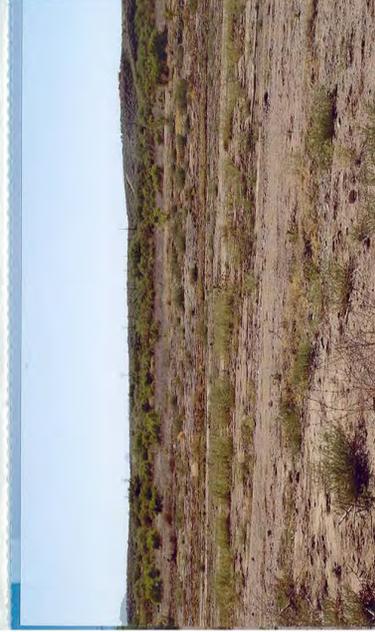
**Photo Point No. 1 West**  
There is more groundcover in the channel (primarily tumbleweeds). There is more groundcover on the far bar. There is an increase in foreground cover.

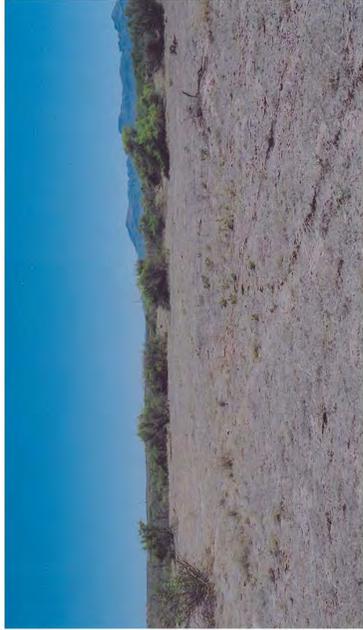
**Photo Point No. 2 South**  
There is little change. Slightly more groundcover.

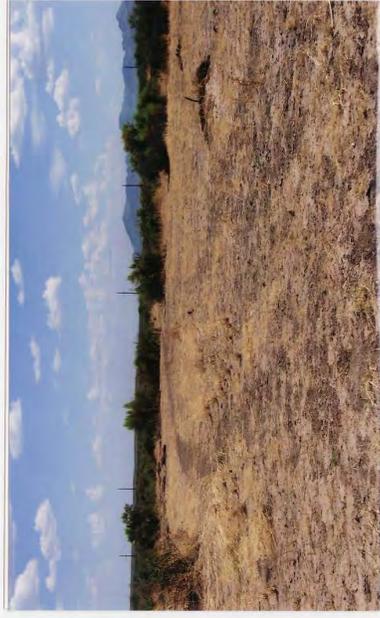
**Photo Point No. 2 South**  
There is little change. Debris mound (center right) seems to have increased amount of debris.

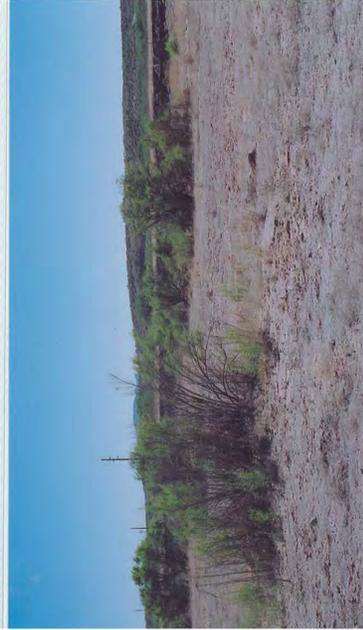
**Photo Point No. 2 West**  
There is little change. Slightly more groundcover.

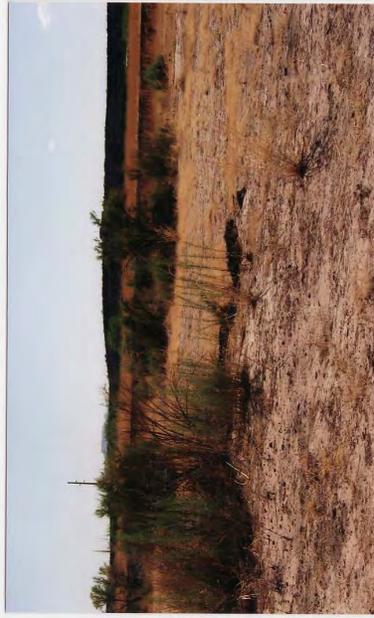
**Photo Point No. 2 West**  
Main burro bush has died. Resprouts occurring. Debris piles evident.

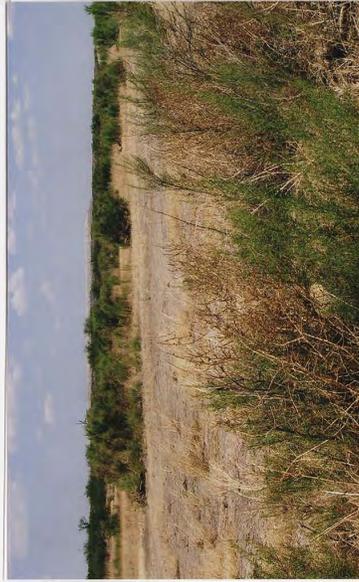
**Photo Point No. 3 North**  
\*Stake not found. Old coordinates did not match photos, restaked photopoint with new GPS coordinates. Increased recruitment and growth of burrobush and tumbleweed. Increased debris. Channel is more apparent.

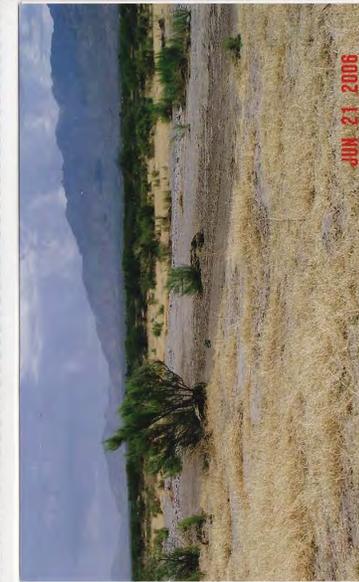
**Photo Point No. 3 East**  
\*Stake not found. Old coordinates did not match photos, restaked photopoint with new GPS coordinates. Flood flows have reduced burrobush and washed away debris. Channel is more evident. Coarse materials in channel.

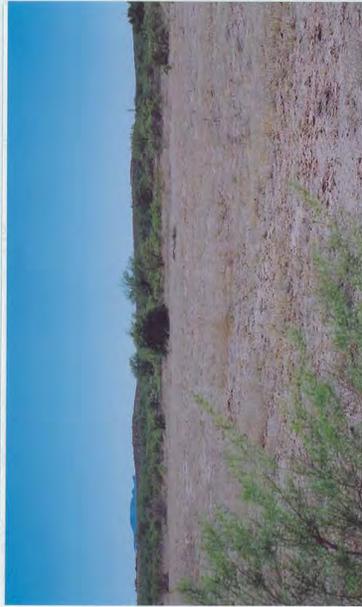
**Photo Point No. 3 West**  
 This site appears very similar to conditions in 2002. There appears to be more flood debris at the base of the shrub in the far left of the photo.

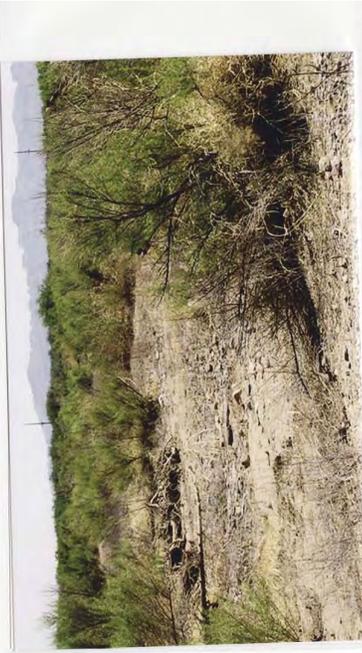
**Photo Point No. 3 South**  
 \*Stake not found. Old coordinates did not match photos, restaked photopoint with new GPS coordinates. Photo does not seem to represent 3 South. Increase of burrobush and woody debris.

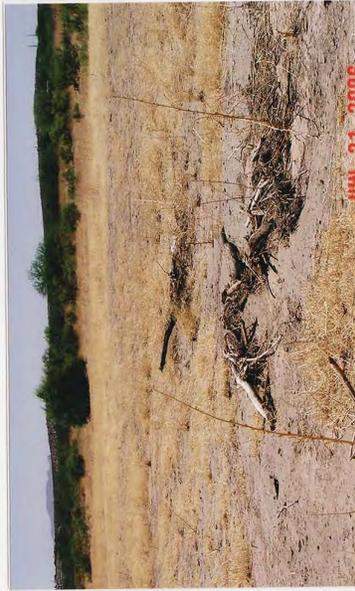
**Photo Point No. 3 West**  
 \*Stake not found. Old coordinates did not match photos, restaked photopoint with new GPS coordinates. Increase in groundcover. Increase in debris piles.

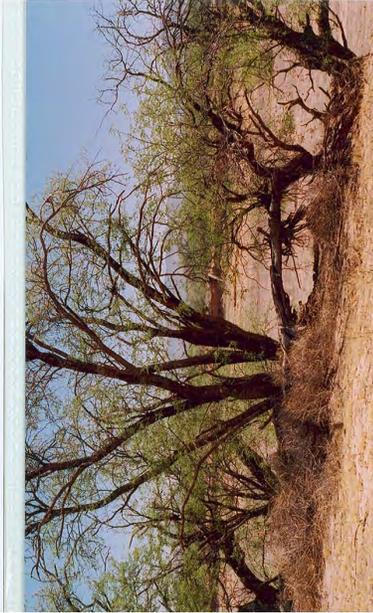
**Photo Point No. 7 East**  
No significant change.

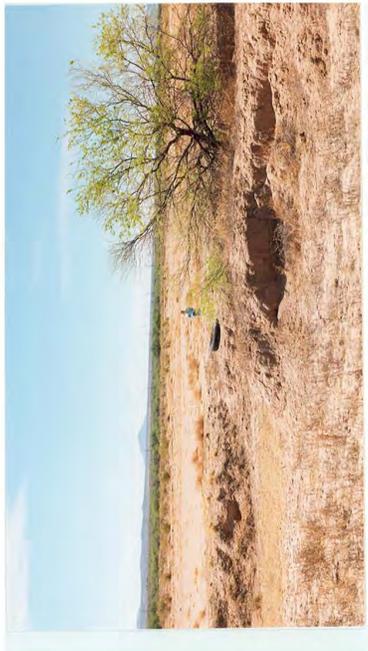
**Photo Point No. 9**  
Looking south across the Santa Cruz River. Note the foreground head cuts that are beginning to extend into the field on the west bank of the river.

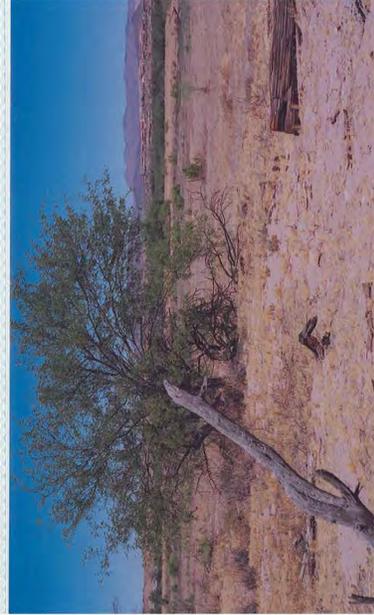
**Photo Point No. 13 West**  
Desert broom in channel is green. There are no tall annuals.

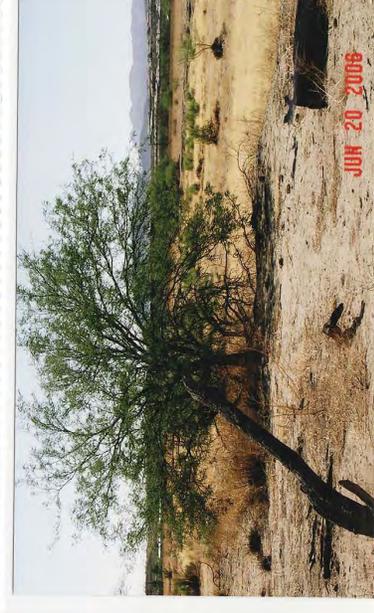
**Photo Point No. 13 West**  
Little change. More fall annuals, less short annuals. Mexican paloverde (center right) has increased in vigor. Increased flood debris on Mexican paloverde and shrub to right.

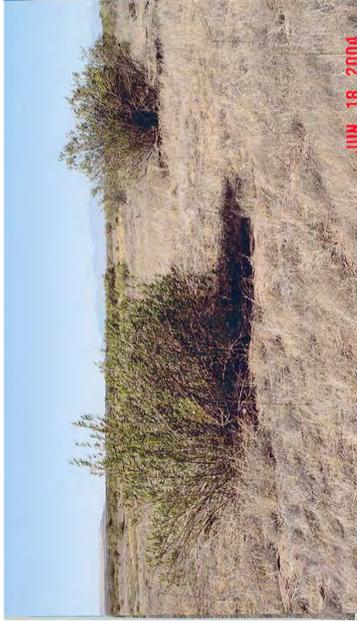
**Photo Point No. 15 North**  
\*\*\*

The seep willows have increased in size and vigor. There is an increase in groundcover. Air quality appears better, despite the very windy conditions.

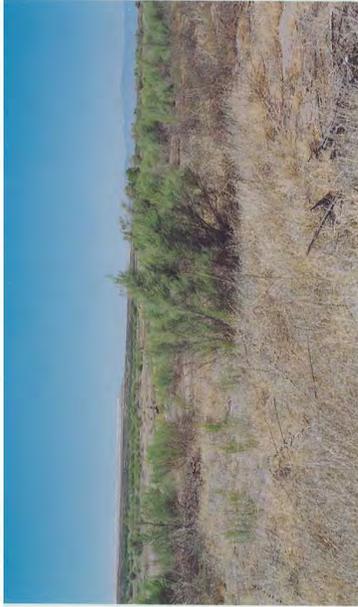
**Photo Point No. 16 North**  
 There is an increase in grass cover. The burro bush is much more vigorous. Less dust present, despite very windy conditions.

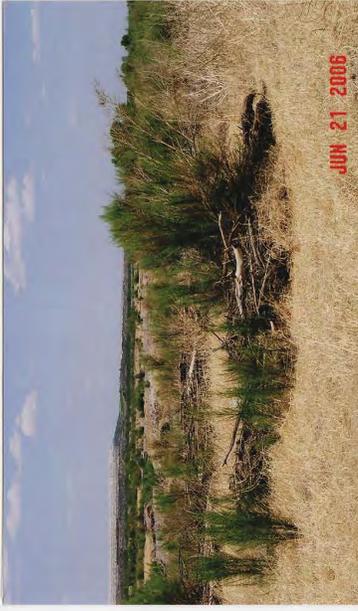
**Photo Point No. 16 North**  
 Increase in woody debris. Increased burrobush recruitment.

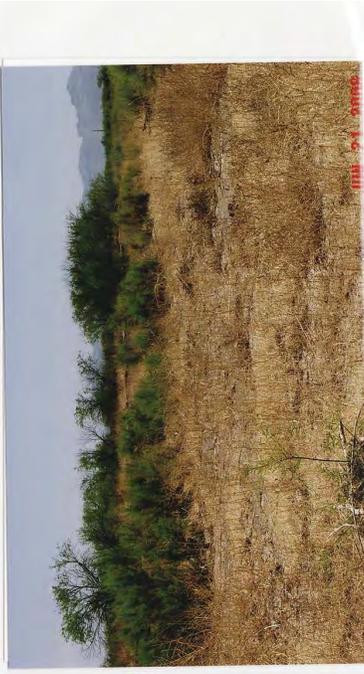
**Photo Point No. 16 South**  
Photo is not an exact match. Increase in burrobush vigor. Increase in groundcover, primarily tumbleweed.

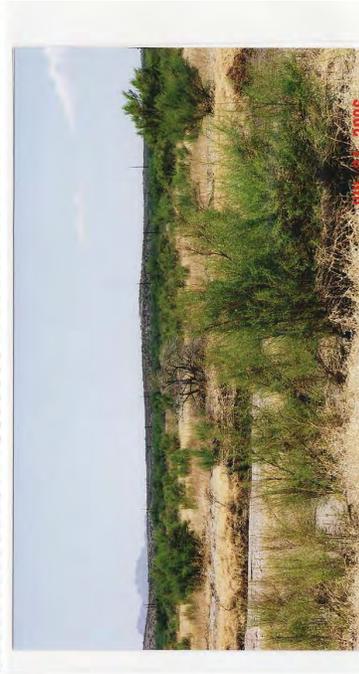
**Photo Point No. 16 West**  
Photo is not an exact match (zoomed in too closely). Increase in burrobush vigor. Mesquite (center left) has died, or is extremely stressed.

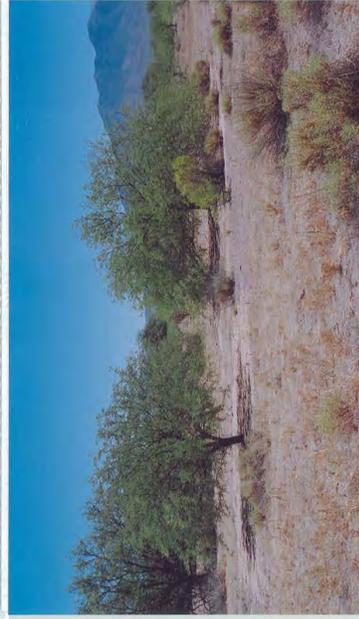
**Photo Point No. 18 East**

Shorter annuals have replaced the taller annuals seen in 2002.

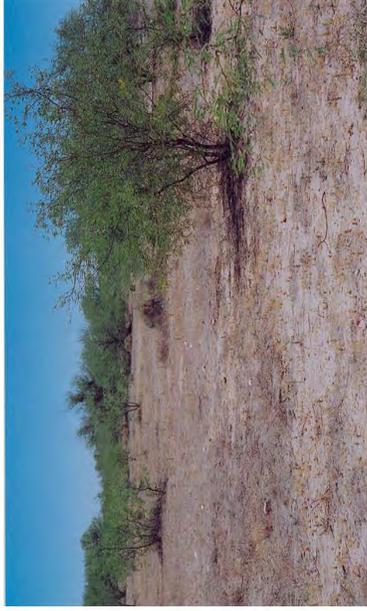
**Photo Point No. 18 South**  
Shorter annuals have replaced the taller annuals seen in 2002.

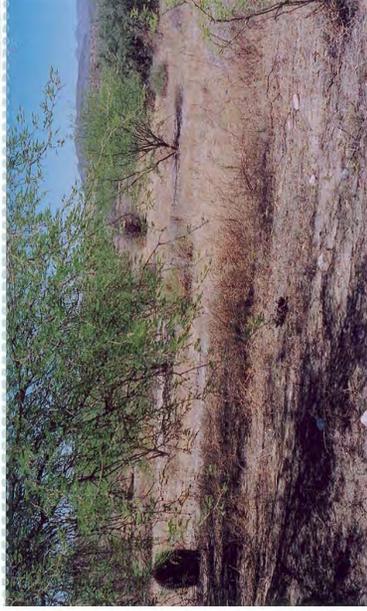
**Photo Point No. 18 West**  
The shrub in the upper middle appears dead or near-dead.

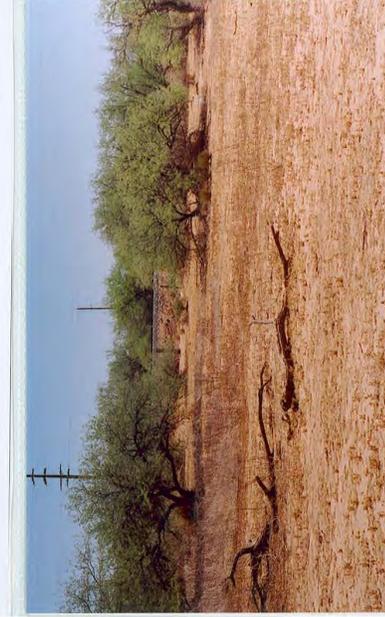
**Photo Point No. 20 East**  
Shorter annuals. Increased mesquite vigor.

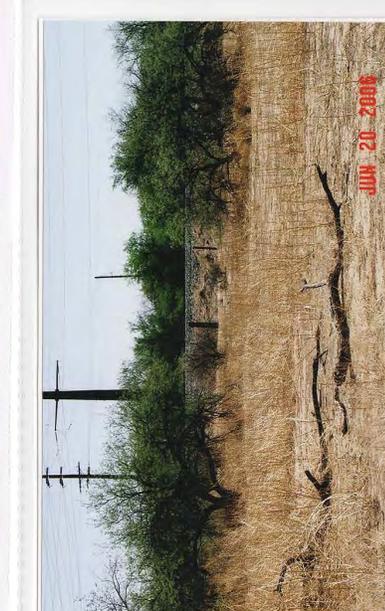
**Photo Point No. 20 East**  
More tall annuals. Mesquites slightly stressed.
