Re: **Davidson Canyon Unique Water Nomination**

*Unique Waters Nomination*

# DAVIDSON CANYON

**Unique Water Nomination**  
**for**  
**Davidson Canyon**

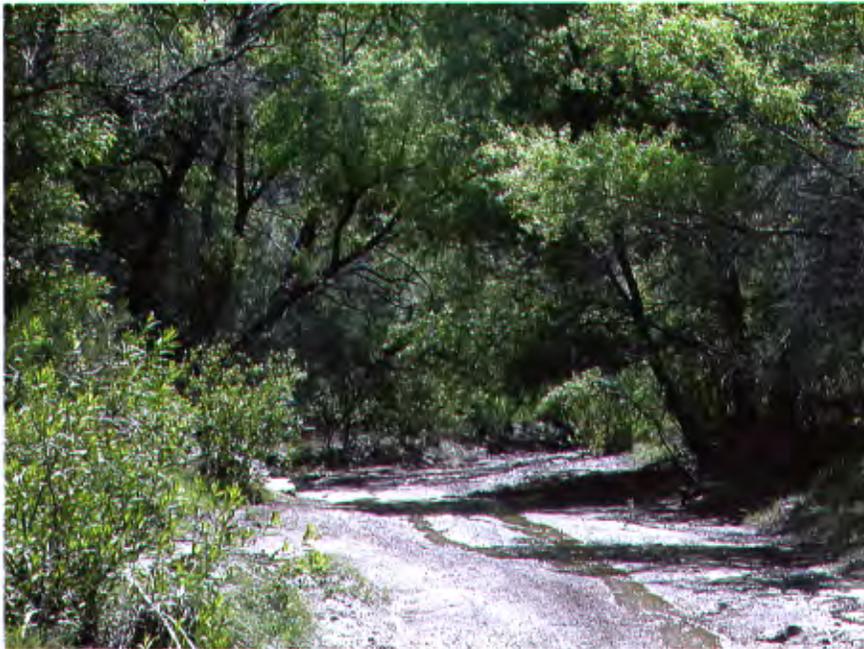
Davidson Canyon near the spring south of I-10 (looking upstream). Photograph by Gloria Browne, November 2004.

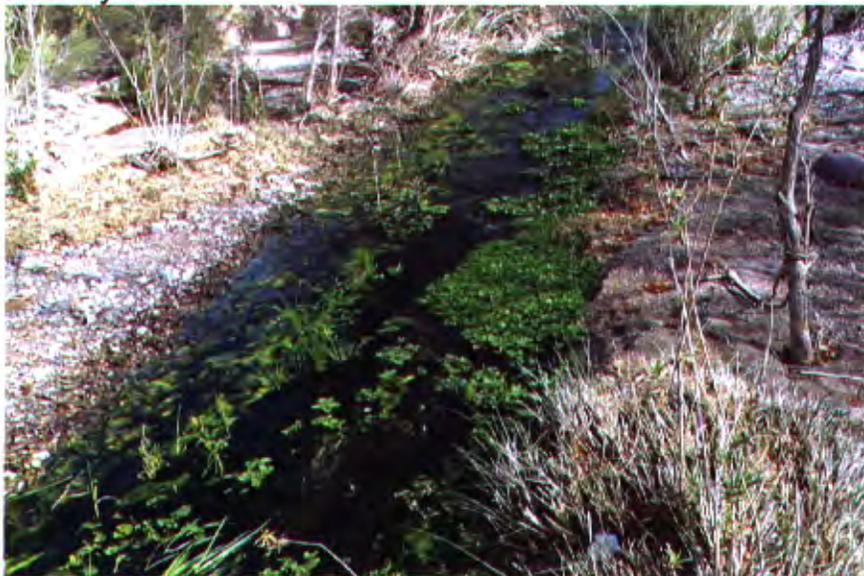
Davidson Canyon Creek, near spring south of I-10. Photograph by Linwood Smith, January 2004.

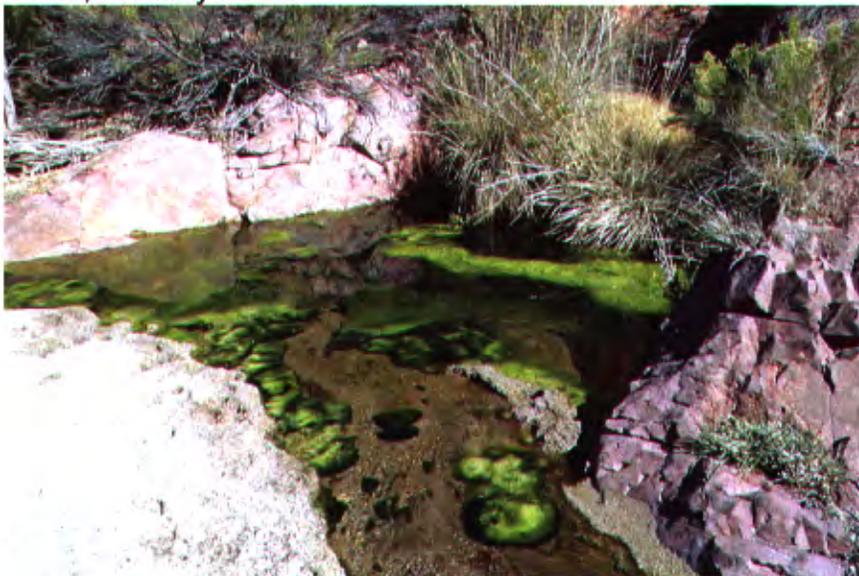
Instream pool in Davidson Canyon near spring south of I-10. Photograph by Linwood Smith, January 2004.

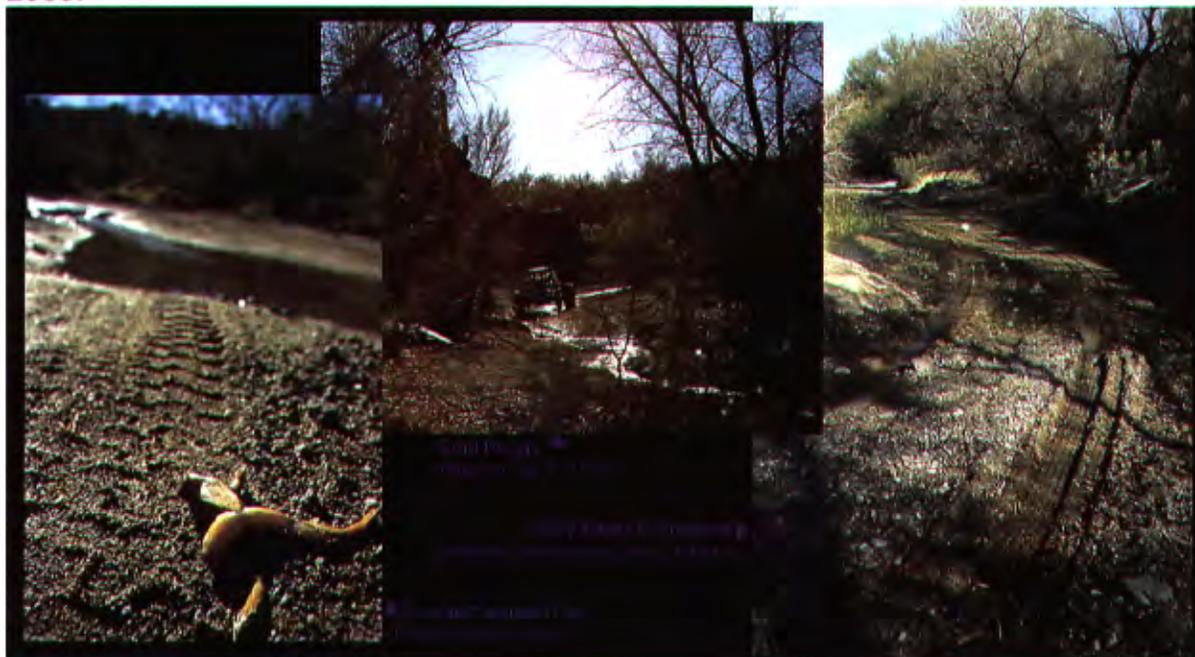
Series of photos showing streamflow and the hazards of ORV use in Davidson Canyon. Notice the dead lowland leopard frog (left). Photographs by Dennis Caldwell, February 2003.
