~~DRAFT~~ MEMORANDUM

Re: **Importance of Conserving Resources in the Altar Valley**

TASK THREE:
INVESTIGATE AND DOCUMENT HISTORIC CONDITIONS

**BRAWLEY WASH GRADE CONTROL STRUCTURE
ENVIRONMENTAL ASSESSMENT**

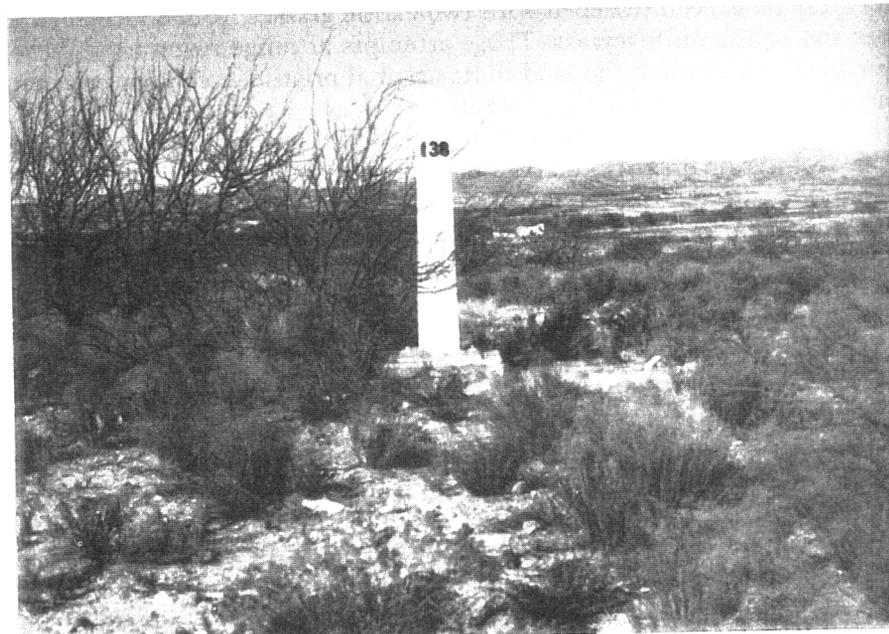
Photo 3.1 (top). Boundary monument 138 in 1893. Source: Humphrey (1987: 294). The monument is 2.5 miles east of the town of Sasabe, which was the nearest water source at the time. Note the absence of mesquite trees or shrubs. The grasses appear heavily grazed but still constitute a cover of vegetation. Humphrey notes that the area “was still essentially open, rolling prairie grassland” in 1930, when he visited as a graduate student (1987: 293).

Photo 3.2 (bottom). Boundary monument 138 in 1983. Source: Humphrey (1987: 294). In his annotations of these photos, Humphrey writes: “A large-scale, extensive mesquite eradication program has been carried out recently north of the boundary here on what is now known as the Buenos Aires Ranch. Were it not for this program, the area showing to the right of Monument 138 and to the left of No. 139 [see photo 3.4] would have appeared in the repeat photos as a mesquite woodland, as it still is across the line in Mexico. The range, both north and south of the boundary throughout this area, has been heavily grazed for many years, and grazing pressure is still extreme on the Mexican side. In Arizona, not only has much of the mesquite been removed, but grazing pressure has been reduced...” (1987: 293).

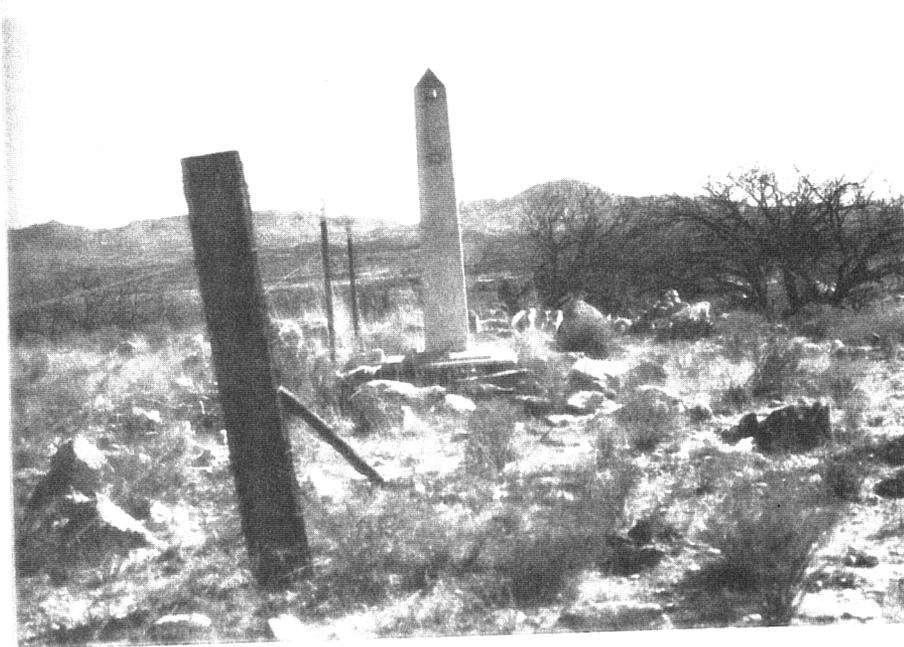
Photo 3.3 (top). Boundary monument 139 in 1893. Source: Humphrey (1987: 295). The lack of grass cover compared to Monument 138 was probably related to this area's greater proximity to water at Sasabe, 0.2 miles to the west.

Photo 3.4 (bottom). Boundary monument 139 in 1983. Source: Humphrey (1987: 295). The photo is taken looking to the east, so that the Buenos Aires Ranch, where mesquites had been cleared, appears on the left.

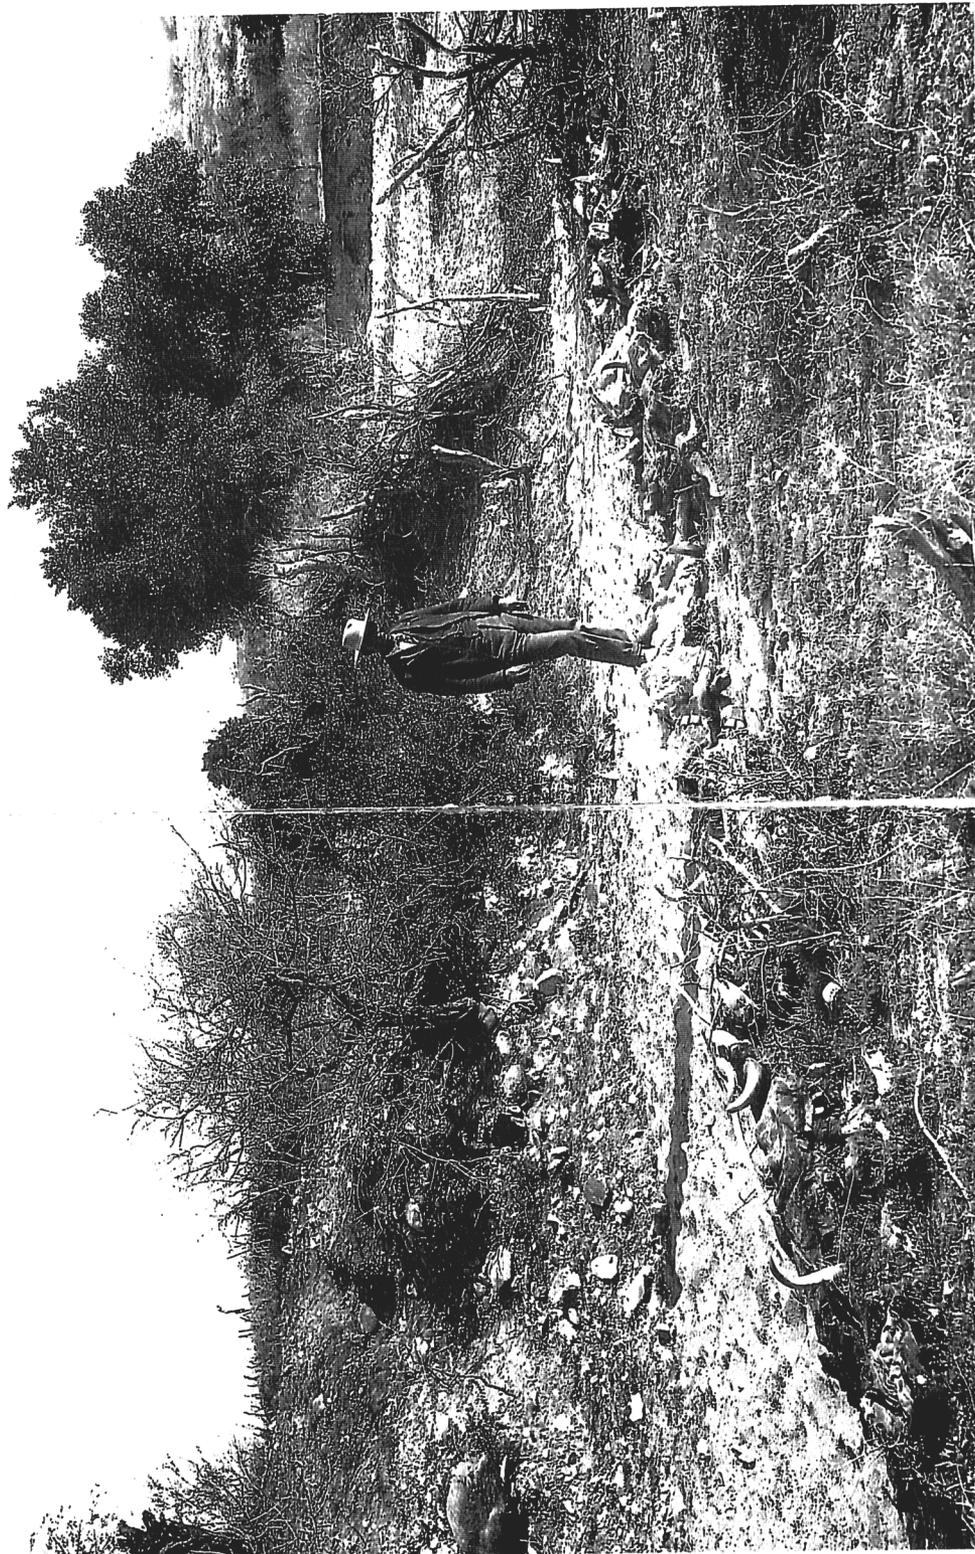
Photo 3.6. Cattle bones along Arivaca wash, 1903. Source: Bahre and Shelton 1996 (reprinted from National Archives, original by David Griffiths). Note the fresh-cut arroyo in the center right of the photo. As far as we know, this arroyo formed prior to the entrenchment of the main Altar Wash.

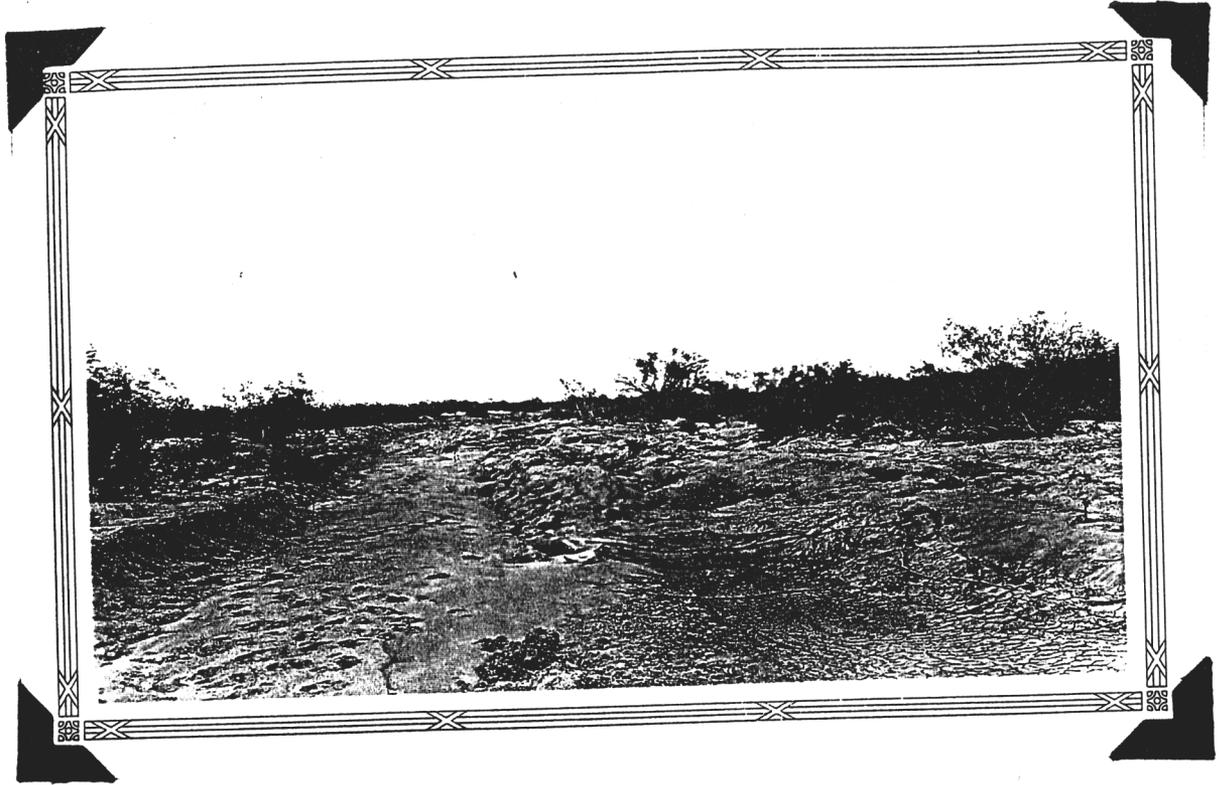
Damage done to flood water ditch, A. J. Stephens
Ranch, Altar Valley. 10-14-29

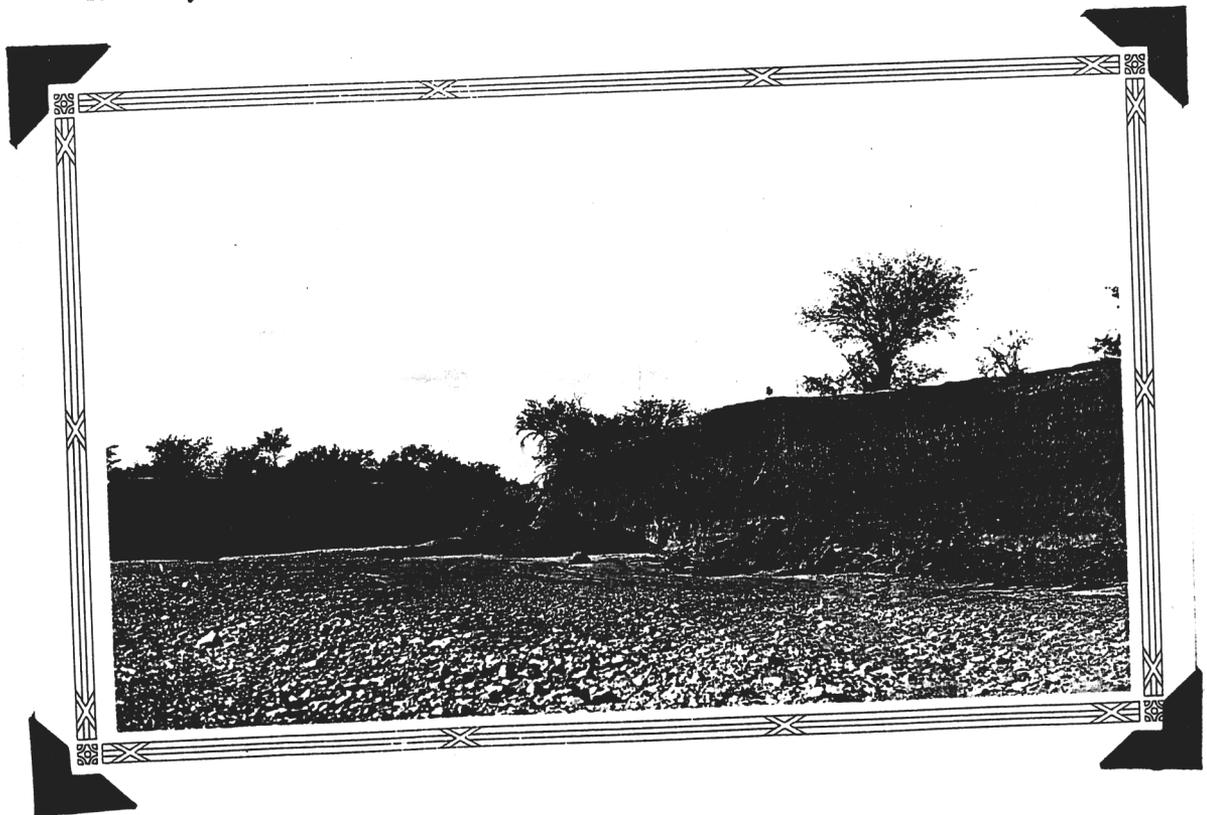
Erosion Robles Wash, La Osa Land and Livestock Co.
at Palo Alto. 10-31-29

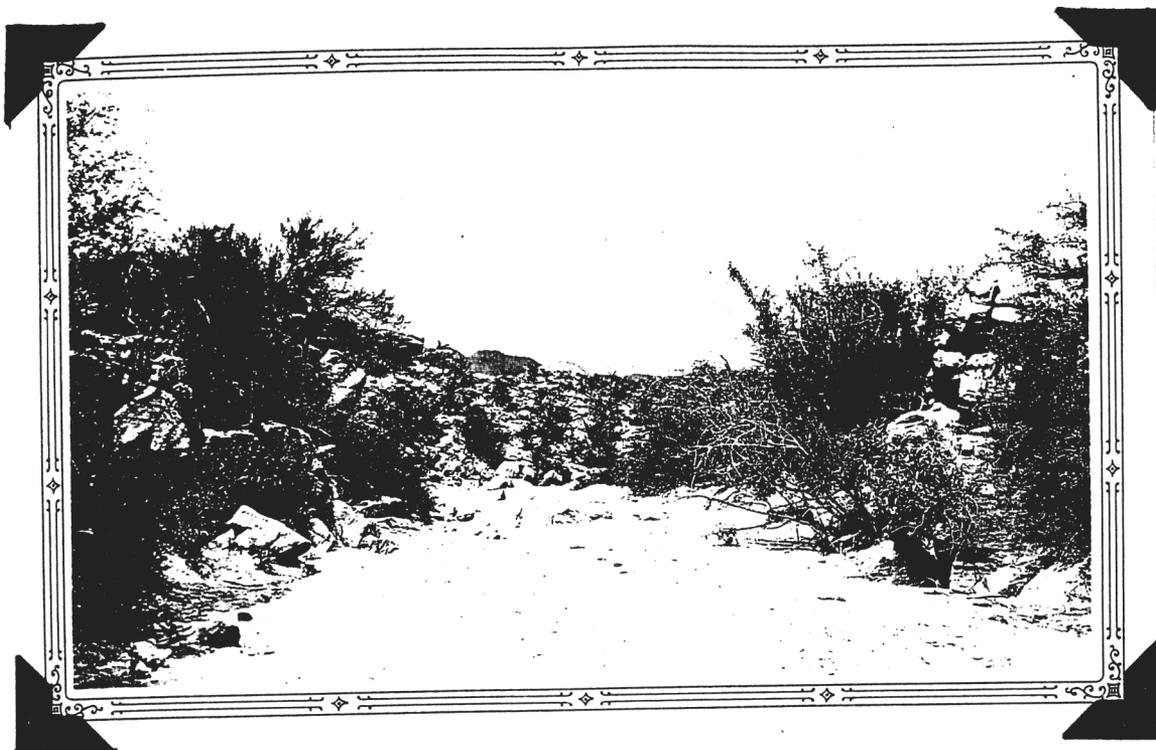
Dam site in canyon on Stump Homestead, Tortollito Mts.
Dam and Reservoir surveyed 7-22-31.

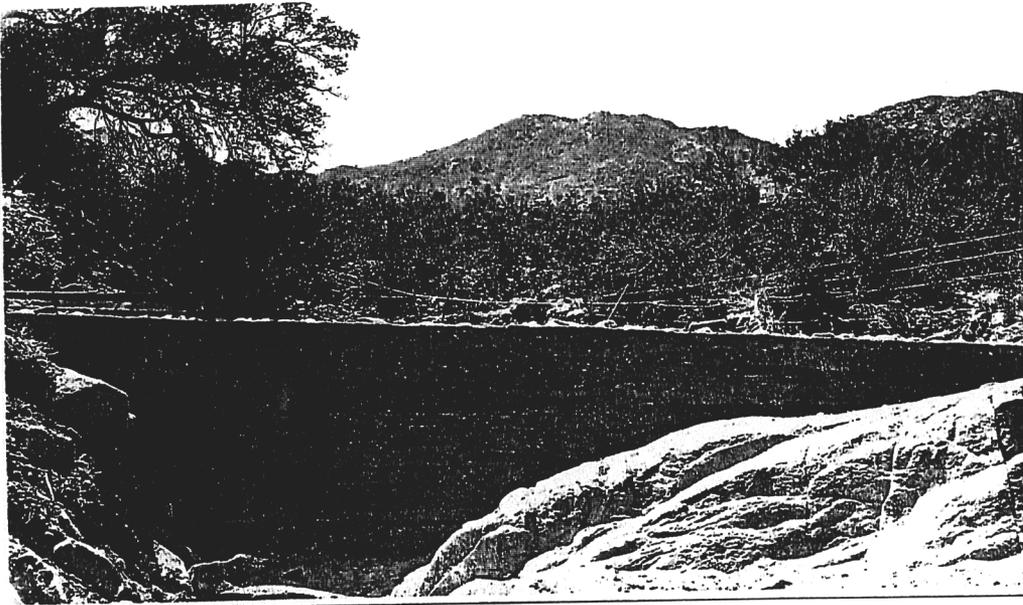
Photo 3.9 (bottom). Dam in Chiltepin Canyon, 1931. Source: Reports of C.B. Brown, Pima County Agricultural Extension Officer, housed at Arizona Historical Society, Tucson. Dams such as this one were built both as erosion control measures and to provide stockwater, usually transported by pipeline to points down in the valley.

Soil Conservation Service also advocated contour plowing and dike construction in the Altar Valley (Photos 3.9, 3.10). These installations intercepted floodwaters and spread them out across the range, increasing forage production. Researchers also experimented with reseeded techniques, although few were found to be consistently successful. One exception was Johnson grass, which established well in the bottomlands where Sacaton has flourished previously. By cutting and stacking Johnson grass, ranchers could conserve its forage value through dry seasons, increasing the carrying capacity of their lands (Photo 3.11).

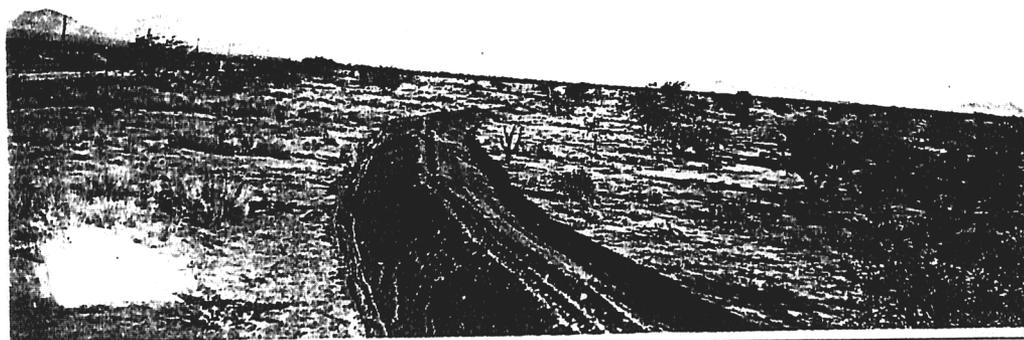
Photo 3.10 (top). Range contour construction near Ajo Highway, at north end of Altar Valley watershed, 1931. Source: Reports of C.B. Brown, Pima County Agricultural Extension Officer, housed at Arizona Historical Society, Tucson. Using small contour ridges like this one, Brown demonstrated the potential of erosion control to retain water and increase vegetation.

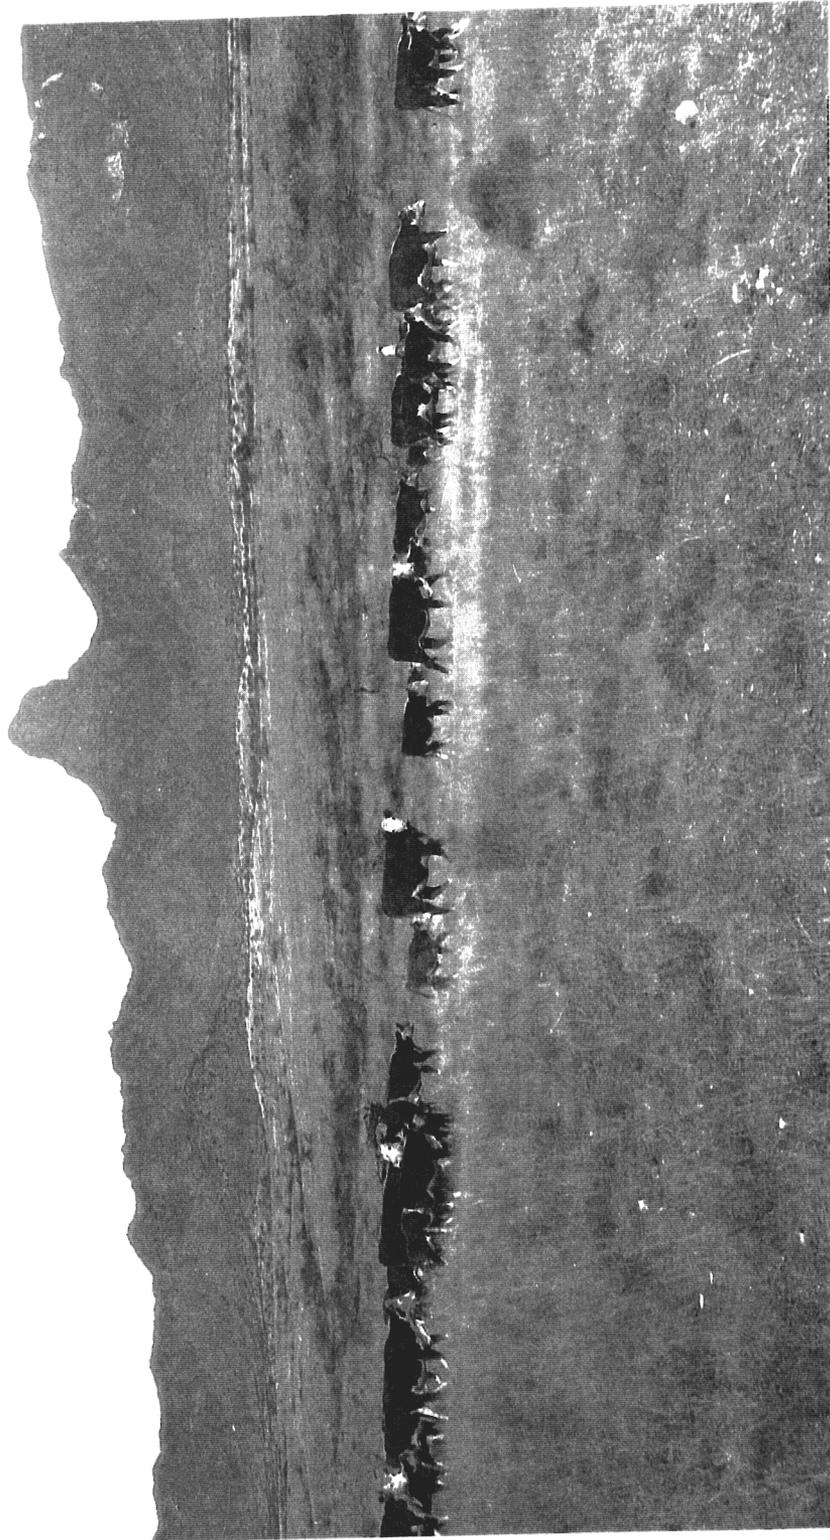
Photo 3.12. Rangeland cleared of mesquite, Santa Margarita Ranch, 1968. Courtesy of Pete Phelps. Mesquites in the bottoms were not cleared. Rows of mesquites pushed up by chaining can be seen on the far hill, center right.

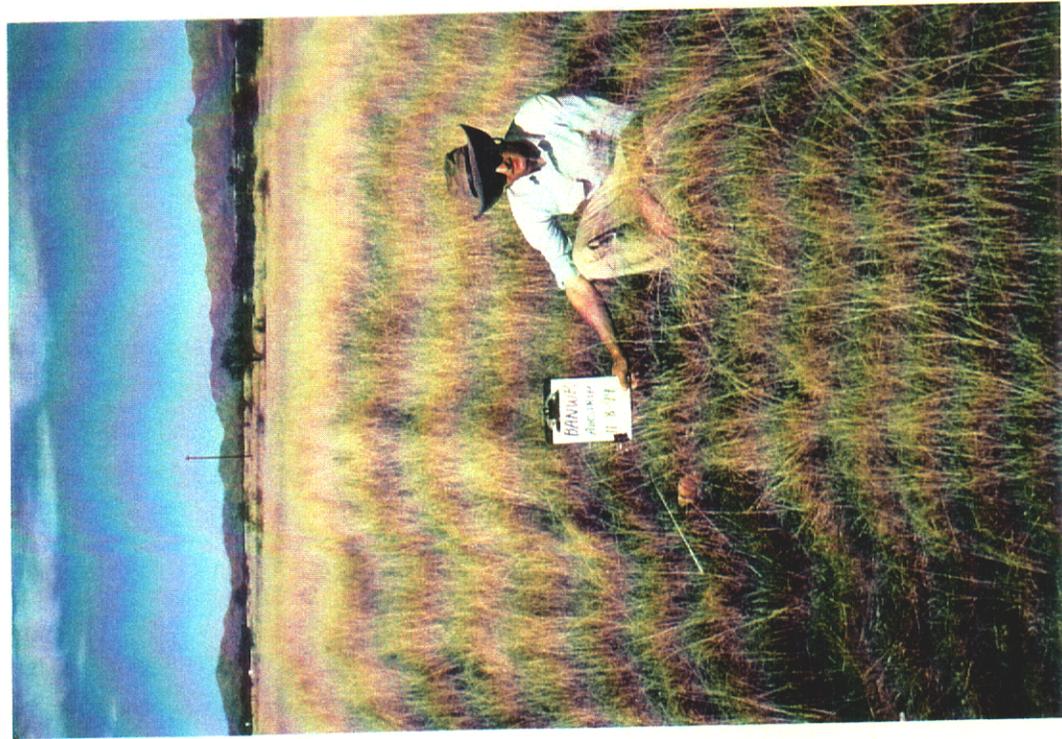
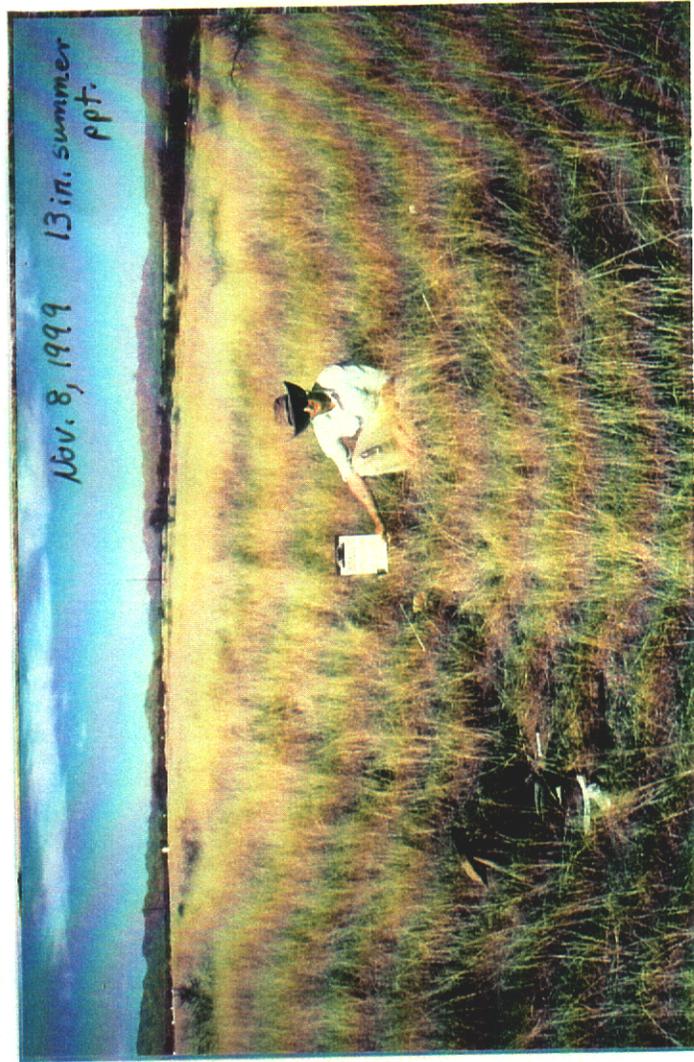
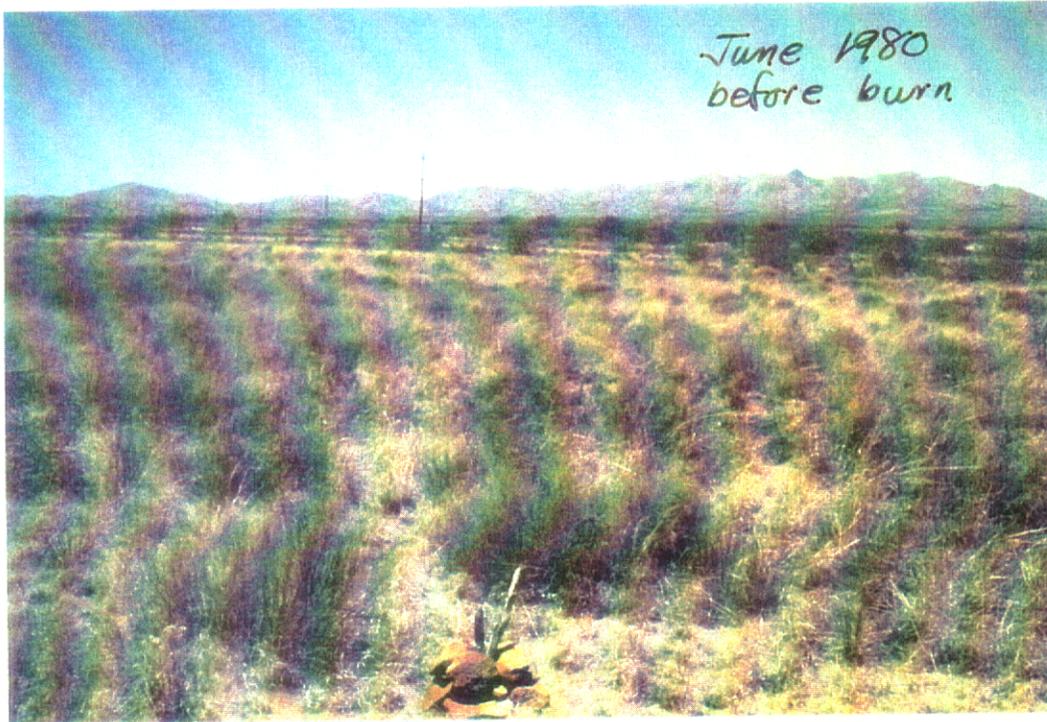
Airstrip Pasture transect

June 1980
after burn

June 1980
before burn

Sept. 9, 1980
4 inches, summer ppt.

Photo 3.14 (top). Pasture of Buenos Aires Ranch before prescribed burning, June 1980. Courtesy of Dan Robinett, Natural Resource Conservation Service.

Photo 3.15 (bottom). Same pasture after burning, September 1981. Courtesy of Dan Robinett, Natural Resource Conservation Service.

In the late 1970s, prescribed fire was used as a management tool on a pasture of the Buenos Aires Ranch. The results, monitored by the NRCS, showed an 85 percent decrease in snakeweed and burroweed production and a 58 percent increase in grass production one year later (Photos 3.14, 3.15). Since conversion of the Buenos Aires to a National Wildlife Refuge in 1985, prescribed fires have been used extensively to keep mesquites in check.

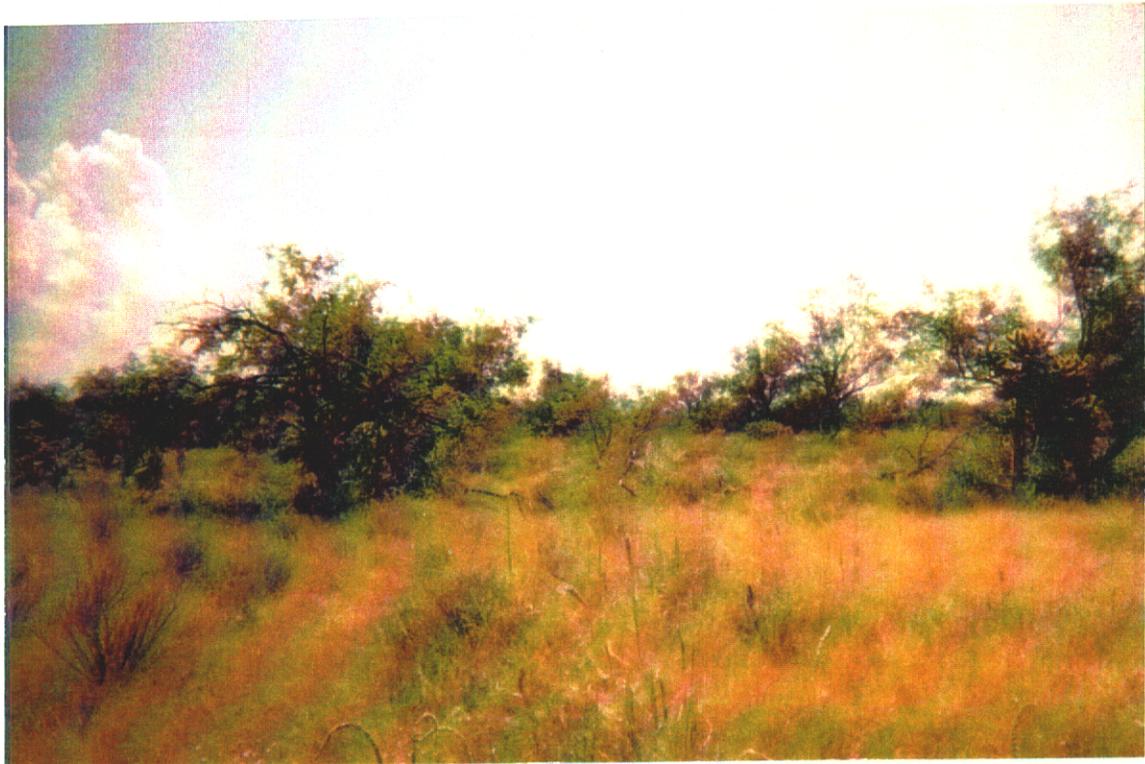
Photo 3.16. Annual grasses and forbs on the Palo Alto Ranch, summer 1998. Courtesy of Francine Snure.

The Snures run 300 cows and 30 bulls on the Palo Alto today. They have destocked the ranch three times due to drought since 1981. The cattle graze the east side of the ranch in the winter and rotate to the west during the summer. This rotation has been in place since 1981, and has benefitted the vegetation. The range produces good browse in all years, and a strong flush of annuals when the rains are good (Photo 3.16).
