# **WALGREENS 44-60 N STONE AVE.**

## **HISTORIC PRESERVATION FEASIBILITY STUDY**

**FINAL DRAFT REPORT, MAY - 2004**

# **BUILDING FEATURE ANALYSIS**

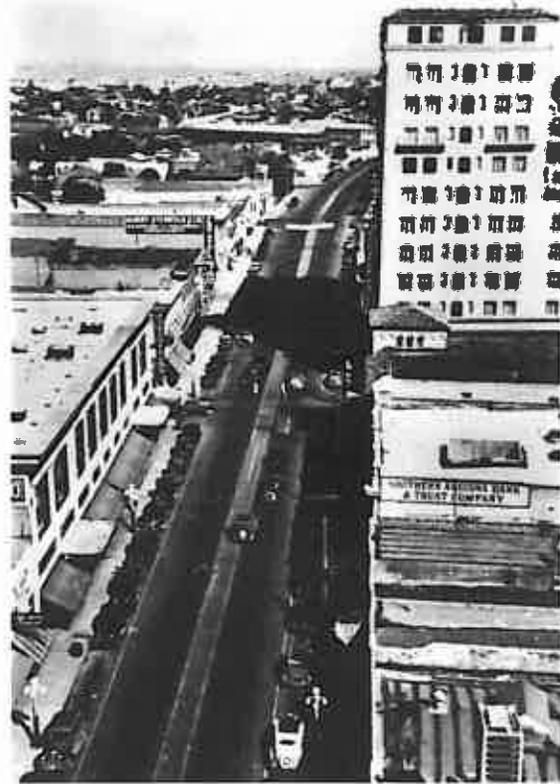
Integrity: Low (1)

"View of roof top from Consolidated Bank of Tucson, 1930's"

The original tiles were likely manufactured by either Gladding-McBean or Ludowici. Both manufactures are still in business and both still manufacture straight barrel pan/cover tiles in 8" widths designed to be set at approximately 10 1/2" centers. Today Ludowici refers to this system as "Mission" tile while Gladding-McBean calls it as "Cordova". Alternately one or more local roofers may have salvaged historic tile on hand fitting the description of the tile originally used. This approach, if workable, could provide a more accurate reconstruction at a lower cost.

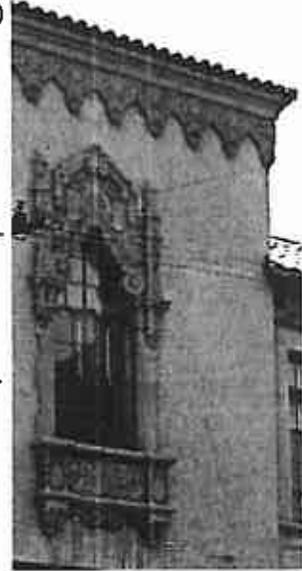
"Cast stone detail @ corner tower, 1929"

Use the remaining historic material as a sample and standard of quality to reconstruct and install new cast stone ornamentation to match the original. Cast stone is still produced today in much the same way it was in 1929. The Cast Stone Institute ([www.caststone.org](http://www.caststone.org)) lists over forty producer members, mostly in Texas and the southeastern states. The ideal panel size is approximately 2 feet by 5 feet. The original drawings show a jointing pattern considerably tighter than this but note that some joints were false.

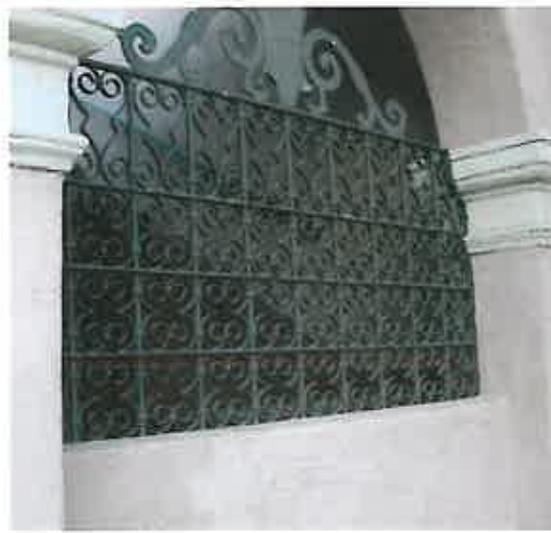
*"Wrought iron grille work @ Pima County Court-house, Roy Place, 1929"*

Reconstruct and install grilles based on the historic drawings. To limit conjecture other works by the same architect could be studied for additional clues. Place used this same material on two other notable projects (the Pima County Court House and the Veterans Administration Hospital) done in the same style (Spanish Colonial Revival) and in the same year (1929) as the Walgreens Building. It is likely that all three were on the boards in his office at the same time.
