NOTICE OF VIOLATION # PC 0912-067

Complaint Investigation Report

Tracking ID: PC0912-067

Source: ASARCO, LLC - Mission Complex

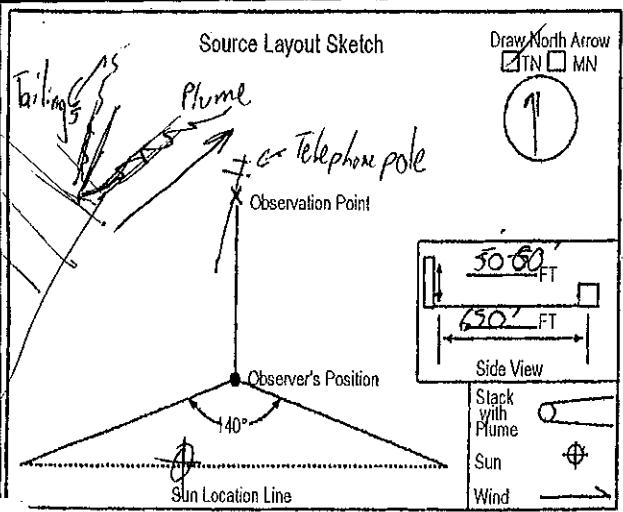
OBSERVATION DATE 12/22/2009	START TIME 13:15 pm	END TIME 13:22 pm
---------------------------------------	-------------------------------	-----------------------------

MIN \ SEC	0	15	30	45	COMMENTS
1	0	5	10	5	
2	10	20	20	5	Observation point
3	5	5	40	40	only catching outer
4	20	15	30	40	fringe of plume
5	20	10	5	10	
6	40	80	40	50	Opacity Avg 23.4%
7	40	15	10		
8					See attached Photos
9					
10					
11					
12					
13					
14					
15					
16					
17					
18					
19					
20					
21					
22					
23					
24					
25					
26					
27					
28					
29					
30

ADDITIONAL INFORMATION
 ① Activity Suspended due to forecast of high winds. Fugitive Dust Control w/ Polymer water trucks

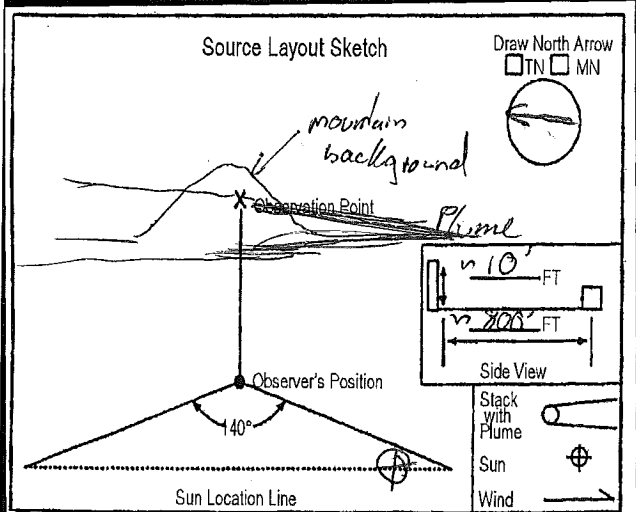
OBSERVATION DATE 12/22/2009	START TIME 2:40 pm	END TIME 2:47 pm
---------------------------------------	------------------------------	----------------------------

MIN	SEC				COMMENTS
	0	15	30	45	
1	100	100	100	40	
2	75	100	60	50	
3	100	100	100	100	
4	100	100	100	100	
5	100	100	40	40	
6	30	70	60	85	
7	60				Opacity Avg. 80.4%
8					
9					(see attached photo)
10					
11					
12					
13					
14					
15					
16					
17					
18					
19					
20					
21					
22					
23					
24					
25					
26					
27					
28					
29					
30

ADDITIONAL INFORMATION
 ① Activity on Tailings Building Suspended due to forecast of high winds. Fugitive Dust Control application of Polymer & Water with Trucks
