ROGER ROAD
WASTEWATER TREATMENT PLANT
LEVEE CERTIFICATION
FOR
SANTA CRUZ RIVER – EAST BANK:
SOUTH OF W. EL CAMINO DEL CERRO

May 30, 2008

Psomas
800 E. Wetmore Road, Suite 110
Tucson, AZ 85719

Pima County Regional Flood Control District
97 E. Congress Street, 2nd Floor
Tucson, Arizona 85701-1797

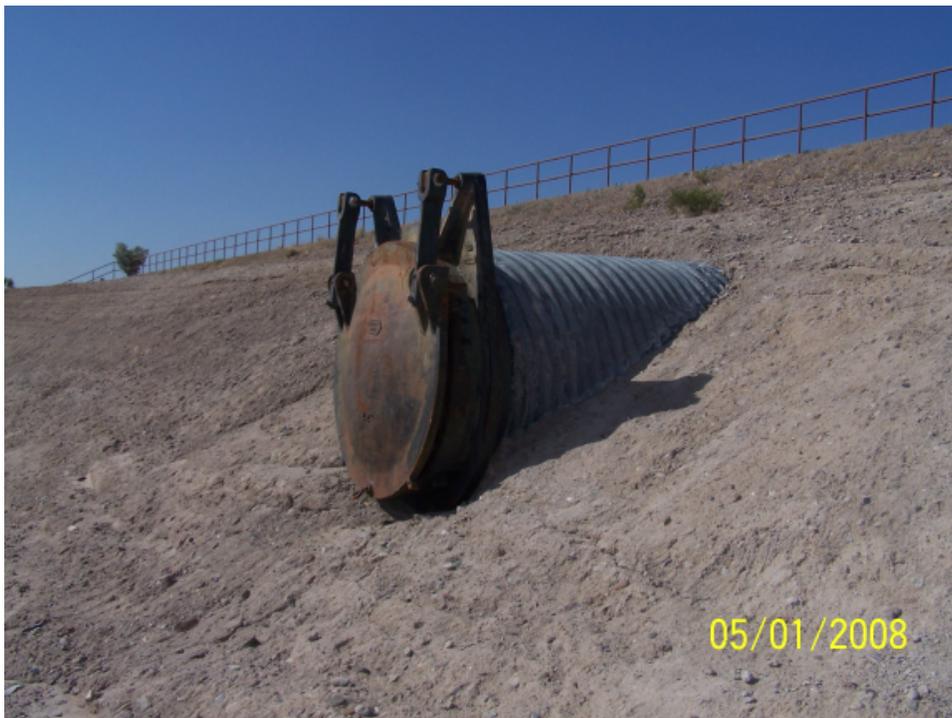
Photo 4: 42” CMP (projecting) w/ flap gate

A site visit was conducted on May 1, 2008. Photos of the study area were recorded by numeral, from downstream to upstream. All photographs presented in this report are provided in Figure 3, sheets 2 and 3. Photo 4 illustrates the 42” CMP (projecting) with a flap gate. The culvert is located approximately 100 feet upstream of Cross Section 26.09.

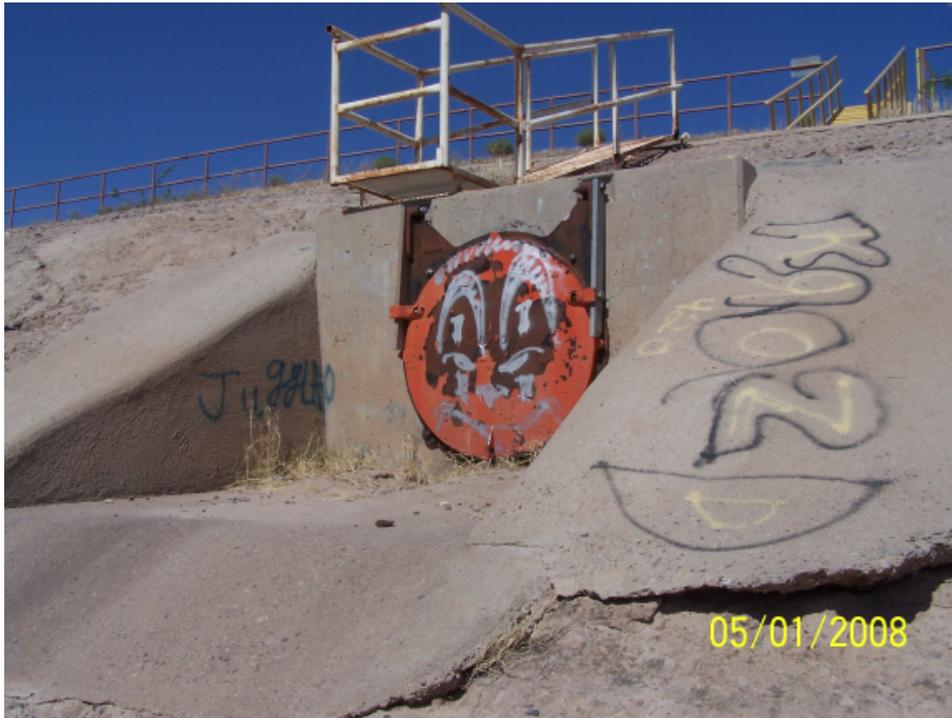
Photo 13: 42" CMP (square headwall) w/ flap gate and stair access

Photo 13 illustrates the 42" CMP (square headwall with apron) with a flap gate. The culvert has stair access, and is located approximately 100 feet downstream of cross section 26.85.

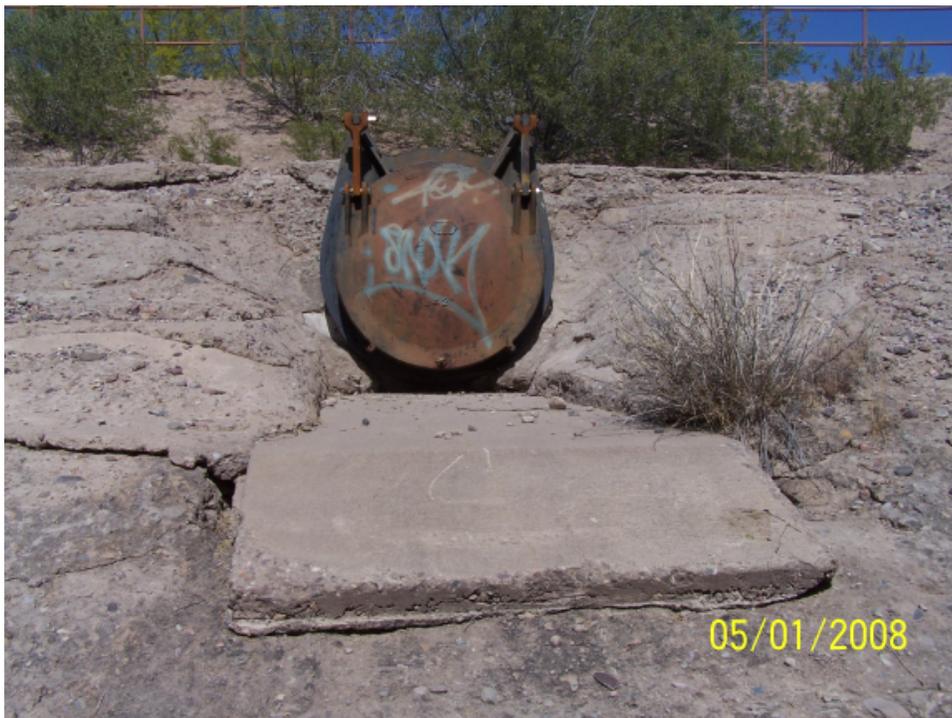
Photo 16: 42" CMP (projecting) w/ flap gate, concrete apron

Photo 16 illustrates the 42" CMP (projecting with apron) with a flap gate. The culvert is located approximately at cross section 27.04.

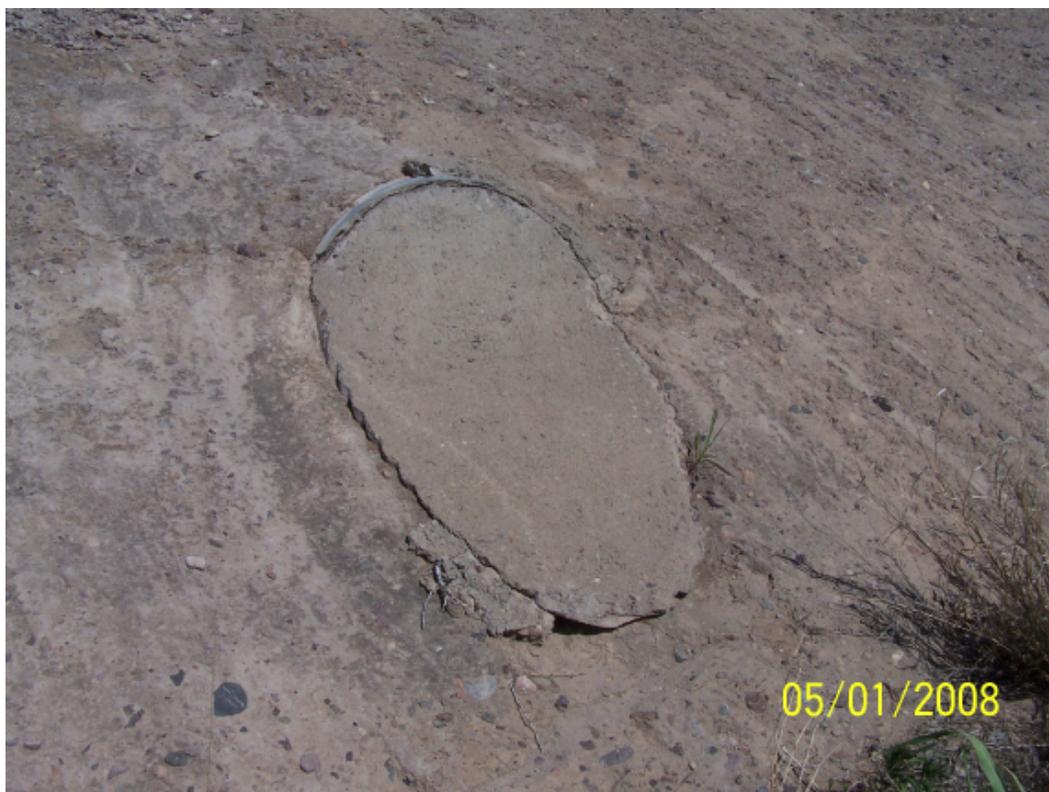
Photo 15: 36" CMP (mitered to slope), plugged

In addition to the culvert outlets with flap gates, a 36" CMP, mitered to slope, has been plugged with concrete. Photo 15 illustrates the plugged culvert, located approximately 50 feet downstream of cross section 26.95.

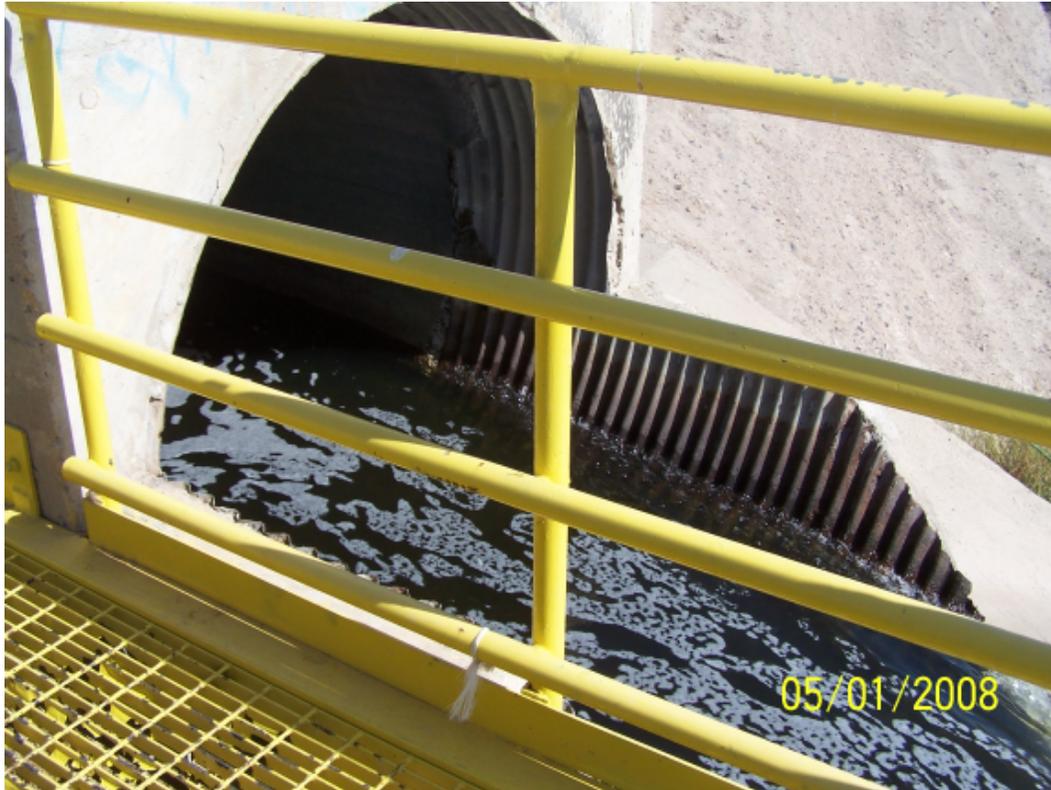
Photo 11: Active outfall, 84” CMP, Roger Road WWTP

The active outfall of the Roger Road WWTP is located approximately 70 feet upstream of cross section 26.66. From *The Pima County Effluent Generation and Utilization Report 2006* (Appendix 5), the treatment plant has a capacity of 41 MGD. The facility receives daily average flows of approximately 38 MGD (when Randolph Park WRF is in operation and the Tucson Boulevard diversion structure is in place). The outfall is a 7'x7' reinforced concrete box culvert (RCBC). At the levee, the outfall is converted to an 84" CMP mitered to the concrete headwall and apron. In 2006, 28,373.9 acre-ft (approx. 40 cfs at steady flow) of effluent was discharged into the Santa Cruz River at the active outfall.

No closure is provided at the active outfall. The outfall is the conveyance outlet to the Effluent Pump Station, approximately 770 feet upstream within the treatment plant. A weir, flap gates and pumps are located within the treatment plant.

From a Psomas ground survey (May 22, 2008), the ground elevation at the Effluent Pump Station is 2256.02' NAVD88 (Point 11021), equivalent to 2253.79' NGVD29. The 100-year WSE at the active outfall, interpolated between cross sections 26.66 and 26.76, is 2249.95' NGVD29. The interpolated velocity head at the active outfall is 2.69 feet. In addition to the WSE, the hydraulic grade elevation at the active outfall is 2252.64' NGVD29, which is 1.15 feet below the ground surface at the Effluent Pump Station. Therefore, no breakout will occur

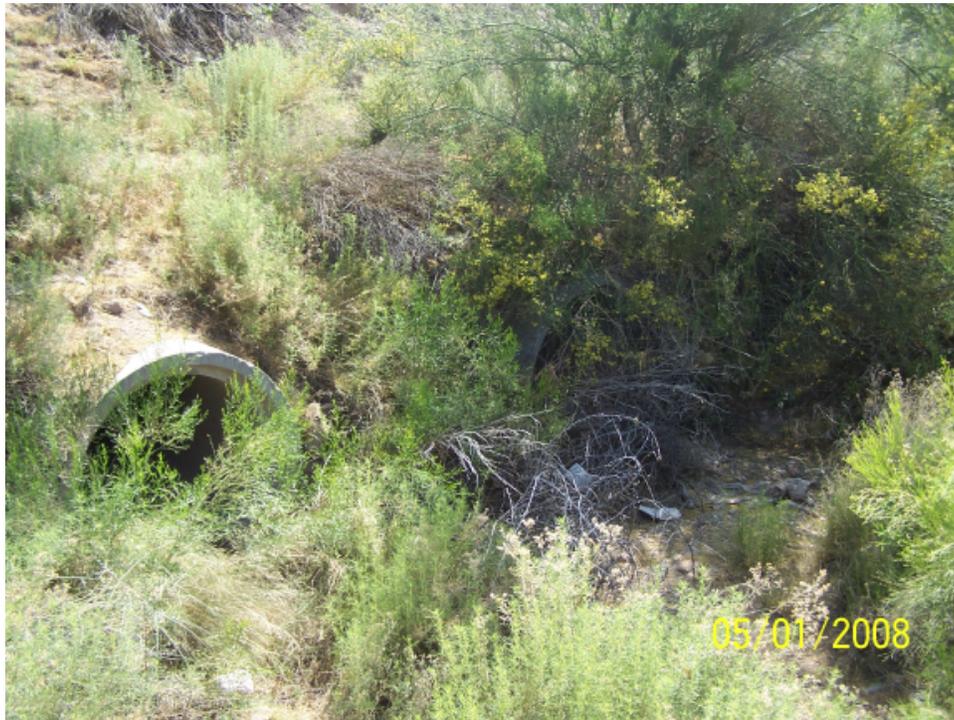
Photo 20: culvert inlet, upstream of project area

Immediately upstream of the levee certification at cross section 27.61, a two-barrel reinforced concrete pipe (RCP) culvert conveys stormwater generated within the landward watershed to the Santa Cruz River. Photo 20 illustrates the culvert inlet on the landward side.

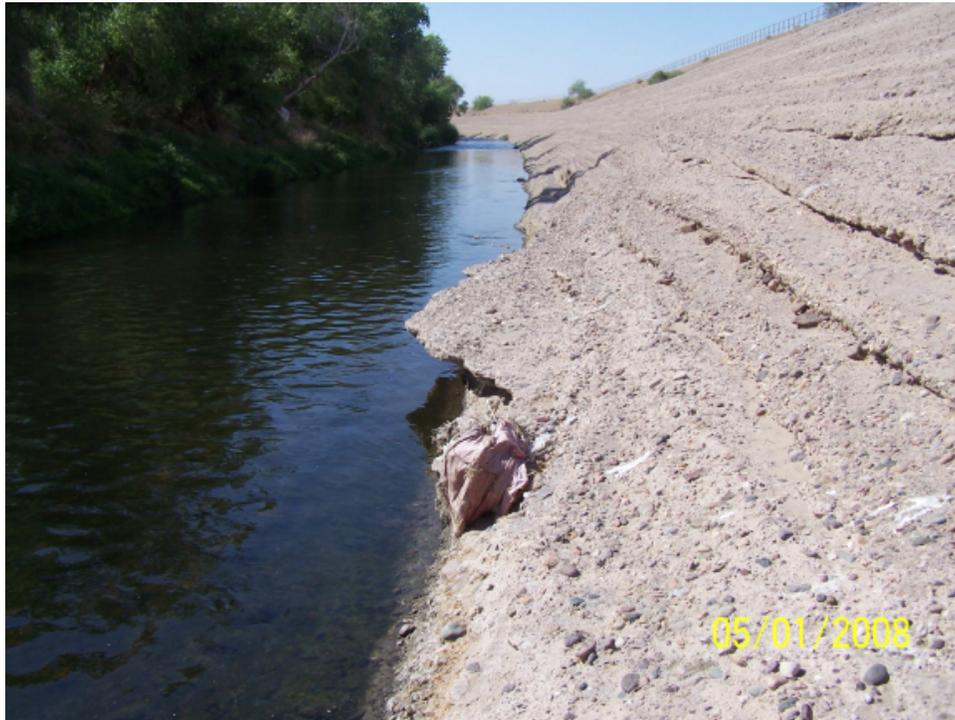
Photo 9: Original Construction Flowline, Cross Sections 26.57 – 26.66

Review of historical records supports this evaluation. The flowline at the edge of the soil cement in most areas of the project reach has experienced aggradation, a condition that has not impacted the available freeboard for the levee. At Cross Sections 26.57-26.66, the original

flowline of soil cement is exposed by less than one foot. Photo 9 shows the original construction ground surface currently under flows derived from the WWTP. The comparison of 1984 flowline elevations to 2008 flowline elevations is provided in Table 2.
