# Santa Cruz River at Canoa Ranch Photo Monitoring

Field Work Dates  
June 20-21, 2006

Pima County  
Natural Resources,  
Parks and Recreation

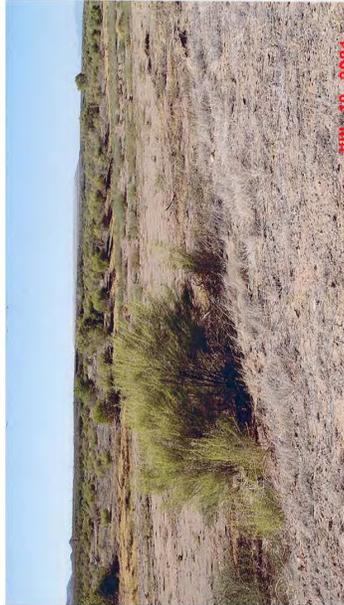
**Photo Point No. 1 North**  
\*\*\*  
Burro bushes have increased in size and quantity. Tumbleweed in channel.

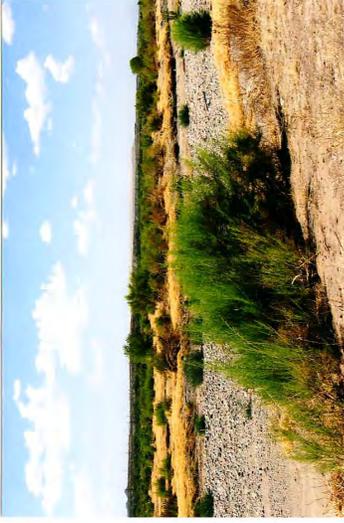
**Photo Point No. 1 North**  
Burrobrush has increased in size. Evidence of channel scouring, increase of coarse materials in channel.

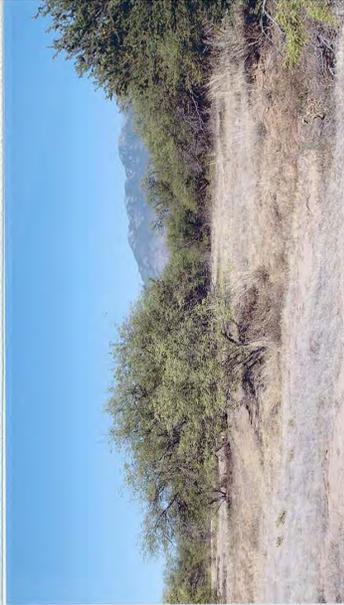
**Photo Point No. 1 East**  
\*\*\*  
There is an increase in annual groundcover. Bunch grasses are taller.  
\*\*\* These photos are not exact matches to 2002. See report.

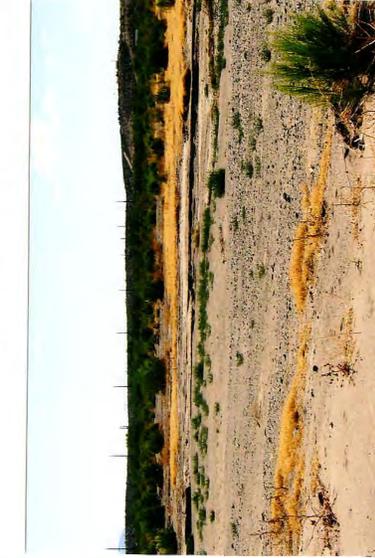
**Photo Point No. 1 West**  
Channel shows evidence of flood flows. Slightly more incised low-flow channel, more coarse materials in channel.

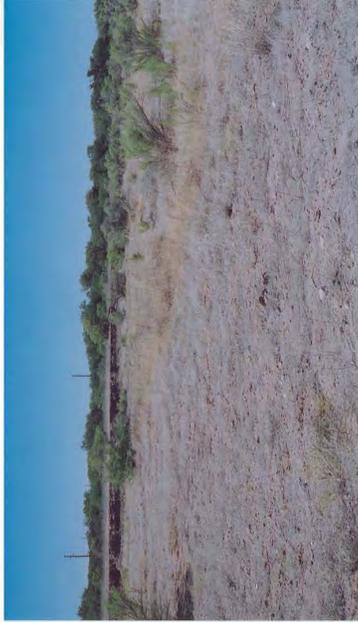
**Photo Point No. 2 North**

There is little change in this site from the April, 2002 photo.

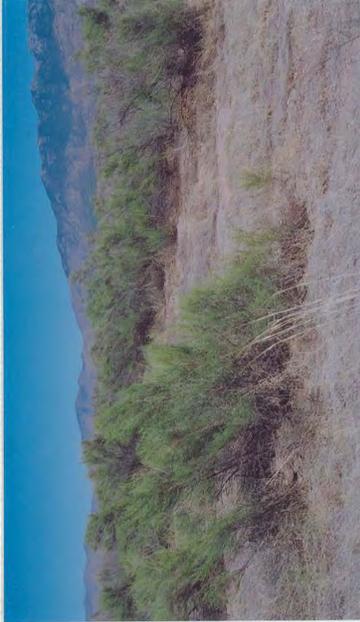
**Photo Point No. 2 East**

There appears to be slightly more groundcover on this site.

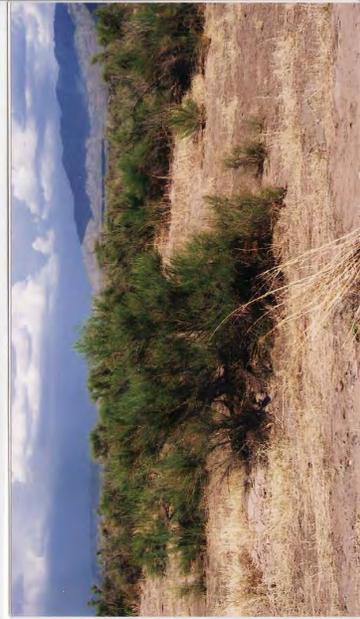
**Photo Point No. 2 East**

There appears to be less groundcover than 2004 photos. Very slight increase in burrobush recruitment.

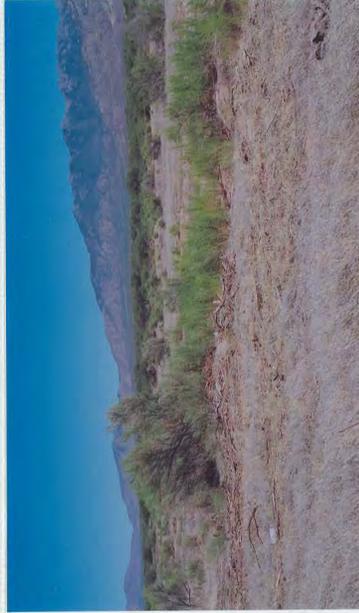
**Photo Point No. 3 East**  
There are more burro bushes present, and existing burro bushes have increased in size. There is more flood debris against burro bush on bar.

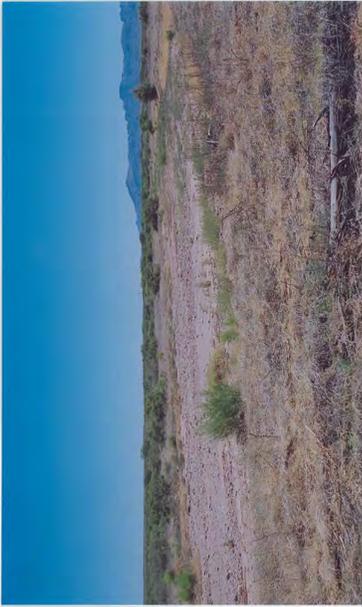
**Photo Point No. 3 South**  
 There is more grass cover present on the bar. The burro bush have increased. Increased annual vegetation in the channel.

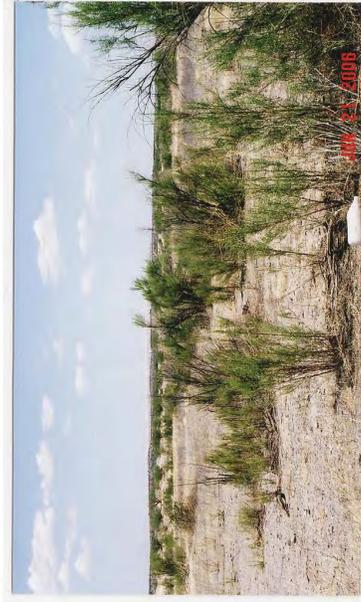
**Photo Point No. 4 North**

Increased burro bush recruitment. Increase of woody debris.

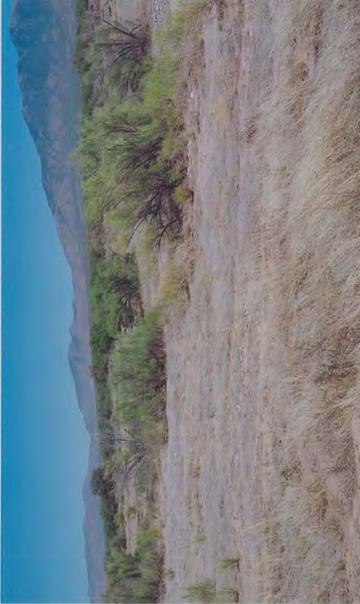
**Photo Point No. 4 East**

There is more ground cover. Some dieback of older burro bush, yet sprouts of young burro bush evident.

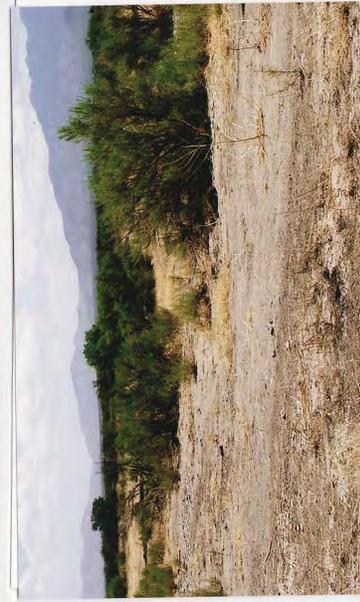
**Photo Point No. 4 East**

Decrease in groundcover. Burrobush on left has died.

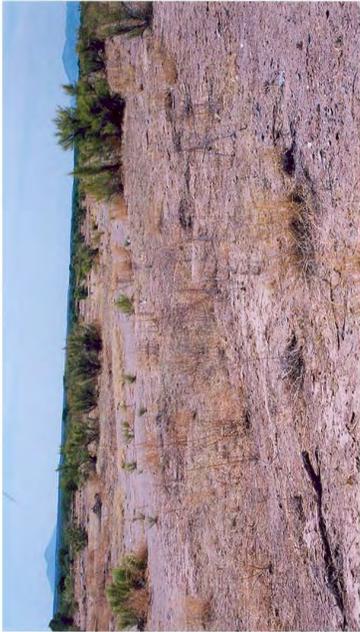
**Photo Point No. 4**  
Looking south along a bank of the Santa Cruz River. The river channel and banks are dominated by burro bush, with cured grasses and Forbs

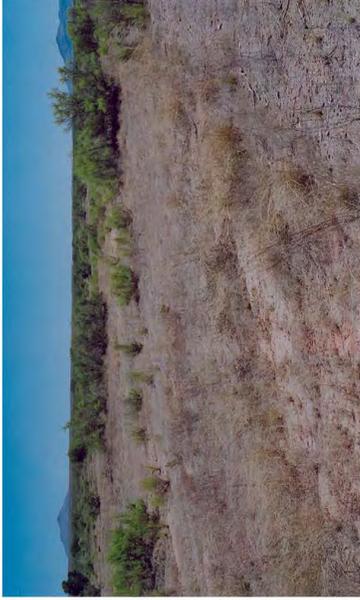
**Photo Point No. 4 South**  
Slight increase in groundcover. Increase in burro bush size and sprouts.

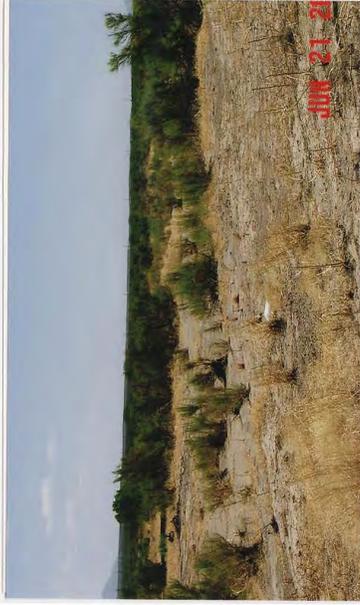
**Photo Point No. 4 South**  
Photo does not match previous photos well. Decrease in groundcover, increase in burro bush cover.

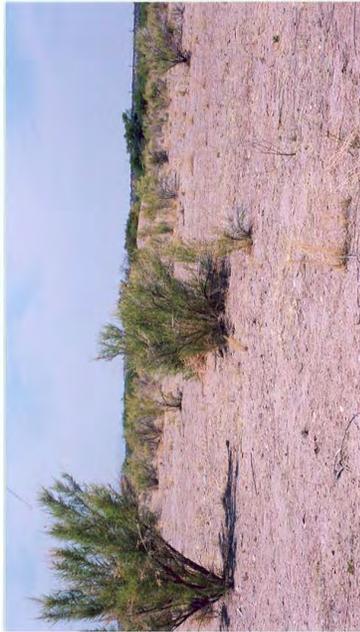
**Photo Point No. 4**  
Looking west toward a man-made berm that presumably was constructed to protect a nearby aircraft landing strip. Burro bush is the dominant plant species.

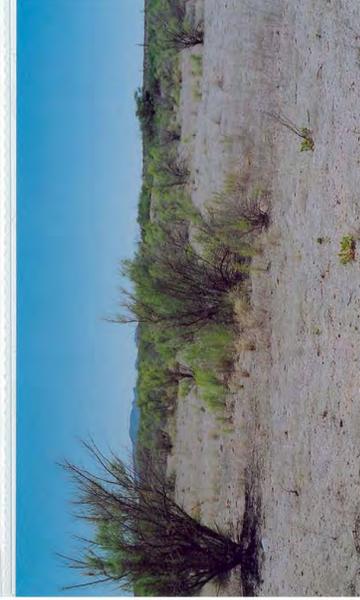
**Photo Point No. 4 West**  
Increase in burro bush sprouts. Slight increase in groundcover.

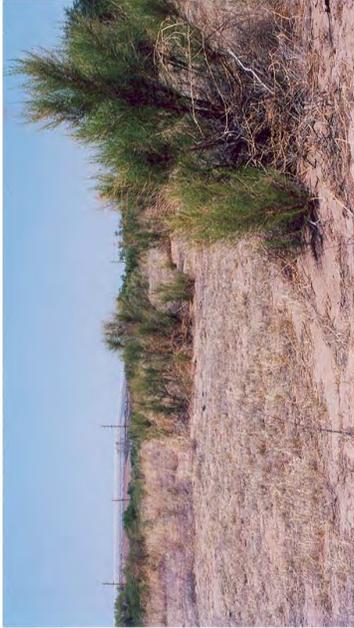
**Photo Point No. 5**  
Looking north across lands dominated by burro bush and cured Bermuda grass and a variety of forbs.

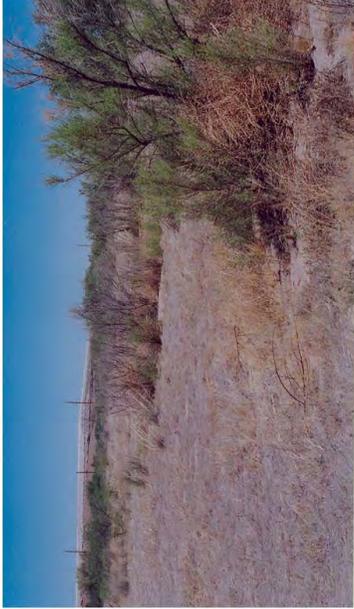
**Photo Point No. 5 North**  
Burro bush shows signs of dieback.

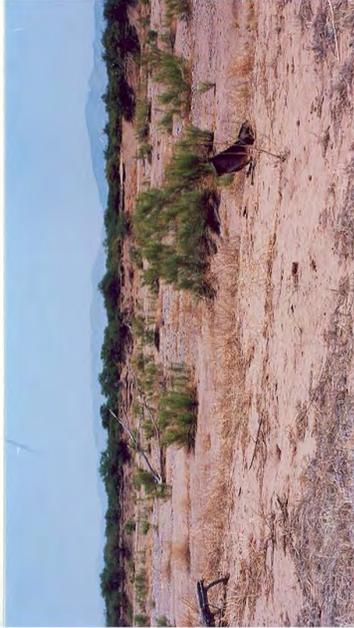
**Photo Point No. 5**  
Looking east across the Santa Cruz River. The eastern bank is dominated by mesquite and the river channel is bordered by burro bush.

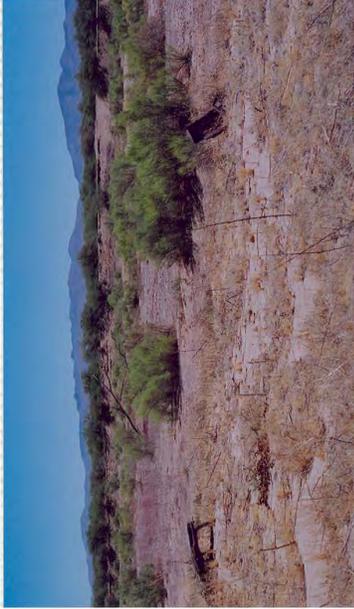
**Photo Point No. 5 East**

Slight increase in annual groundcover. Burro bush shows increased vigor and sprouting in channel.

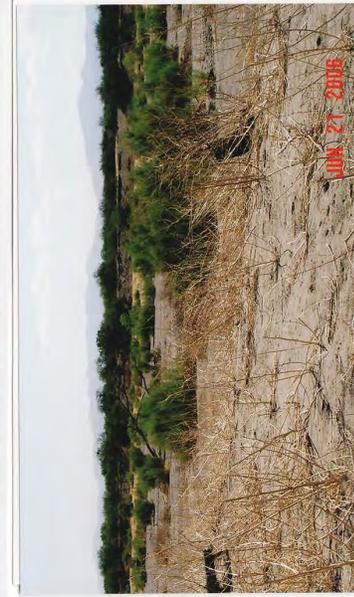
**Photo Point No. 5 East**

Increase in tall annuals. Decrease in short annuals.

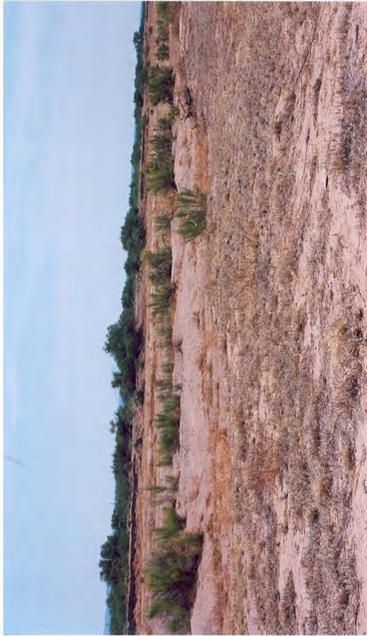
**Photo Point No. 5**  
Looking south along the Santa Cruz River. Foreground consists of cured Bermuda grass and forbs. Near the terminus of this 50 m transect is a seep willow (*Baccharis glutinosa*).

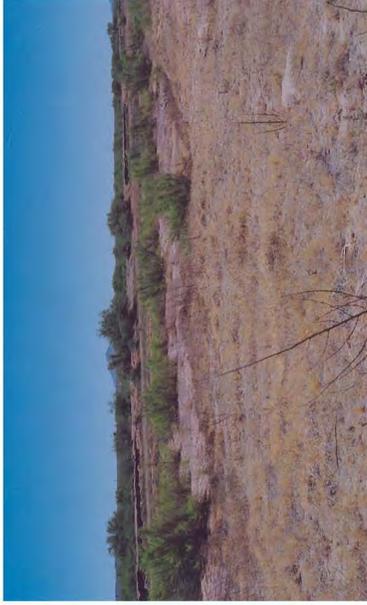
**Photo Point No. 5 South**  
Increase in annual groundcover over gravel in channel bed.

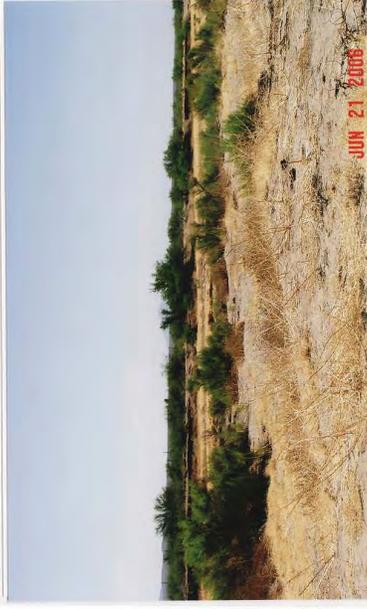
**Photo Point No. 5 South**  
Slight decrease in burrobush cover. More tall annuals.

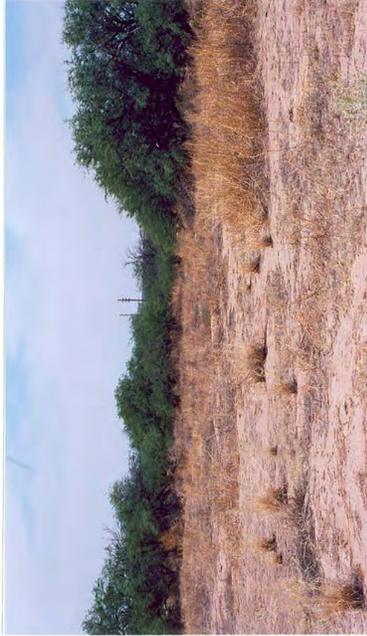
**Photo Point No. 5**  
Looking west over mesquite-dominated lands. Tall, cured forbs. In this photo are species of Chenopodiaceae and/or Amaranthaceae.

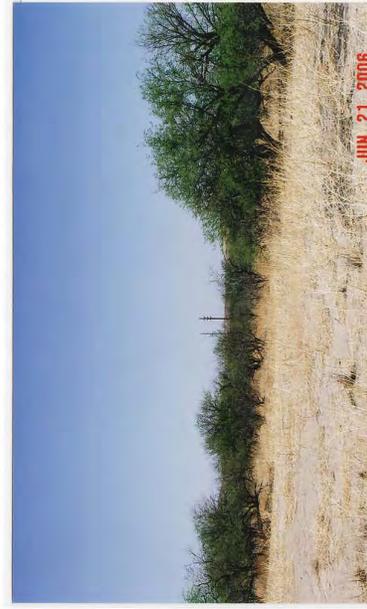
**Photo Point No. 5 West**  
Trees showing sign of stress. Decrease in short annuals, increase in tall annuals.

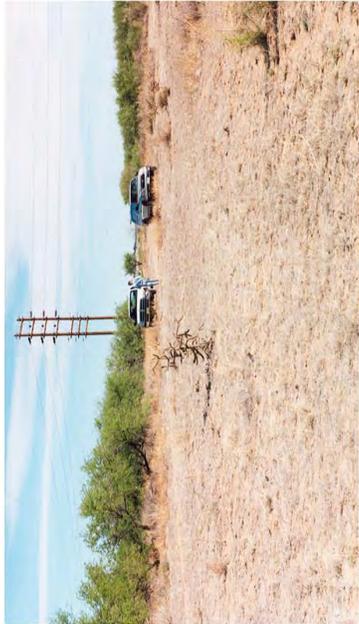
**Photo Point No. 6**  
Looking north from a point near the northern boundary of Pima County land at Canoa Ranch. Mesquite is the dominant plant species in this area. Small cactus at left-center is a cane cholla (*Opuntia spinosior*).

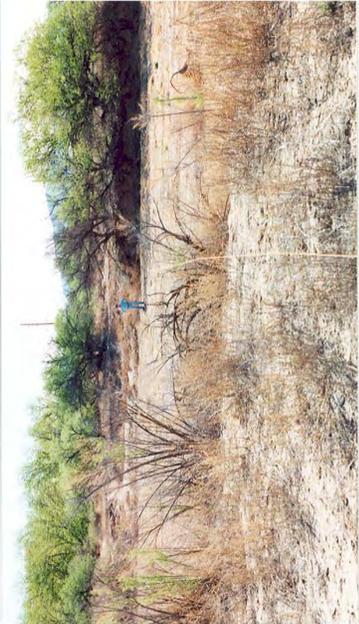
**Photo Point No. 6**  
Looking east across the Santa Cruz River. The river channel at this location is fairly narrow, supports little vegetation and has well-defined banks.

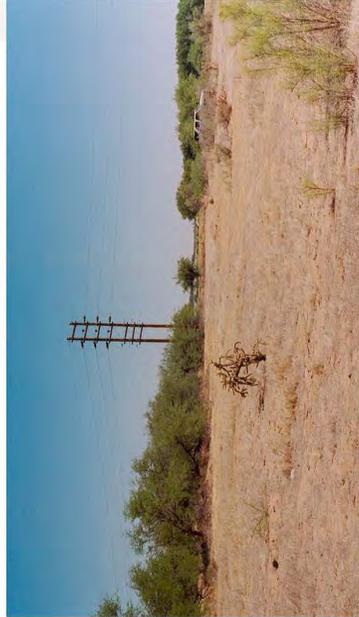
**Photo Point No. 6 North**  
Burro bush has increased its vigor (lower left). Cholla morphology has changed.

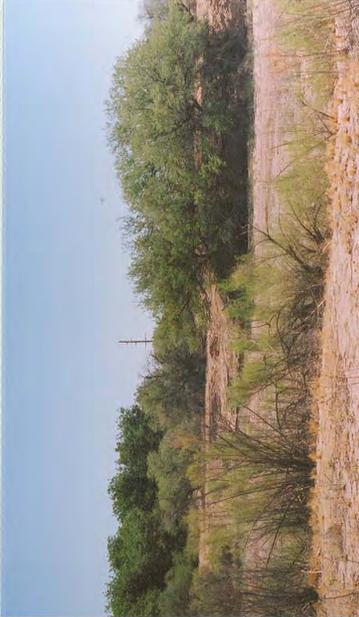
**Photo Point No. 6 East**  
The mesquites, cat claw acacia, and burro bush have increased vigor. It appears the west wash bank-center left in the photo-has experienced an increased in OHV traffic.

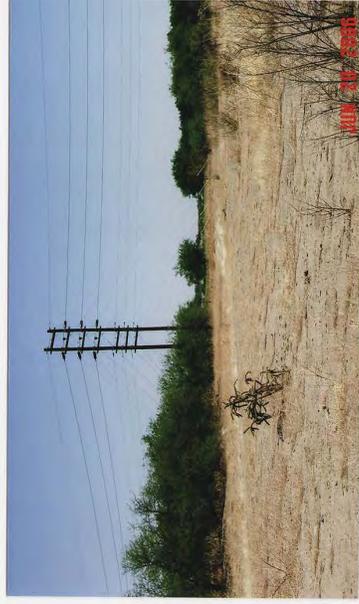
**Photo Point No. 6 North**  
Burrobush has experienced dieback. Decrease in groundcover. Mesquites showing signs of stress. Cholla has experienced some dieback.

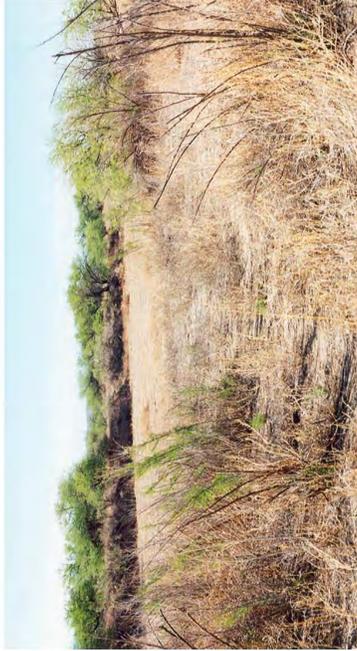
**Photo Point No. 6**  
Looking south across the Santa Cruz River. Burro Bush is common here, but not as dominant as it is further downstream.

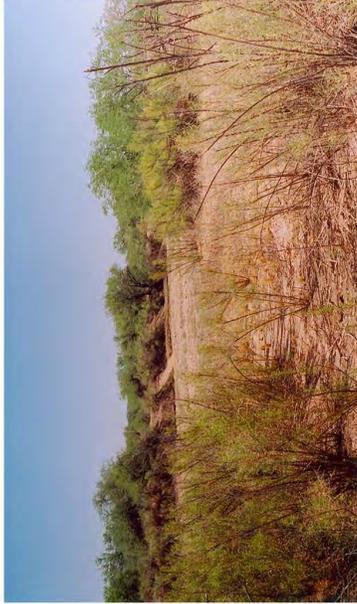
**Photo Point No. 6 South**  
The burro bush has increased. Note the road cut into the west bank (center left).

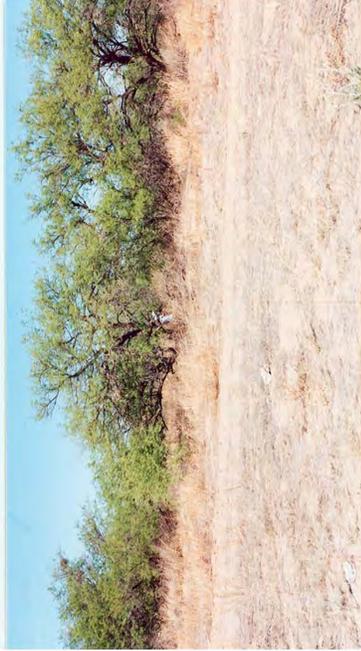
**Photo Point No. 6**  
Looking west across weedy lands where mesquite is the dominant perennial species.

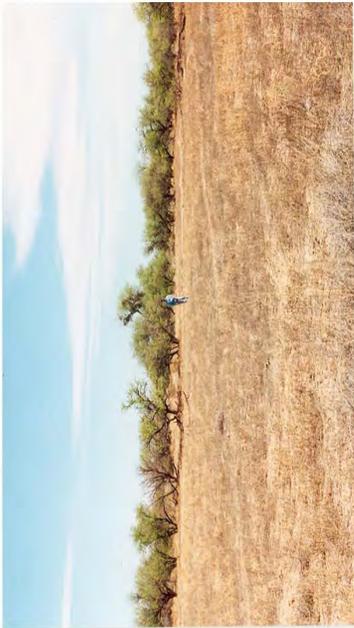
**Photo Point No. 7**  
Looking north across what appears to be a long-abandoned agricultural field bordered by mesquite.

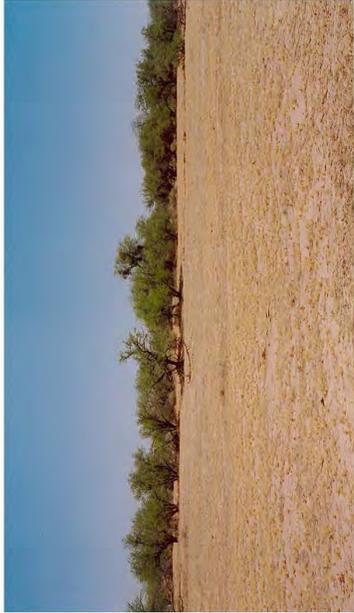
**Photo Point No. 7 North**  
Not much change. Shorter annuals. Slightly increased mesquite vigor.

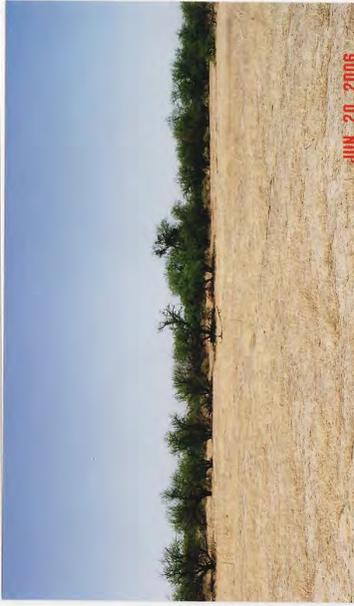
**Photo Point No. 7 North**  
Mesquite showing signs of stress, with some dieback and leaf loss. Taller annuals present.

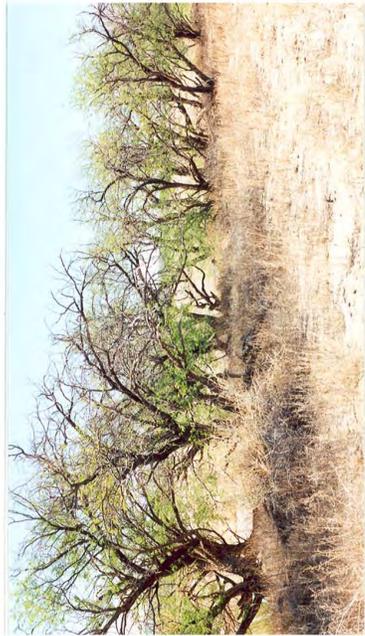
**Photo Point No. 7**  
Looking south along the mesquite-lined west bank of the Santa Cruz River.

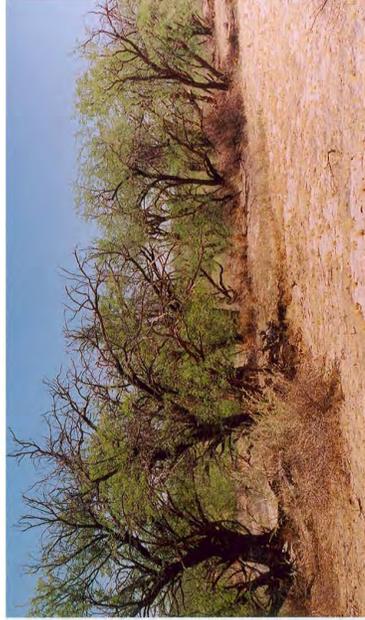
**Photo Point No. 7 South**  
No significant change.

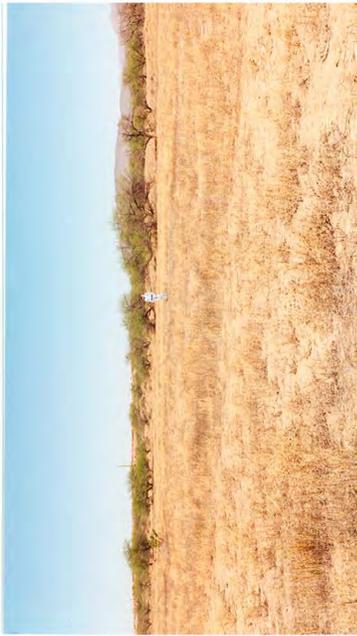
**Photo Point No. 7**  
Looking west across an abandoned, mesquite-bordered agricultural field.

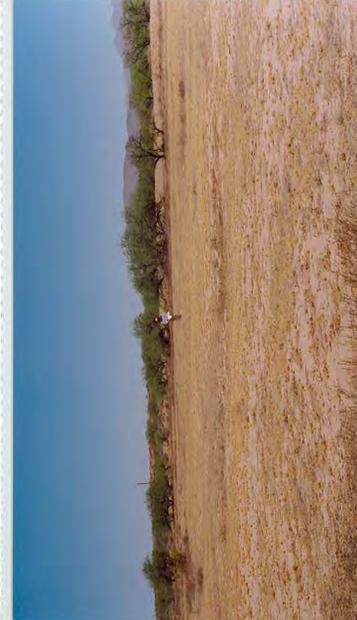
**Photo Point No. 7 West**  
No significant change.

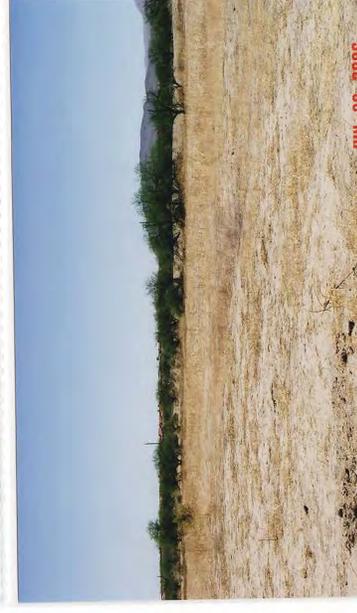
**Photo Point No. 7 West**  
Taller annuals present. Mesquites in distance showing signs of dieback.

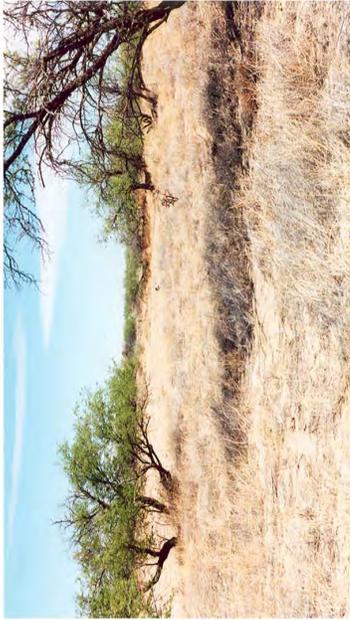
**Photo Point No. 8**  
Looking north along the east bank of the Santa Cruz River. A variety of cured weed, forb, and grass species along with mesquite are dominant at this location.

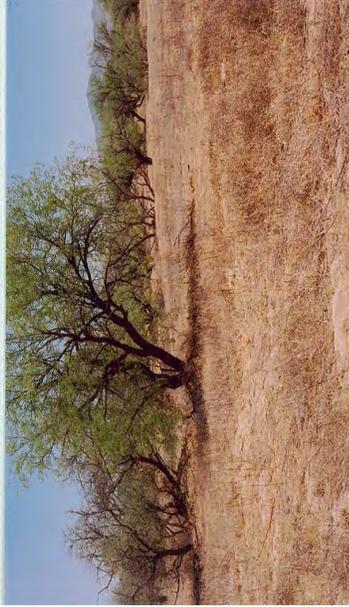
**Photo Point No. 8 East**

Increased foliage on foreground mesquite. The background mesquite appears dead.

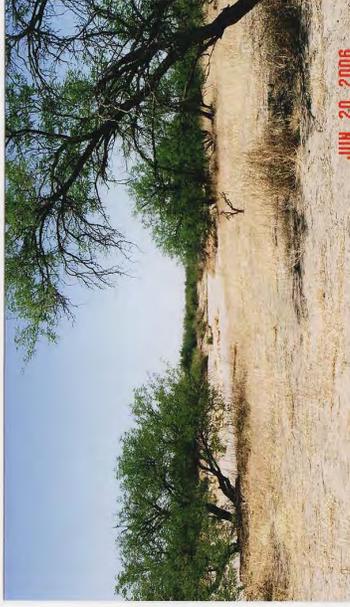
**Photo Point No. 8 North**

Mesquite in foreground experiencing dieback. Channel more apparent, note formation of island (center left). Cholla dieback.

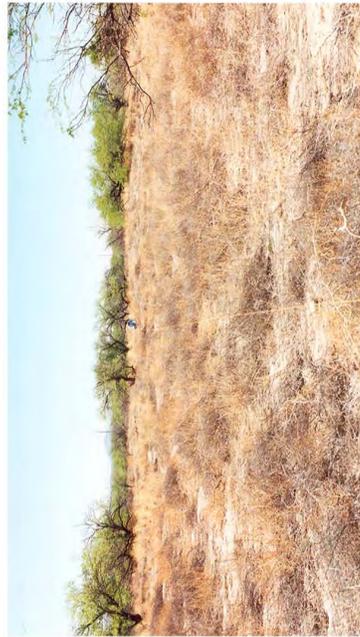
**Photo Point No. 8**

Looking south across an opening in the mesquite bosque that supports a variety of grass, forb, and weed species.

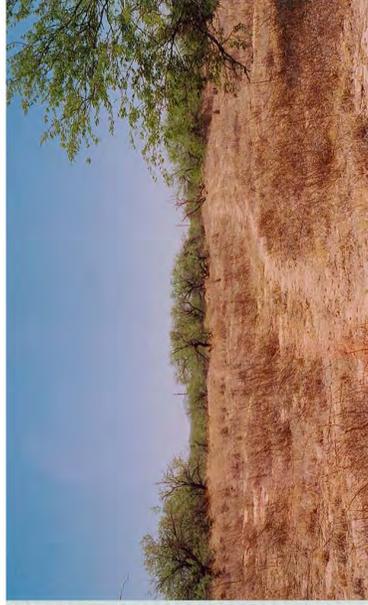
**Photo Point No. 8 South**

Well-used path through the center of the photo. Bunchgrass is more prominent. Increased mesquite vigor.

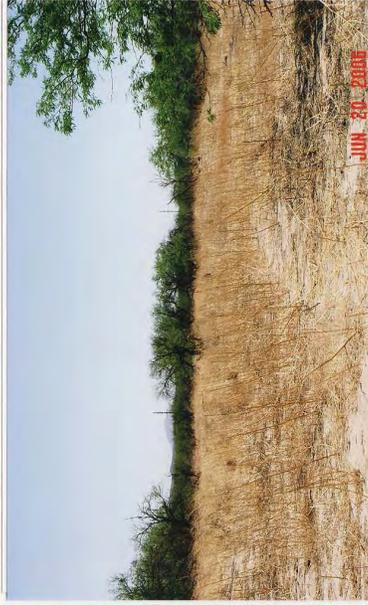
**Photo Point No. 8 South**

Little change in mesquite vigor. Bunch grasses not visible, tall annuals prominent.

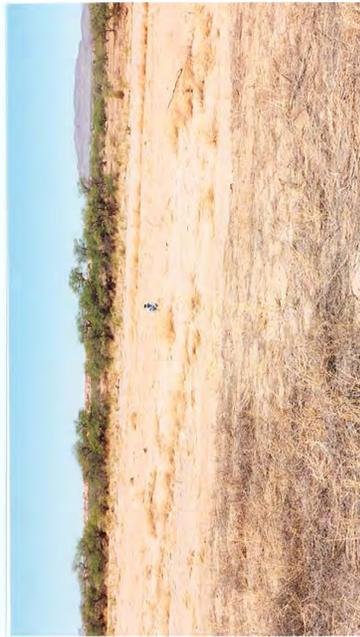
**Photo Point No. 8**

Looking west across the Santa Cruz River to the location of Photo Point No. 8.

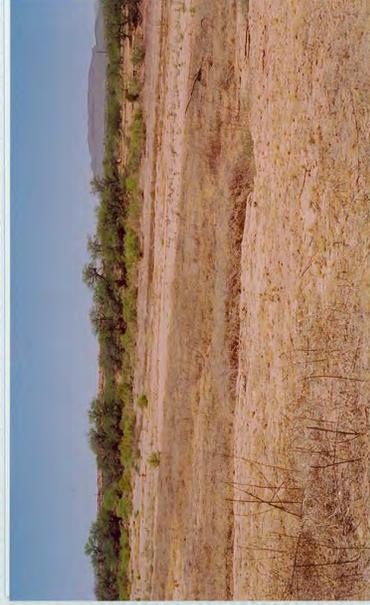
**Photo Point No. 8 West**

Desert broom and mesquite on the far side of the channel have increased vigor. It appears a grass bar has formed in the channel.

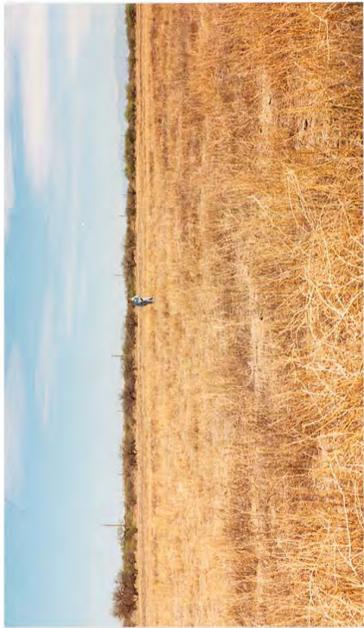
**Photo Point No. 9**  
Looking east across long-abandoned agricultural field on the west bank of the Santa Cruz River.

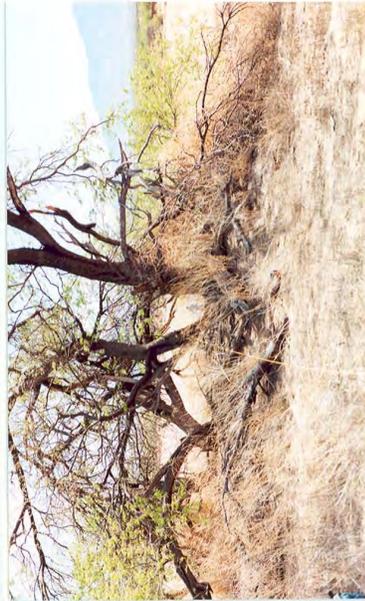
**Photo Point No. 9**  
Looking east across the Santa Cruz River. Note the foreground head cuts that are beginning to erode into the field on the west bank of the river.

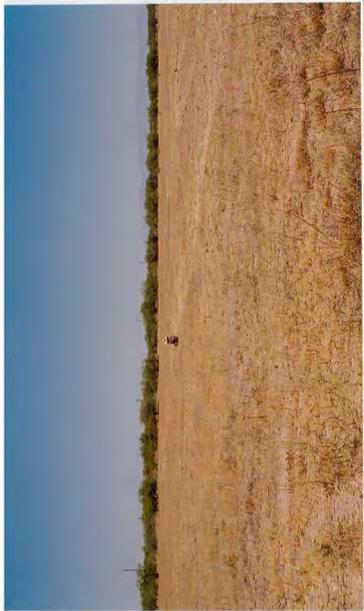
**Photo Point No. 9 North**

Mesquites in background more vigorous. Groundcover has decreased.

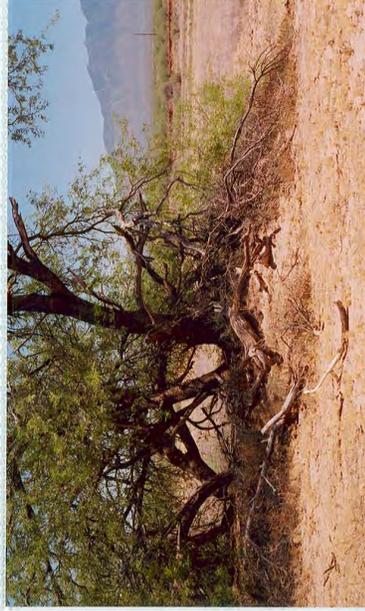
**Photo Point No. 9 East**

Mesquites have increased vigor. Annuals are shorter. Mesquite trees used as an immigrant camp.

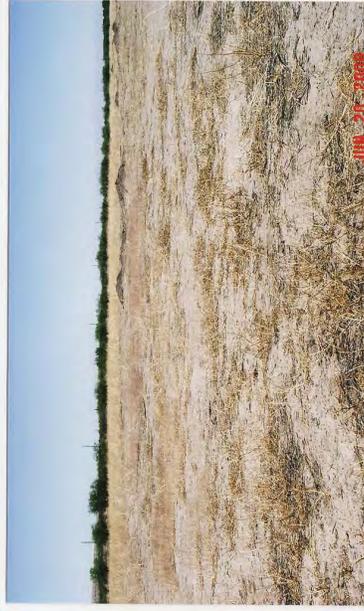
**Photo Point No. 9 North**

Decrease in annual groundcover. Test pits visible.

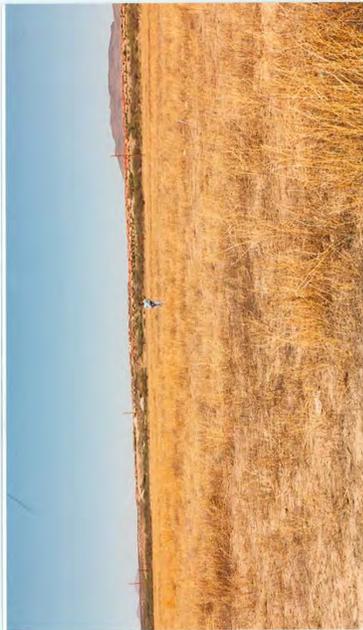
**Photo Point No. 9**  
Looking west across the large field at this location.

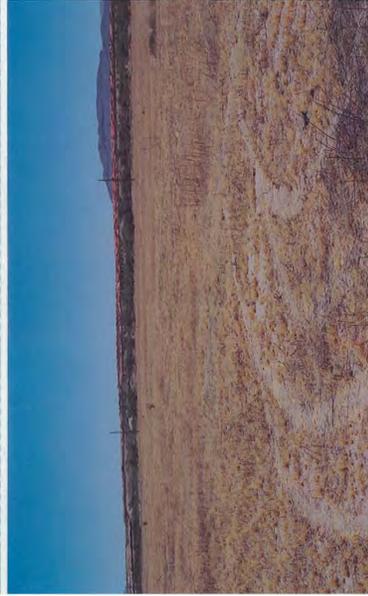
**Photo Point No. 9 West**

The annuals are shorter. Cholla visible in the center left of the photo.

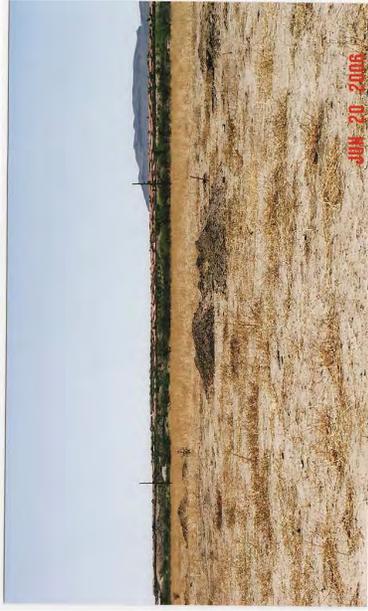
**Photo Point No. 9 West**

Test pits visible. Taller annuals, few short annuals.

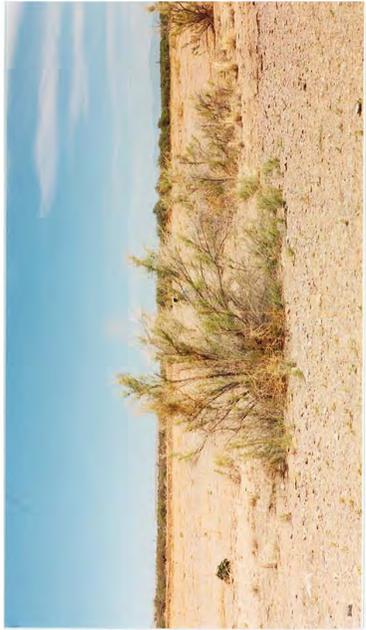
**Photo Point No. 10**  
Looking north along the flood plain of the Santa Cruz River. This photo point is west of the main east bank and just of a secondary bank.

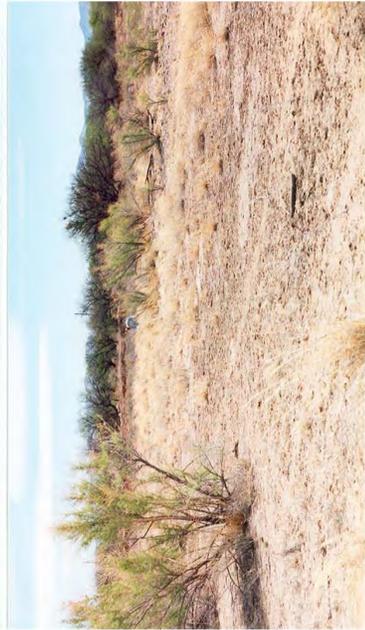
**Photo Point No. 10**  
Looking east toward the main (primary) bank of the Santa Cruz River. Vegetation here is burro bush on the floodplain with mesquite on the adjacent uplands.

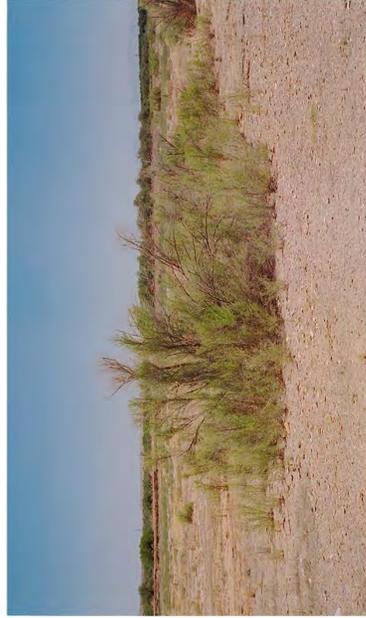
**Photo Point No. 10 North**  
The burro bush has grown. Annuals are present within the channel.

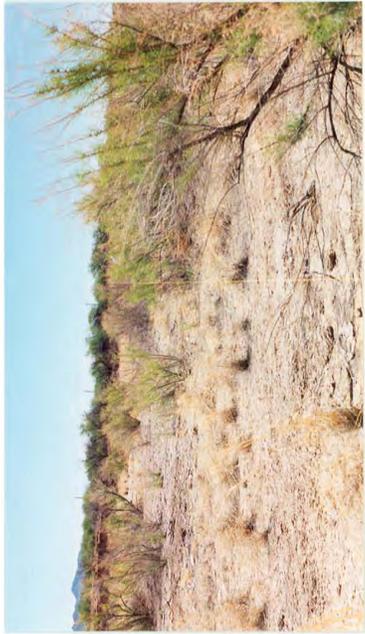
**Photo Point No. 10**  
Looking south across the burro bush-dominated Santa Cruz floodplain

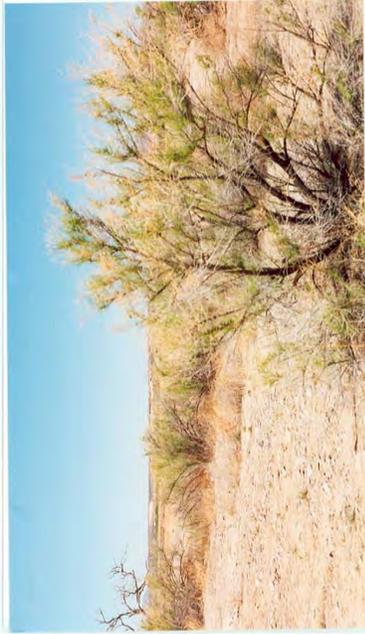
**Photo Point No. 10**  
Looking west across the Santa Cruz River. A secondary bank is situated 82.5' west of this photo point. Burro Bush is the dominant plant species at this site.

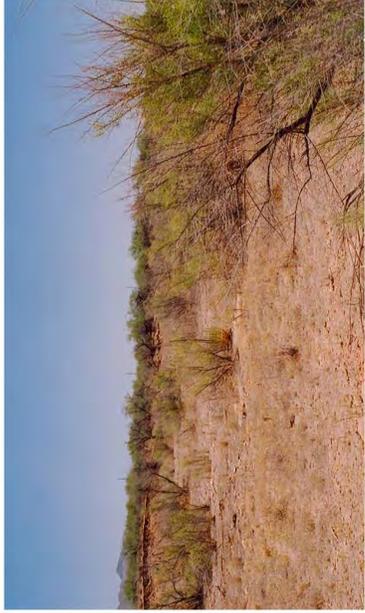
**Photo Point No. 10 South**  
No significant change.

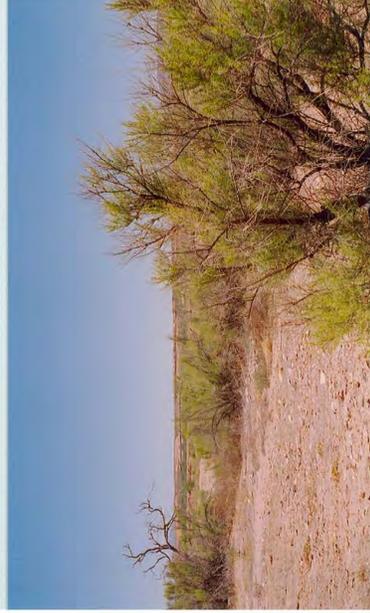
**Photo Point No. 10 West**  
No significant change.

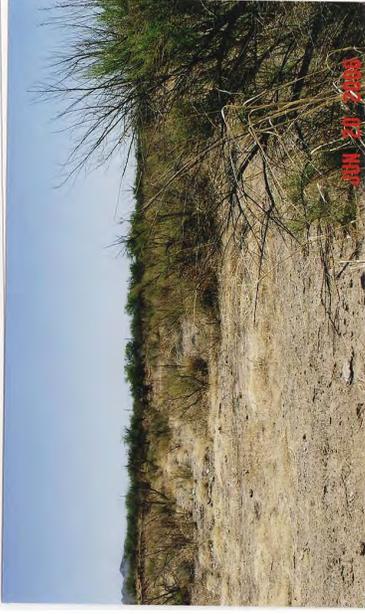
**Photo Point No. 10 South**  
Little change. Decrease in groundcover.

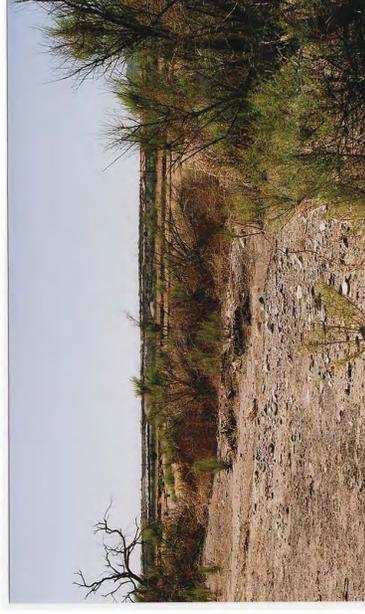
**Photo Point No. 10 West**  
Slight increase in burro bush. Increase in tumbleweeds.

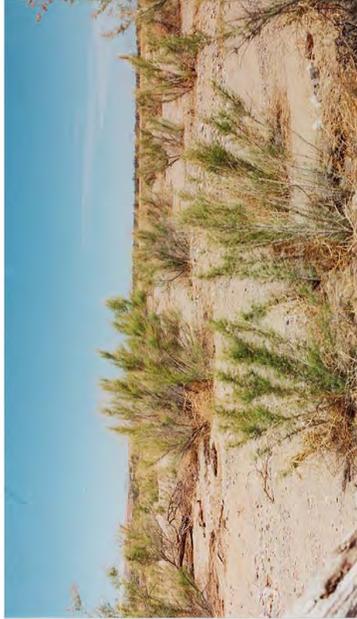
**Photo Point No. 11**  
Looking east across the center of the channel of the Santa Cruz River. Burro bush is essentially the only perennial plant species at this location.

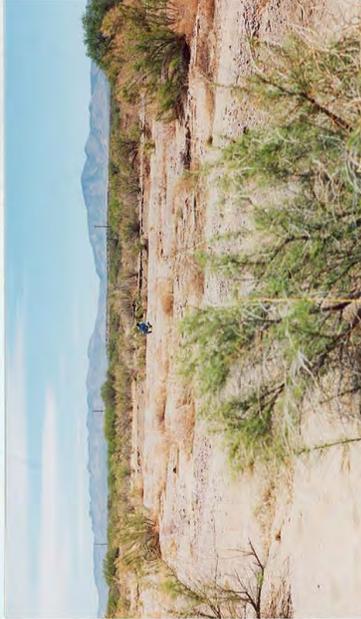
**Photo Point No. 11**  
Looking east across the Santa Cruz River channel. Burro bush dominates the river channel at this location.

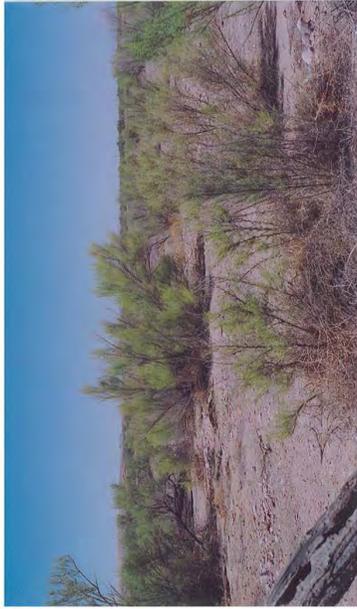
**Photo Point No. 11 North**  
There is little change from 2002.

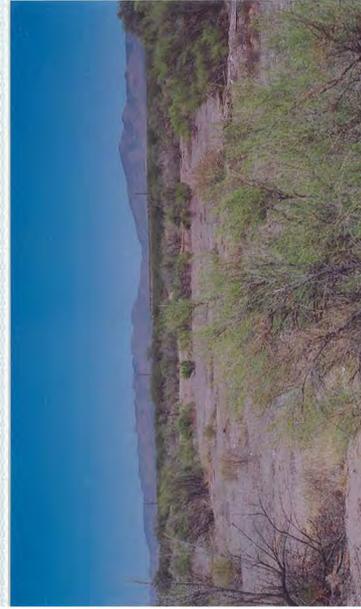
**Photo Point No. 11 East**  
Burro bush on the far side of the bank appears to have some dieback. Burro bush on the near side of the bank appear more vigorous.

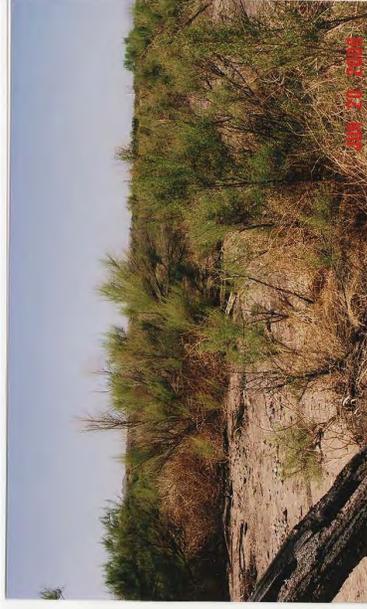
**Photo Point No. 11 North**  
Increase in tumbleweed and woody debris.

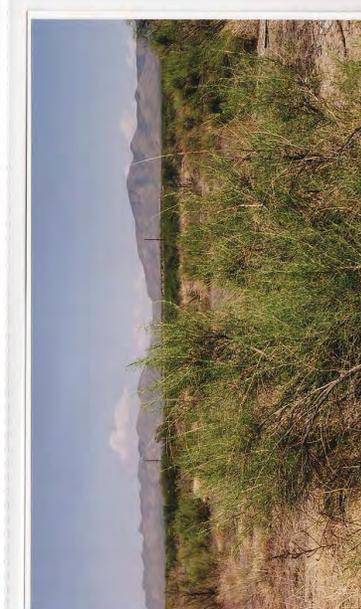
**Photo Point No. 11 East**  
Increase in burrobush vigor. Increase in groundcover.

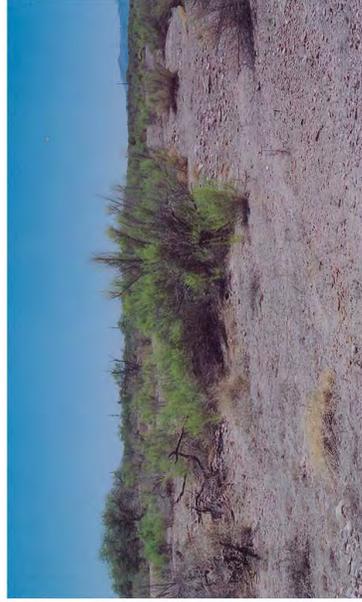
**Photo Point No. 11 South**  
 Burro bush appears more vigorous. No significant change.

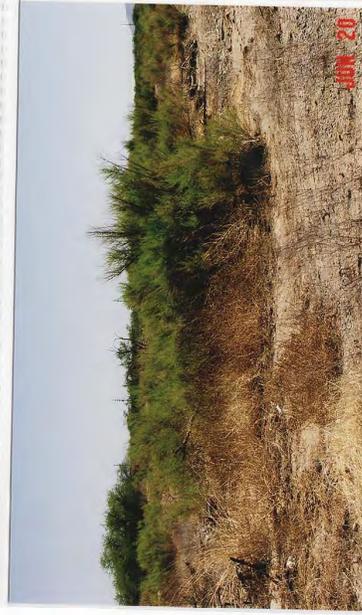
**Photo Point No. 11 South**  
 Increase in burrobush. Increase in tumbleweed debris. More bunch grasses present.

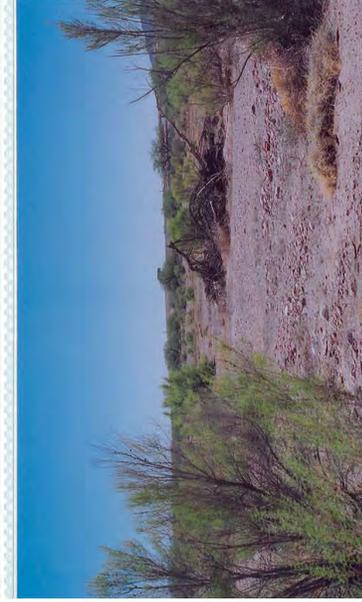
**Photo Point No. 11 West**  
 Burro bush appears slightly more vigorous. No significant change.

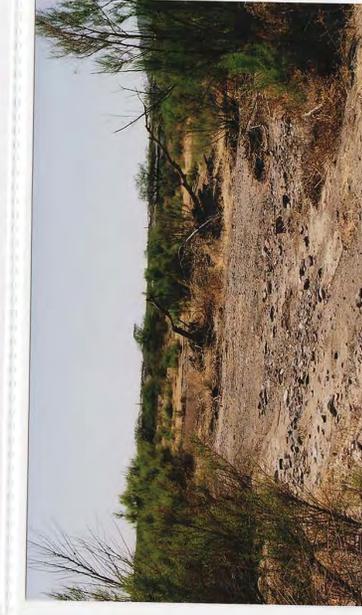
**Photo Point No. 11 West**  
 Increase of woody debris, slight increase in grasses.

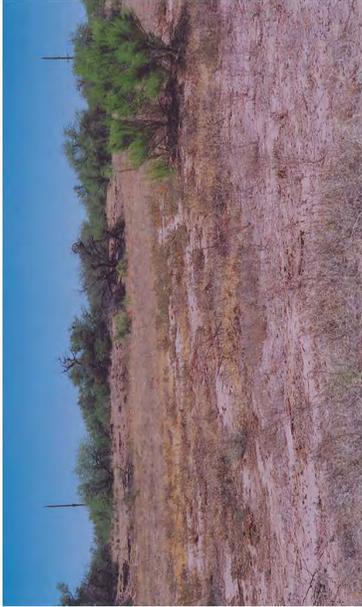
**Photo Point No. 12 South**  
Burro bush has increased in size. Increase of annual groundcover on bar.

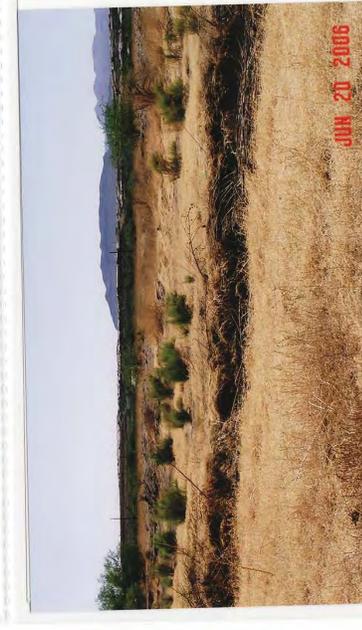
**Photo Point No. 12 West**  
Channel aggradation evident. Burrobush increase. Increase in Bermuda grass.

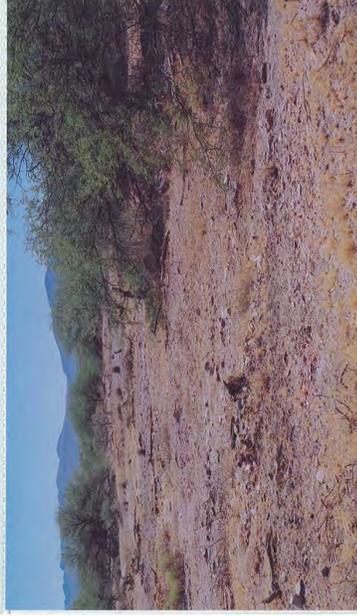
**Photo Point No. 13 East**  
Bunch grass is more prominent. Little change.

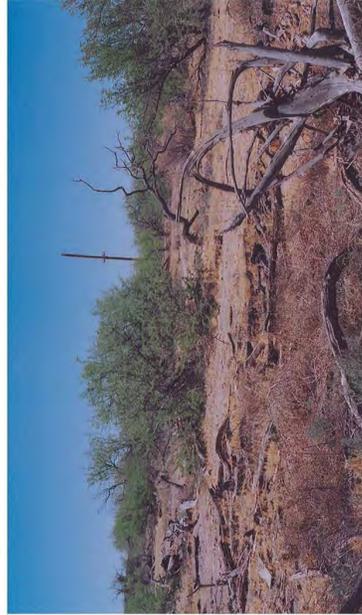
**Photo Point No. 13 South**  
There is very little change at this site. There are fewer tall annuals present.

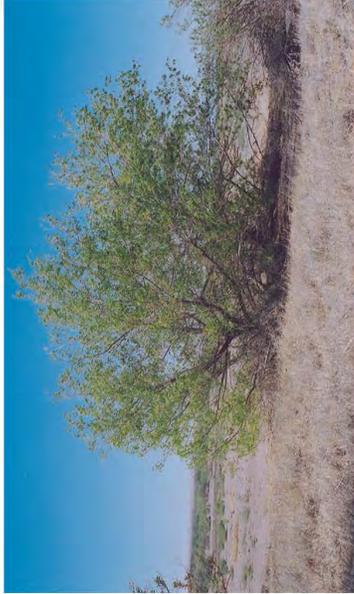
**Photo Point No. 14 North**

The Goodding willow has less foliage. There is an increase in Bermuda grass.

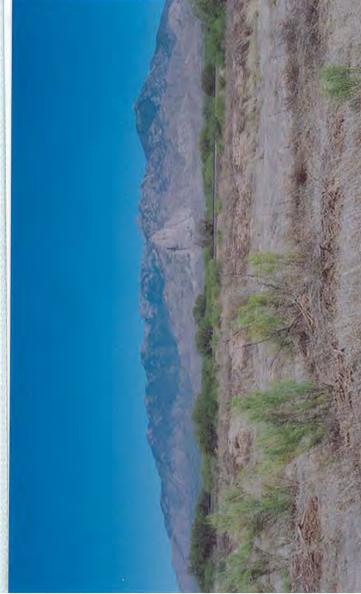
**Photo Point No. 14 East**

Burro bush has increased in size and number. Tumbleweeds are no longer present in the quantities shown in 2002.

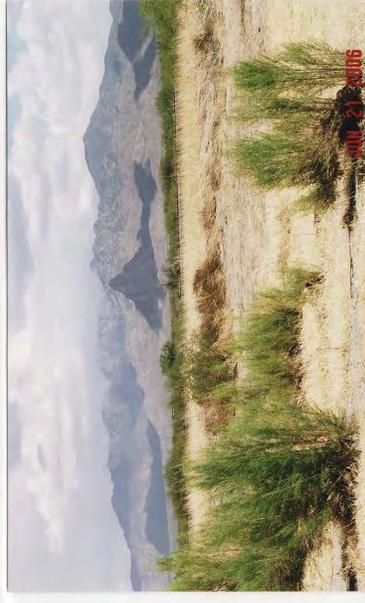
**Photo Point No. 14 East**  
\*New stake pounded in at this location.

Increase in burrobush vigor. Small mesquite (middle left) has increased in size. Less woody debris.

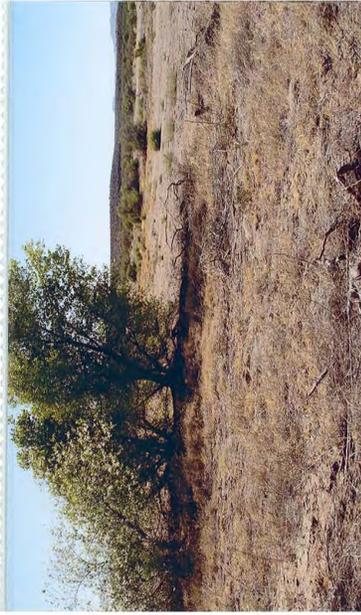
**Photo Point No. 14 West**  
\*\*\*

The cottonwoods have grown taller. Groundcover increase on bar. More burro bush and tumbleweed in wash.

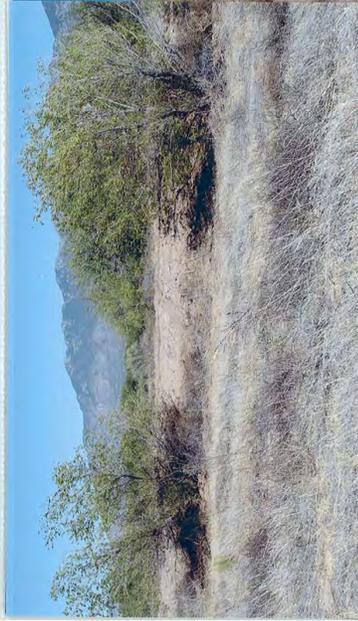
**Photo Point No. 15 East**

The Goodding willows appear sparser. There is an increase in groundcover. There is much woody flood debris.

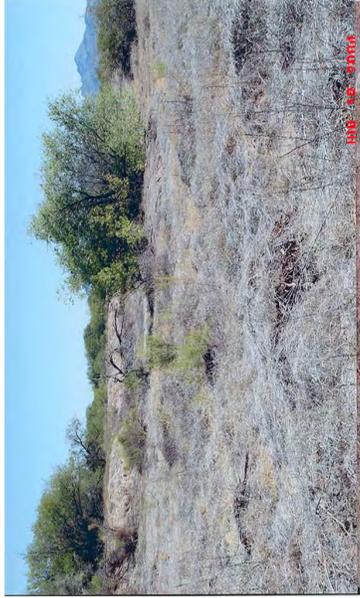
**Photo Point No. 15 South**  
There are more burro bush foliage and sprouts. There is more grass cover in the channel. The banks are lacking the orange colored annual present in 2002.

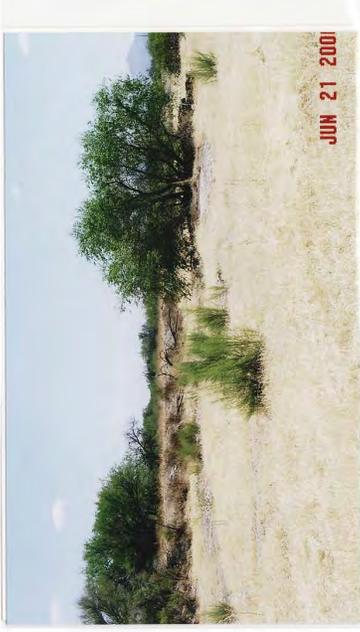
**Photo Point No. 15 South**  
\*New stake pounded in at this location.  
Burrobush has grown. Less woody debris.

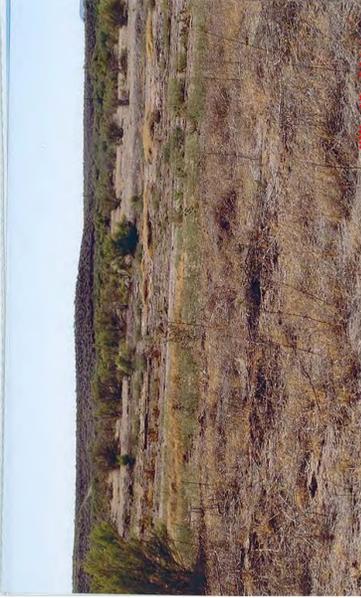
**Photo Point No. 15 West**  
\*\*\*  
The burro bush is taller. Increase in groundcover. Increase in woody flood debris.  
\*\*\*These photos are not exact matches to 2002 photos.  
See report for details.
