# Santa Cruz River at Canoa Ranch Photo Monitoring

Field Work Dates  
June 20-21, 2006

Pima County  
Natural Resources,  
Parks and Recreation

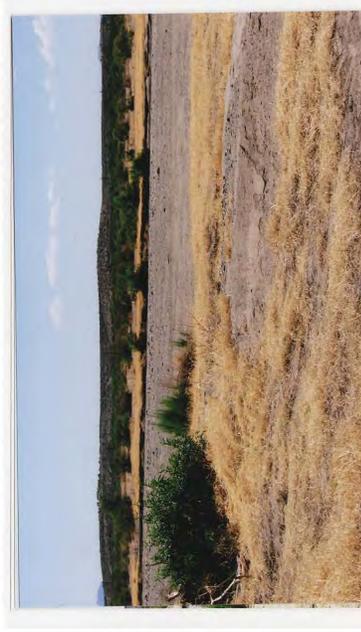
**Photo Point No. 15 West**  
\*New stake pounded in at this location.  
Channel has aggraded. Flood flows removed annual vegetation and woody debris.

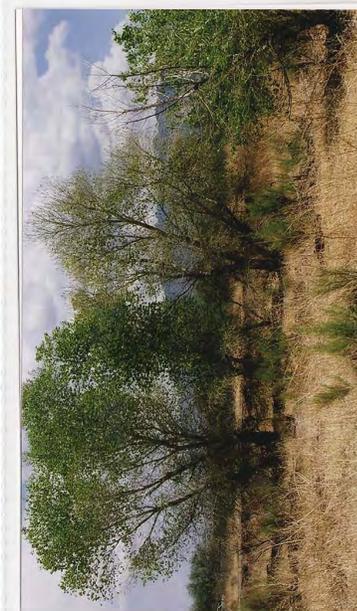
**Photo Point No. 16 East**  
 Cottonwoods showing signs of stress. Increase in tall annuals.

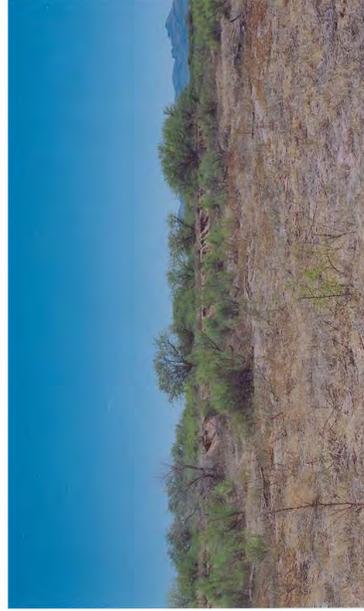
**Photo Point No. 16 South**  
Mesquite on top-left has died. More burro bush present.

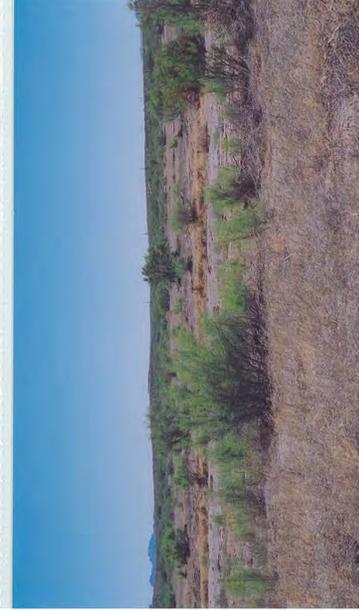
**Photo Point No. 16 West**  
Increase in burro bush sprouts and vigor. More annual groundcover present in channel.

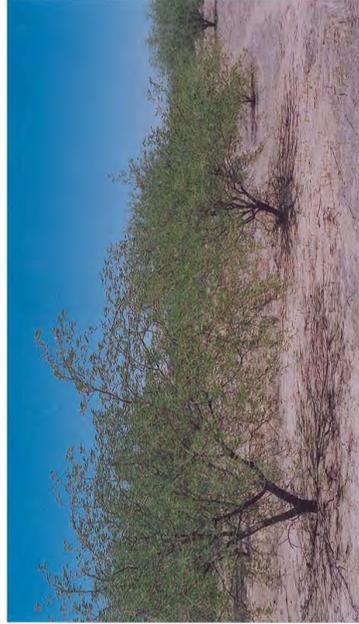
**Photo Point No. 17 North**  
The tall annuals present in April 2002 are no longer there. Mesquite vigor looks similar. A prominent trail is visible on the far left center of the photo.

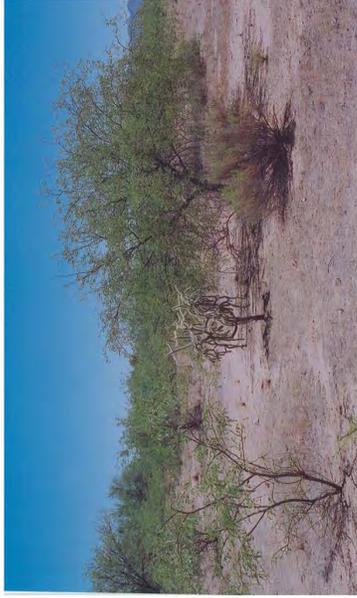
**Photo Point No. 17 South**  
The cholla has grown.

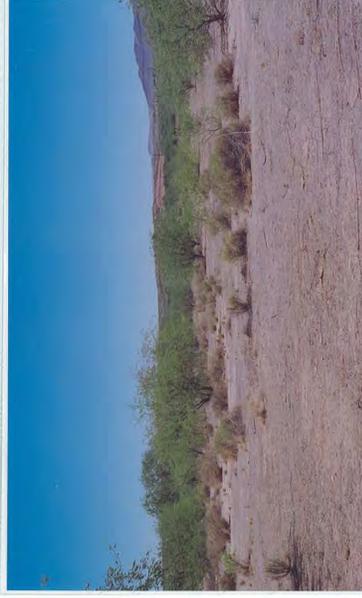
**Photo Point No. 17 West**  
There are no fall annuals.

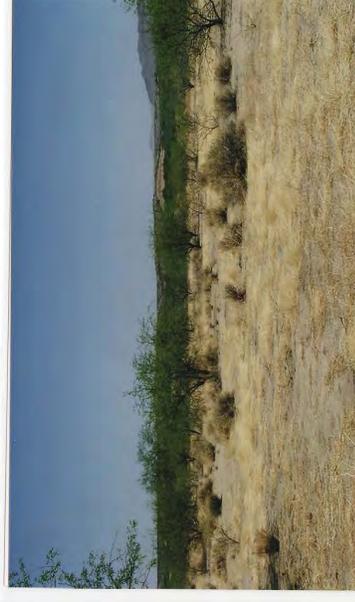
**Photo Point No. 17 West**  
Mesquites and shrubs showing signs of stress. Increase in low annuals.

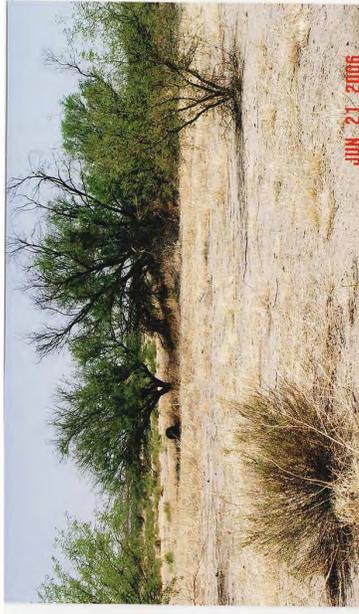
**Photo Point No. 18 North**

Decrease in annuals. Mesquites showing signs of stress and dieback.

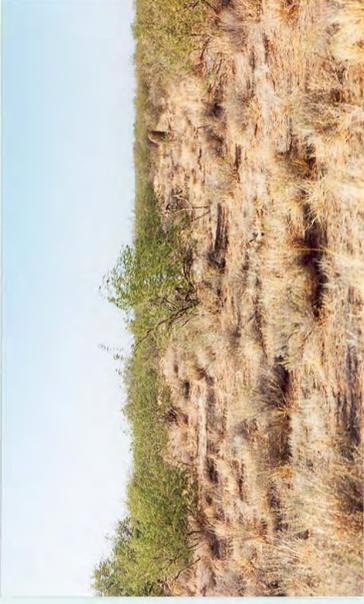
**Photo Point No. 19**  
 Looking north across mesquite-dominated landscape on the east bank of the Santa Cruz River. Small shrubs in the foreground are burrow weed. Note the large barrel cactus near right-center.

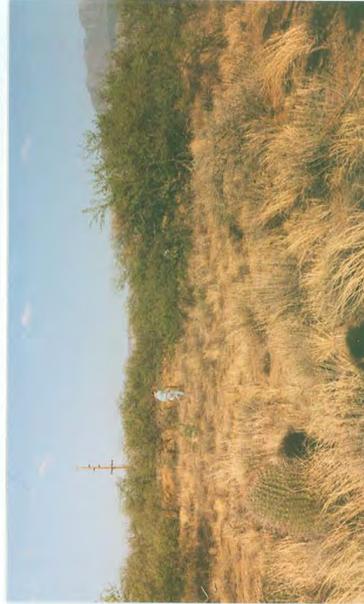
**Photo Point No. 19**  
 Looking east across the grass, burrow weed, and mesquite-dominated landscape. Note the barrel cactus in the lower left corner of the photo

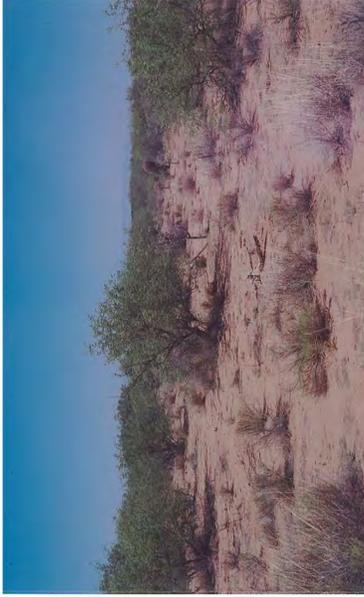
**Photo Point No. 19 North**  
 There are fewer shrubs and less groundcover.

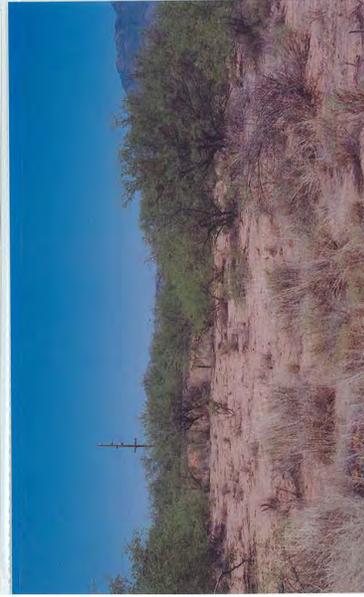
**Photo Point No. 19 East**  
 Barrel cactus (used to be lower left in the photo) had fallen over by October 2002. There are fewer and less vigorous grasses.

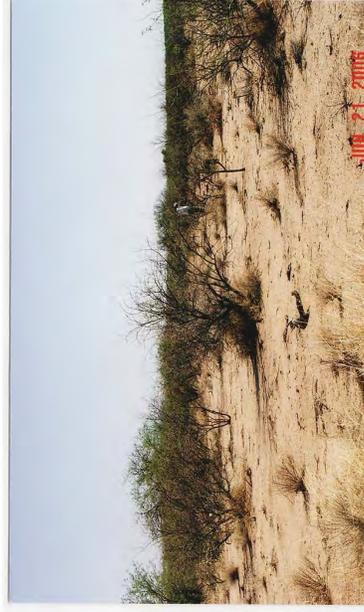
**Photo Point No. 19 North**  
 \*New stake pounded in at this location.  
 Mesquites stressed, leaf loss, and die back.

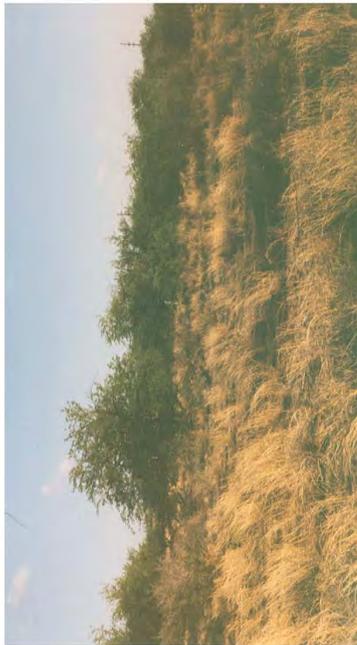
**Photo Point No. 19**  
Looking south across a landscape whose physiognomy is that of Semidesert grassland on the east bank of the Santa Cruz River.

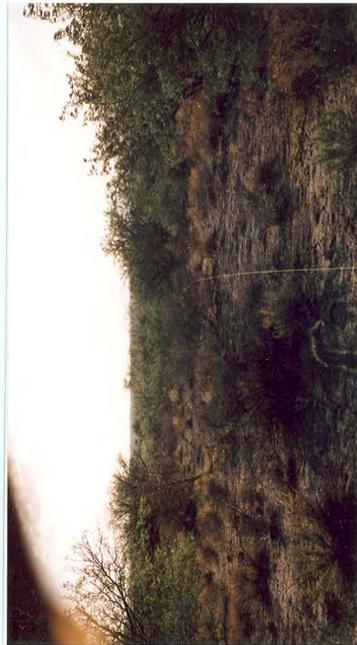
**Photo Point No. 19**  
Looking west toward the Santa Cruz River. Grasses, burrow weed, and mesquite are dominant forms and species here.

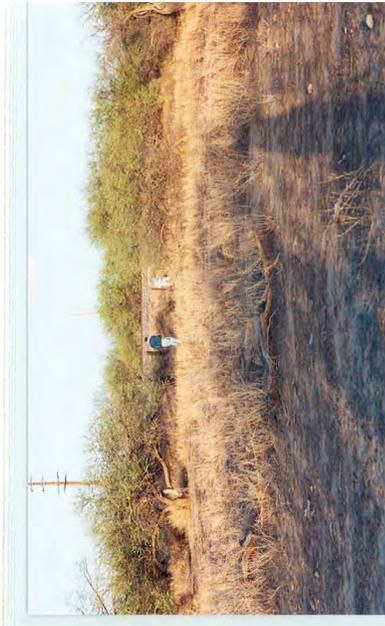
**Photo Point No. 20**  
Looking east toward the railroad grade.

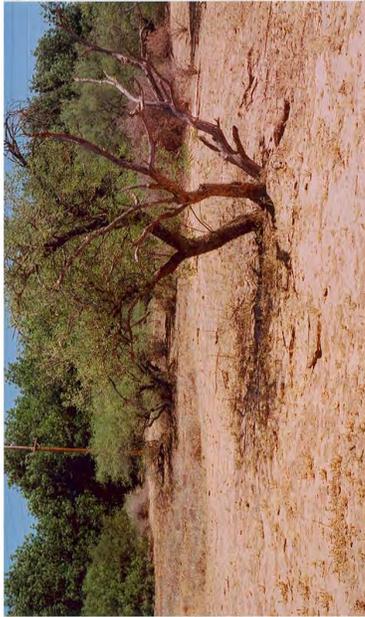
**Photo Point No. 20 North**  
Mesquite at right-center has increased vigor. Shrubs at upper center-right appear dead. Pecans appear more dense.

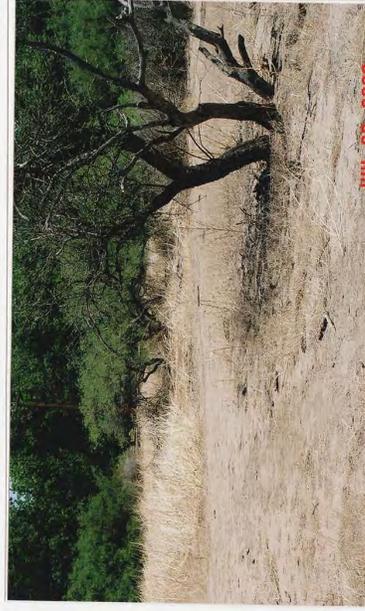
**Photo Point No. 20 North**  
Mesquites stressed, dieback. More tall annuals.

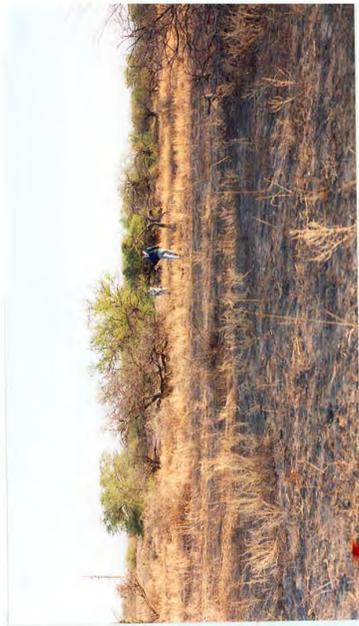
**Photo Point No. 20**  
Looking south across the mesquite-dominated landscape

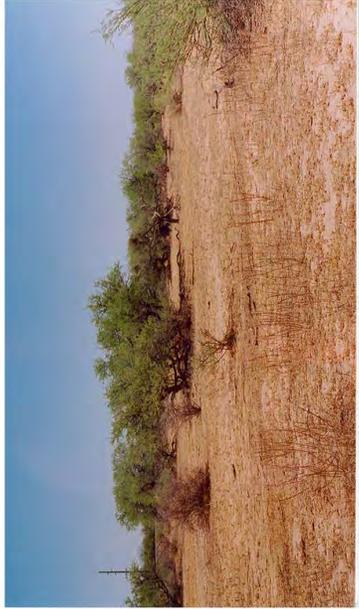
**Photo Point No. 20 South**  
Acacias have leafed-out. Increased mesquite vigor.

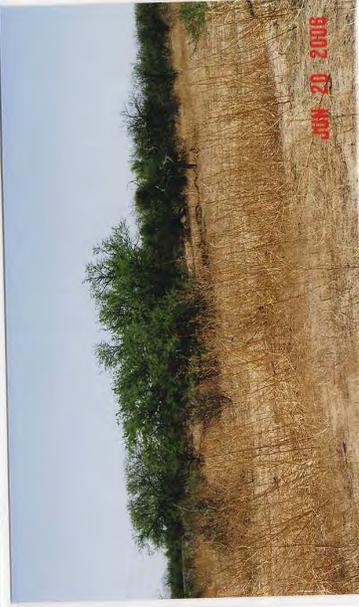
**Photo Point No. 20 South**  
More tall annuals. Small mesquite appears dead.

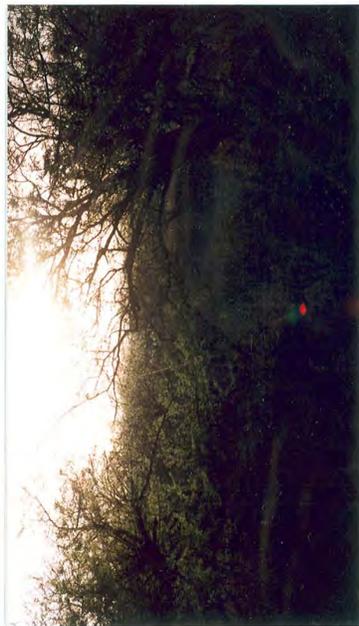
**Photo Point No. 20**  
Looking west into the sun.
